ALABAMA SHORELINE CHANGE RATES:
1970-1993

Tina A. Sanchez & Scott L. Douglass
College of Engineering Report No. 94-1

prepared for
Coastal Programs Office
Alabama Department of Economic and Community Affairs
401 Adams Avenue
Montgomery, Alabama 36103-5690

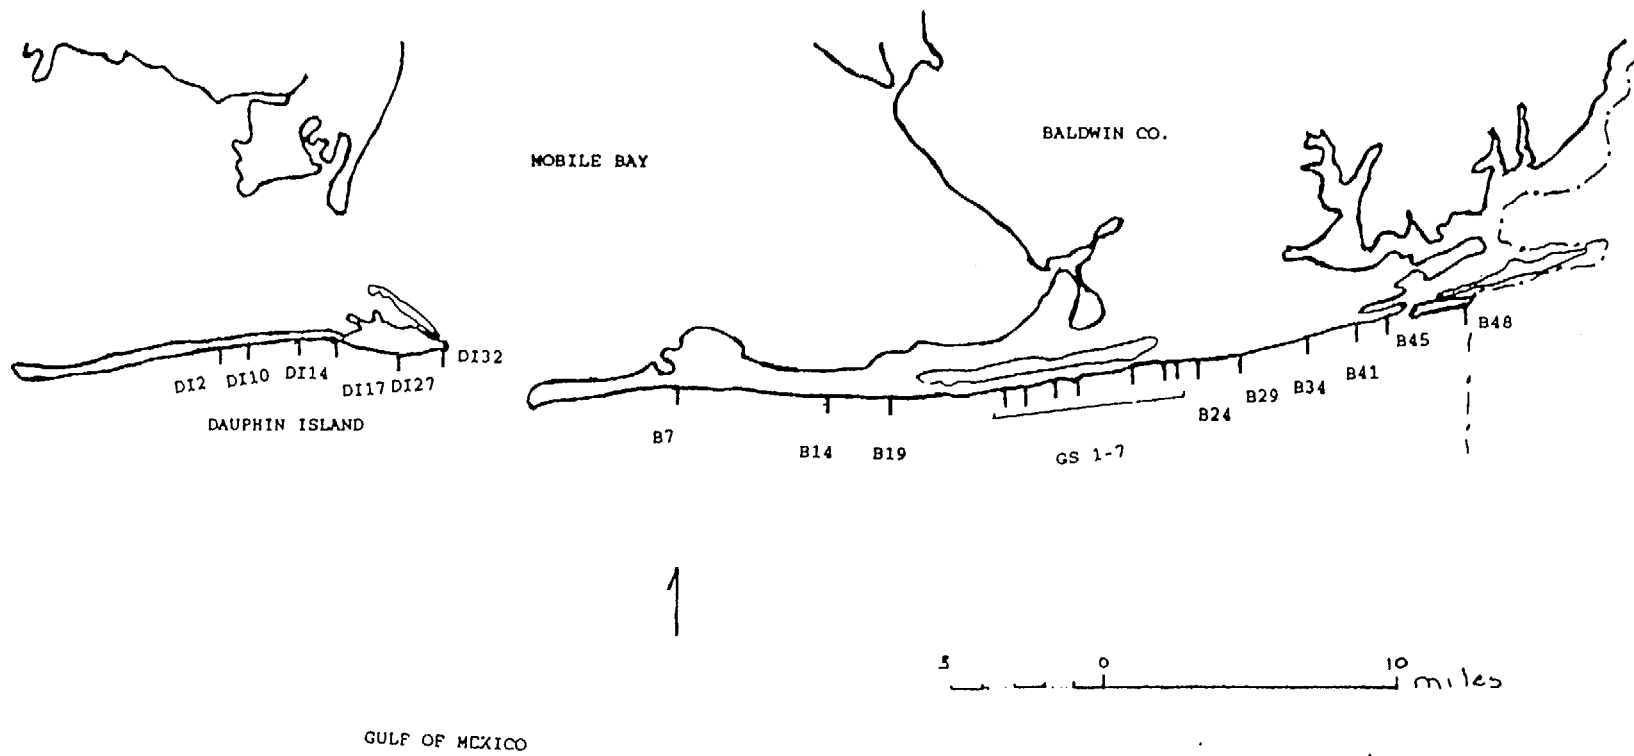
Fig. 1

Beach profiles were surveyed at 22 selected locations along the Alabama coast at 6 month intervals during the year of this study. The locations of the profiles are shown in Figure 1.

BEACH PROFILE LOCATIONS

Individual profiles began at Alabama Department of Environmental Management Construction Control Line monuments whenever possible. In this report, these profiles are designated by their ADEM CCL line number. Seven additional profiles were established as part of this study in Gulf Shores and are designated with "GS" numbers (Gulf Shores does not have ADEM CCL numbers). Elevations of most of the profiles were tied to the NGVD (National Geodetic Vertical Datum of 1929) through surveys. ADEM CCL monuments selected in Baldwin Co. were #48, #45, #41, #34, #29, #24, #14, #19, #7. Profiles on Dauphin Island were located at ADEM CCL monuments #32, #27, #17, #14, #10, #2.

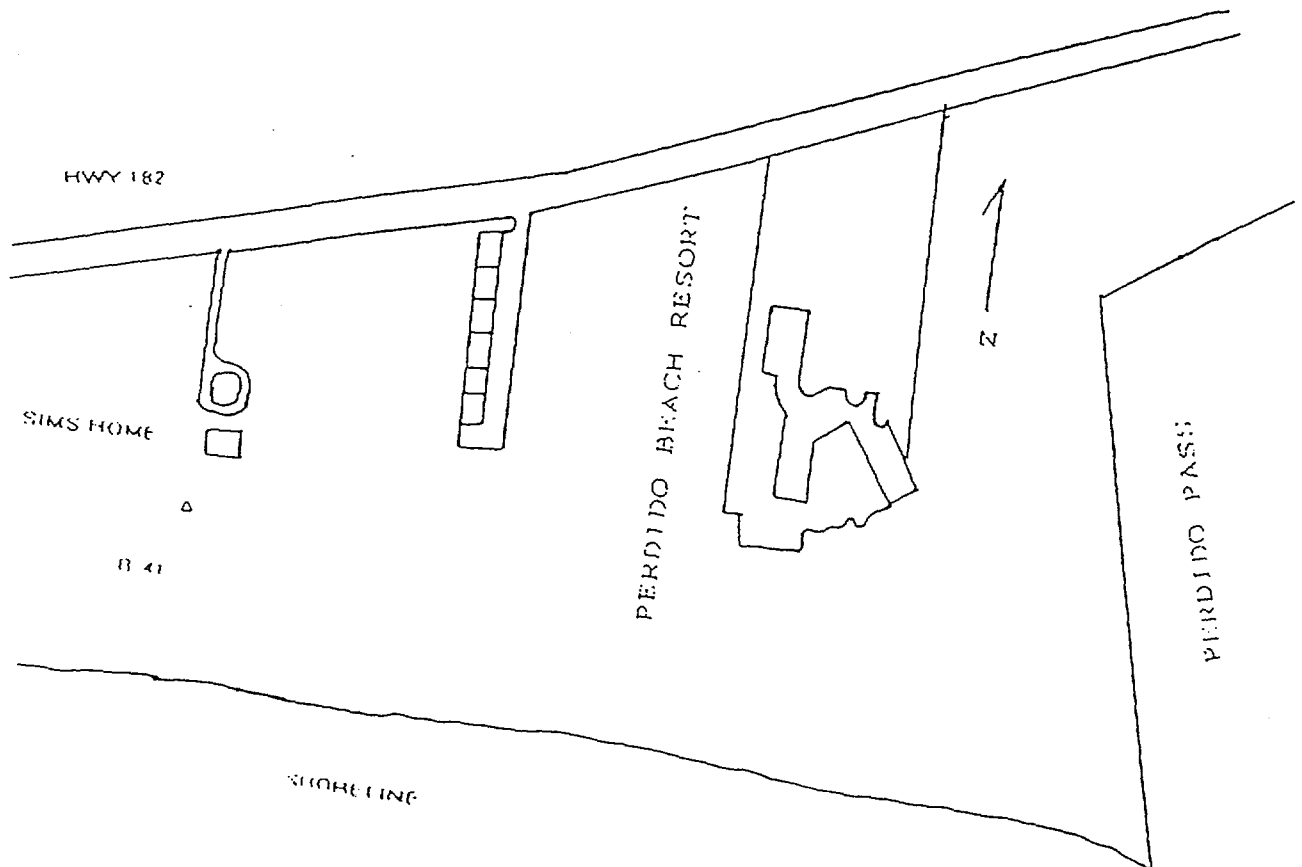
PROFILE NAME: Sims Home

DESCRIPTION: From the junction of Al. 59 and Al. 182 drive east on 182 for 7.9 miles to Mile Post 14.35 and turn right at Sims mailbox. The station is located on a low sand dune approximately 100 ft north of the beach. From a light pole near the beach-S 60 degreesW-57 ft. The station is an aluminum disk set in the top of a six inch square concrete post, projecting six inches, and stamped ADEM B-41 1985.

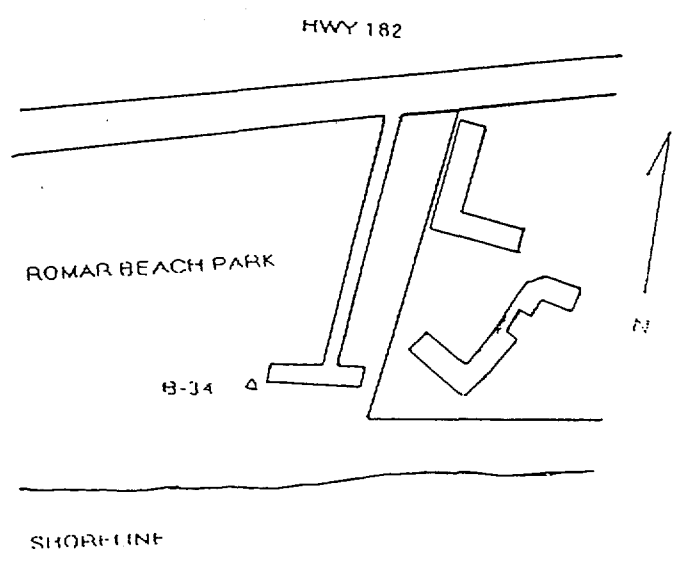
PROFILE NAME: Romar Beach Park

DESCRIPTION: The station is located on the side of a sand dune near the southwest corner of the paved parking lot and approximately 100 ft. north of the beach. From the southwest corner of the paved parking lot-West-20.3 ft. From a four-inch square concrete post-S 85 degrees W-62.9 ft. The station is an aluminum disk set in the top of a six inch square concrete post, projecting ten inches, and stamped ADEM B-34 1985.

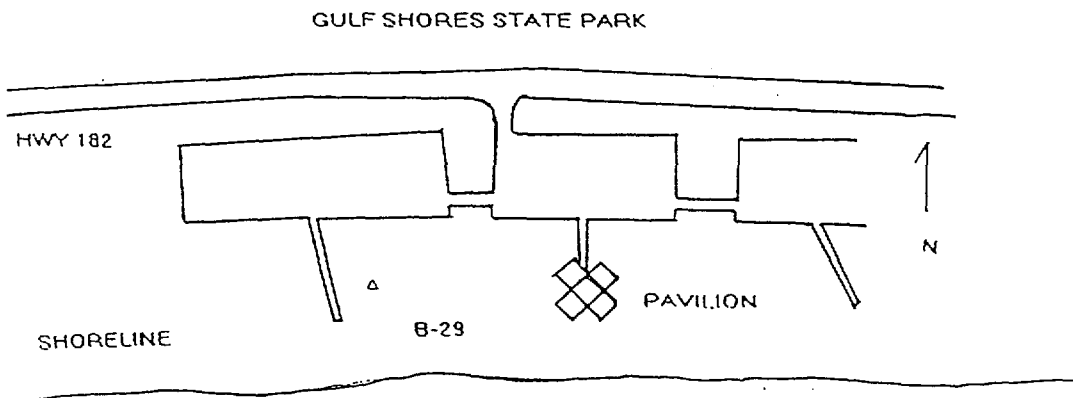
PROFILE NAME: Gulf Shores State Park Pavilion

DESCRIPTION: The station is located in the Gulf State Park approximately 250 ft. north of the beach. From the east edge of the wood walkway-N 70° E-80ft. From the southeast corner of the wood walkway-N 25 degrees E-98ft. From a light pole at the south edge of the parking lot-S 05 degrees W-149ft. The station is an aluminum disk set in the top of a sixteen-inch square concrete post, projecting eighteen inches, and stamped ADEM B-29 1985.

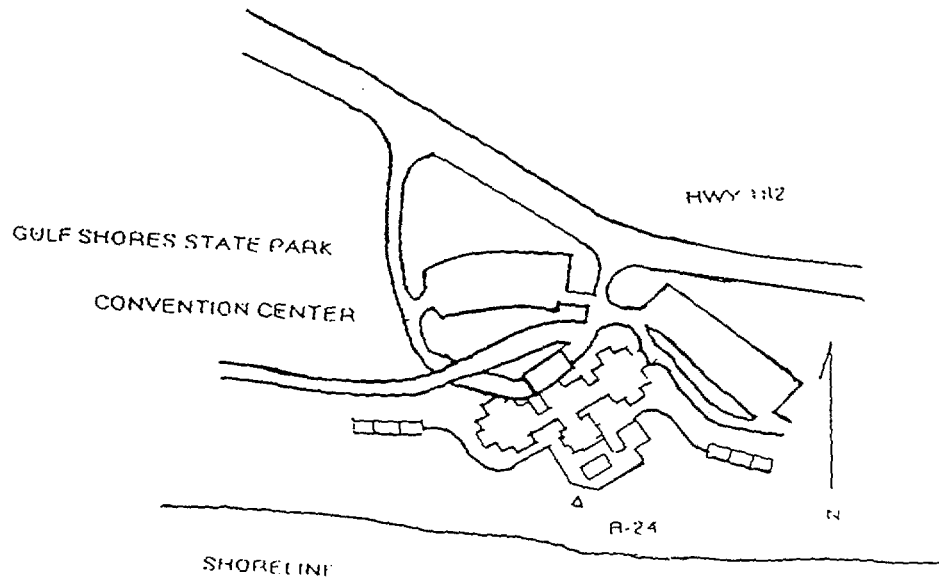
PROFILE NAME: Gulf Shores State Park Convention Center

DESCRIPTION: The station is located near the southwest corner of the Gulf State Park Convention Center outside the concrete seawall. From the curved concrete seawall-S 10 degrees E-4.9ft. From the southwest corner of a porch at the southwest corner of the Convention Center-S10 degrees E-37.8 ft. The station is an aluminum disk set in the top of a six inch square concrete post, projecting six inches, and stamped ADEM B-24 1985.

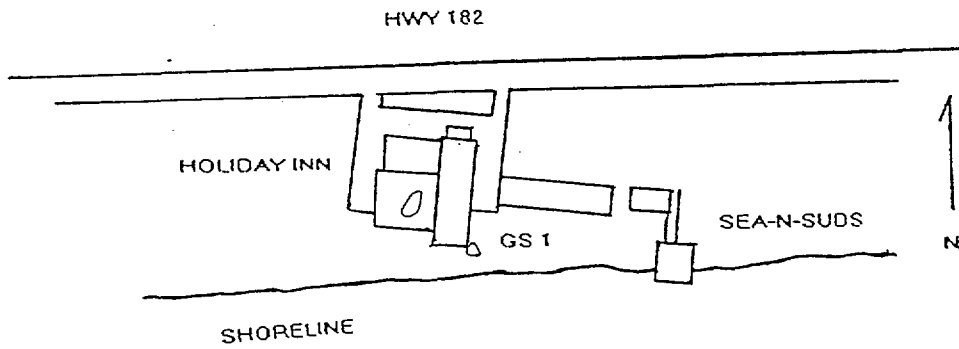
PROFILE NAME: Holiday Inn, Gulf Shores

DESCRIPTION: Benchmark is top corner (SE) of top step at base of vertical wall at Holiday Inn.

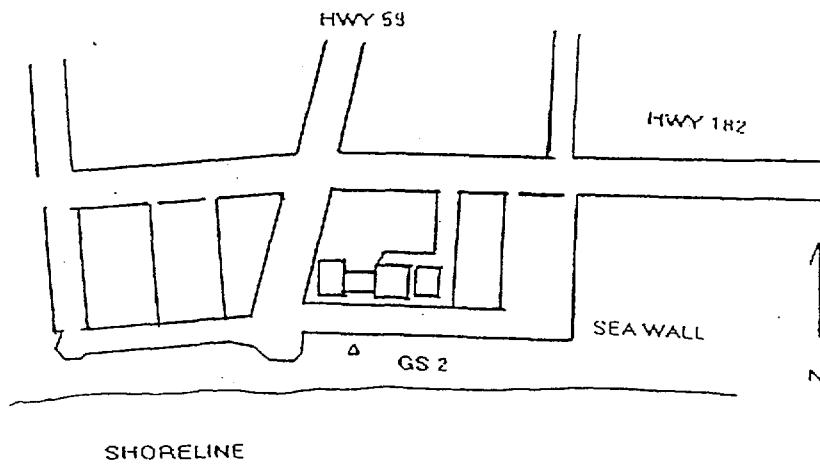
PROFILE NAME: Main Beach, Gulf Shores

DESCRIPTION: Benchmark is top of aluminum seawall in front of second light pole (#481) east of main beach pavilion.

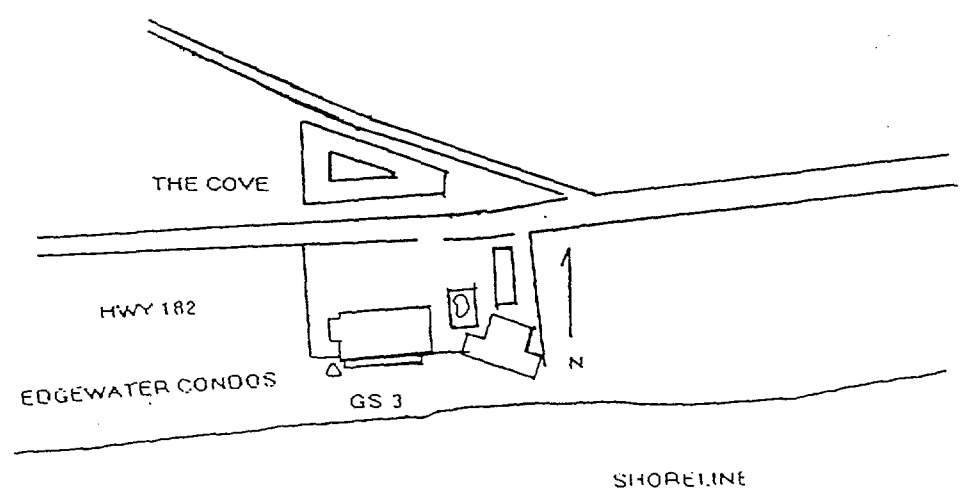
PROFILE NAME: Edgewater Condos

DESCRIPTION: Benchmark is SW corner of aluminum bulkhead beneath wooden rail.

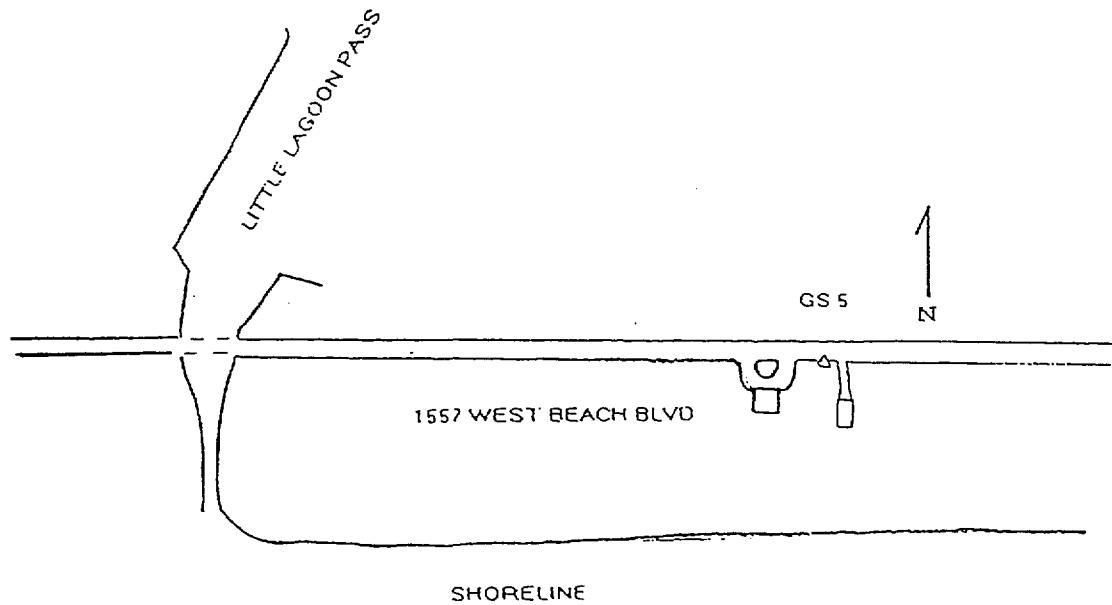
PROFILE NAME: 1557 West Beach Blvd. (East of Pass)

DESCRIPTION: Benchmark is located on edge of highway approximately 1500 feet east of Little Lagoon Pass.

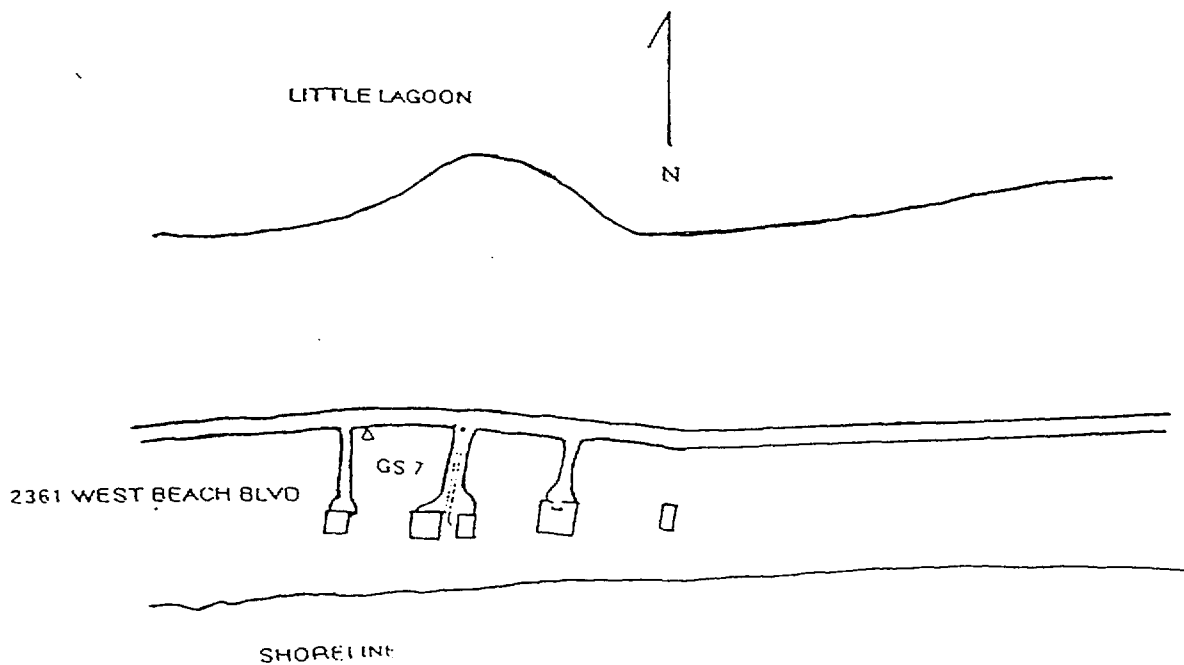
PROFILE NAME: 2361 West Beach Blvd.

DESCRIPTION: Benchmark is located on edge of highway 8500 feet west of Little Lagoon Pass. Line is parallel to side of house to west.

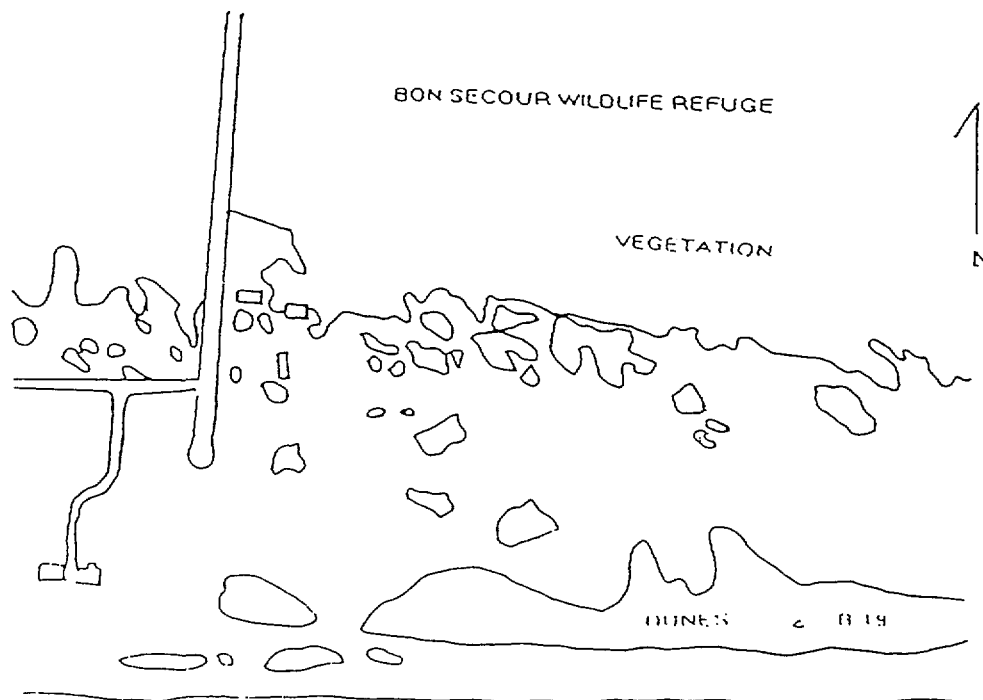
PROFILE NAME: Bon Secour Wildlife Refuge

DESCRIPTION: Drive west from Al. 59 and Al. 180 for 9.05 miles to Mile Post 11.9 turn left at "Dunes Lakes East Boundary" sign drive south 1.35 miles to the end of the road, then walk for .25 mile to the station. The station is located near the southwest corner of a National Wildlife Refuge on top of a small sand dune approximately 175 feet north of the beach and approximately 550 feet east of a 100 foot radio tower. The station is an aluminum disk set in the top of a six-inch square concrete post, projecting six inches, and stamped ADEM B-19 1985.

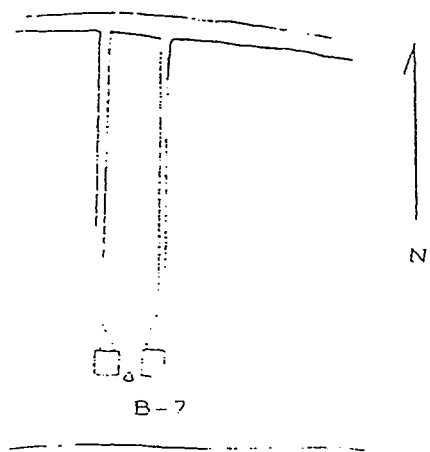
PROFILE NAME: Fort Morgan Rd., Mile Post 4.6

From the northeast corner of the house on the west-S-45 degrees E-84ft.

The station is an aluminum disk set in the top of a six-inch square concrete post, projecting six inches, and stamped ADEM B-7 1985.

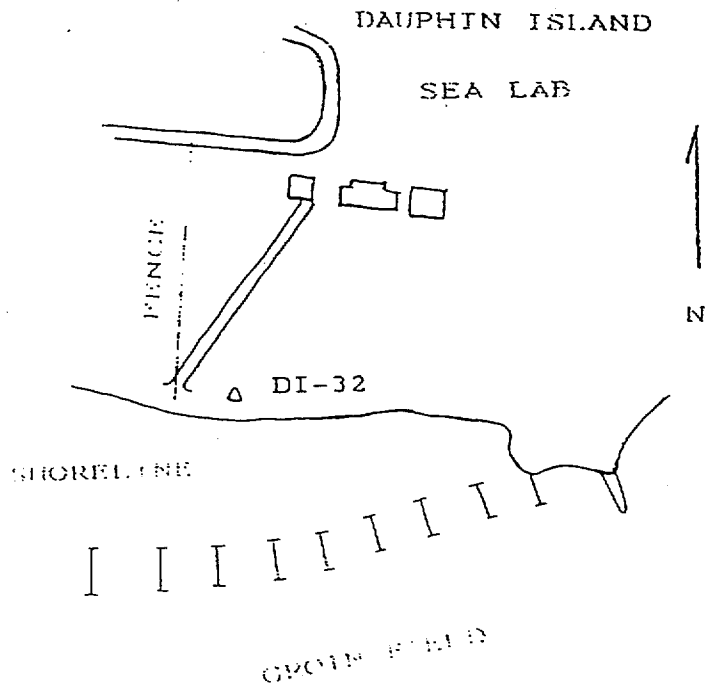
PROFILE NAME: Groin Field

DESCRIPTION: The station is on Dauphin Island Sea Lab property, approximately 50 ft. N of the Gulf and 300 ft. S of Galathea Hall, Dauphin Island Sea Lab. The marker is set in a 6"x6" concrete block with an aluminum disk stamped ADEM DI 32 1986. The elevation was taken from Corps. marker 21D-aB located at State Plane Coordinates: x = 316,787.303 y = 90,061.148, EL = 6.09 NGVD.

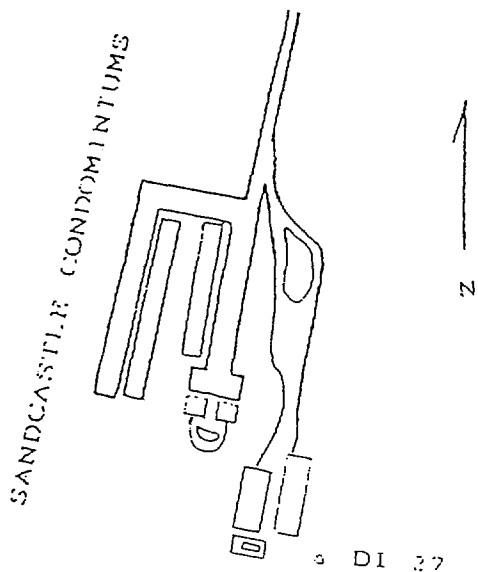
PROFILE NAME: Sand Castle Condominiums

DESCRIPTION: This station is located at Sand Castle Condominiums at the end of Forney Johnston Drive. The station is approximately 51 ft. SE of the SE corner of the eastern most seaward condominium and approximately 100 ft. E of the NE corner of the swimming pool. The marker is set in a 6"x6" concrete block with an aluminum disk stamped ADEM DI 27 1986. The elevation was taken from Corps marker 21D-1F located at State Plane Coordinates: x = 310,599.731 y = 88,946.689 EL = 7.15 NGVD.

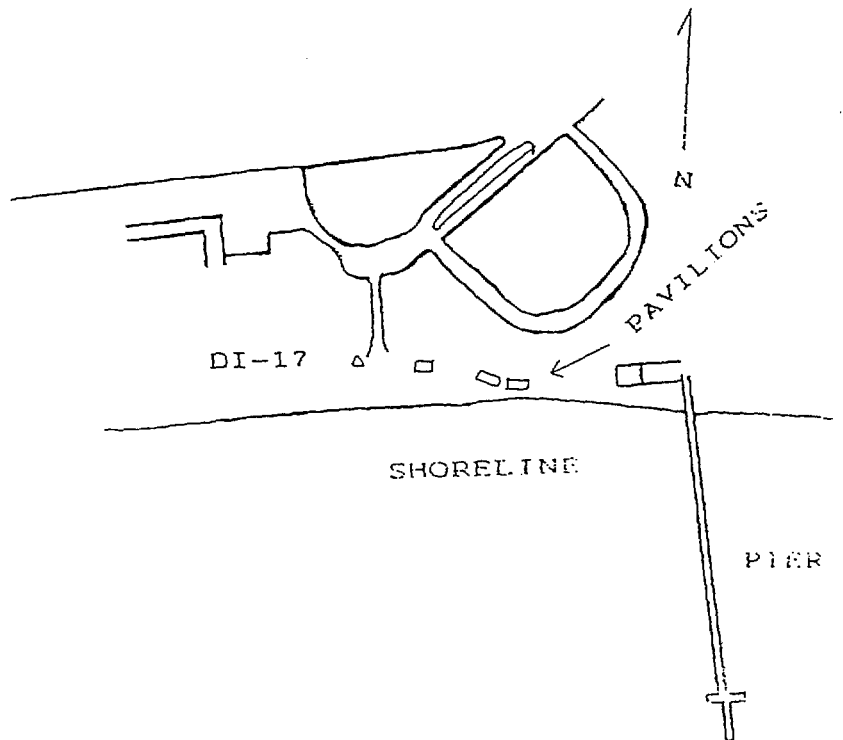
PROFILE NAME: Public Pier & Beach

DESCRIPTION: This station is located on Dauphin Island Public Beach property on a large sand dune W of eastern most pavilion. It is approximately 100 ft. N of the Gulf and 175 ft. W of western most pavilion. The marker is set in a 6"x6" concrete block with an aluminum disk stamped ADEM DI 17 1986. The elevation was taken from Corps marker 21D-1U located at State Plane Coordinates: x = 302,085.424 y = 91,443.011 EL = 17.42 NGVD.

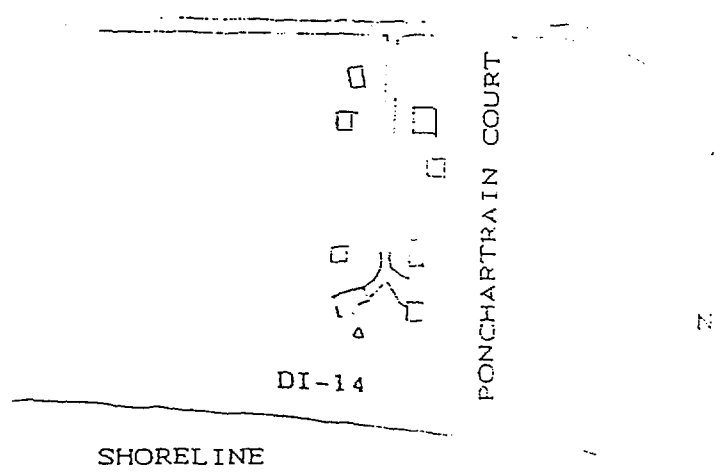
PROFILE NAME: Ponchartrain Court

DESCRIPTION: This station is located at the end of Ponchartrain Court 130 ft. SW of the end of the pavement and approximately 50 ft. SW of a palm tree in the front yard of the house named "Huracan." The marker is set in a 6"x6" concrete block with an aluminum disk stamped ADEM DI 14 1986. The elevation was taken from Corps marker 21D-1L located at State Plane Coordinates: x = 297,858.145 y = 91,712.678 EL = 6.25 NGVD.

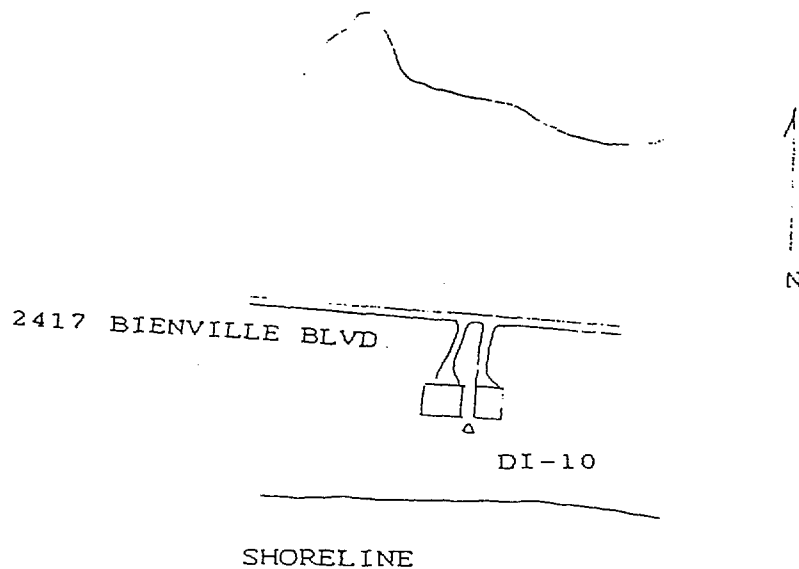
PROFILE NAME: 2417 Bienville Boulevard

DESCRIPTION: This station is located between two houses, one of the houses being 2417 Bienville Blvd. The monument is 15 ft. W of the blue house (2417 Bienville Blvd.) and 30 ft. E of the grey house. The marker is set in a 6"x6" concrete block with an aluminum disk stamped ADEM DI 10 1986. The elevation was taken from a nearby benchmark furnished by Mr. Showers, a local surveyor.

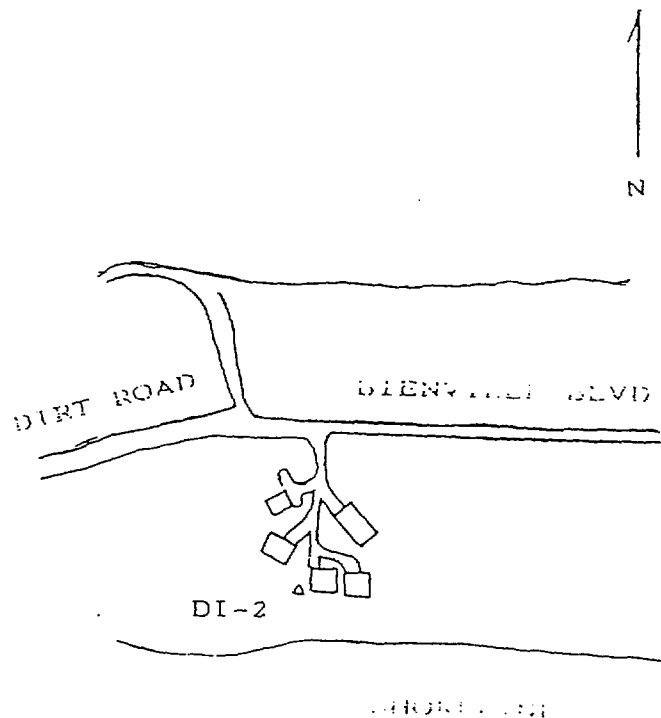
PROFILE NAME: West End

DESCRIPTION: This station is located at the western end of Bienville Blvd. approximately 140 ft. N of the Gulf, 2 ft. NW of SW most pile of the newly built house "Tales End", 100 Bienville Blvd., and approximately 100 ft. S of manhole cover on the S side of Bienville Blvd.'s end. We believe that this monument was disturbed in the Fall of 1991, and that it's location should be resurveyed. The elevation was taken from a nearby benchmark furnished by Mr. Showers, a local surveyor.
