CHEATHAM ANNEX PROJECT

DEPARTMENT OF ENVIRONMENTAL SCIENCES
UNIVERSITY OF VIRGINIA
CHARLOTTESVILLE, VA 22903

NOVEMBER 19, 1990

NOV 1990
FEDERAL
SUPERFUND
(REMEDIAL)

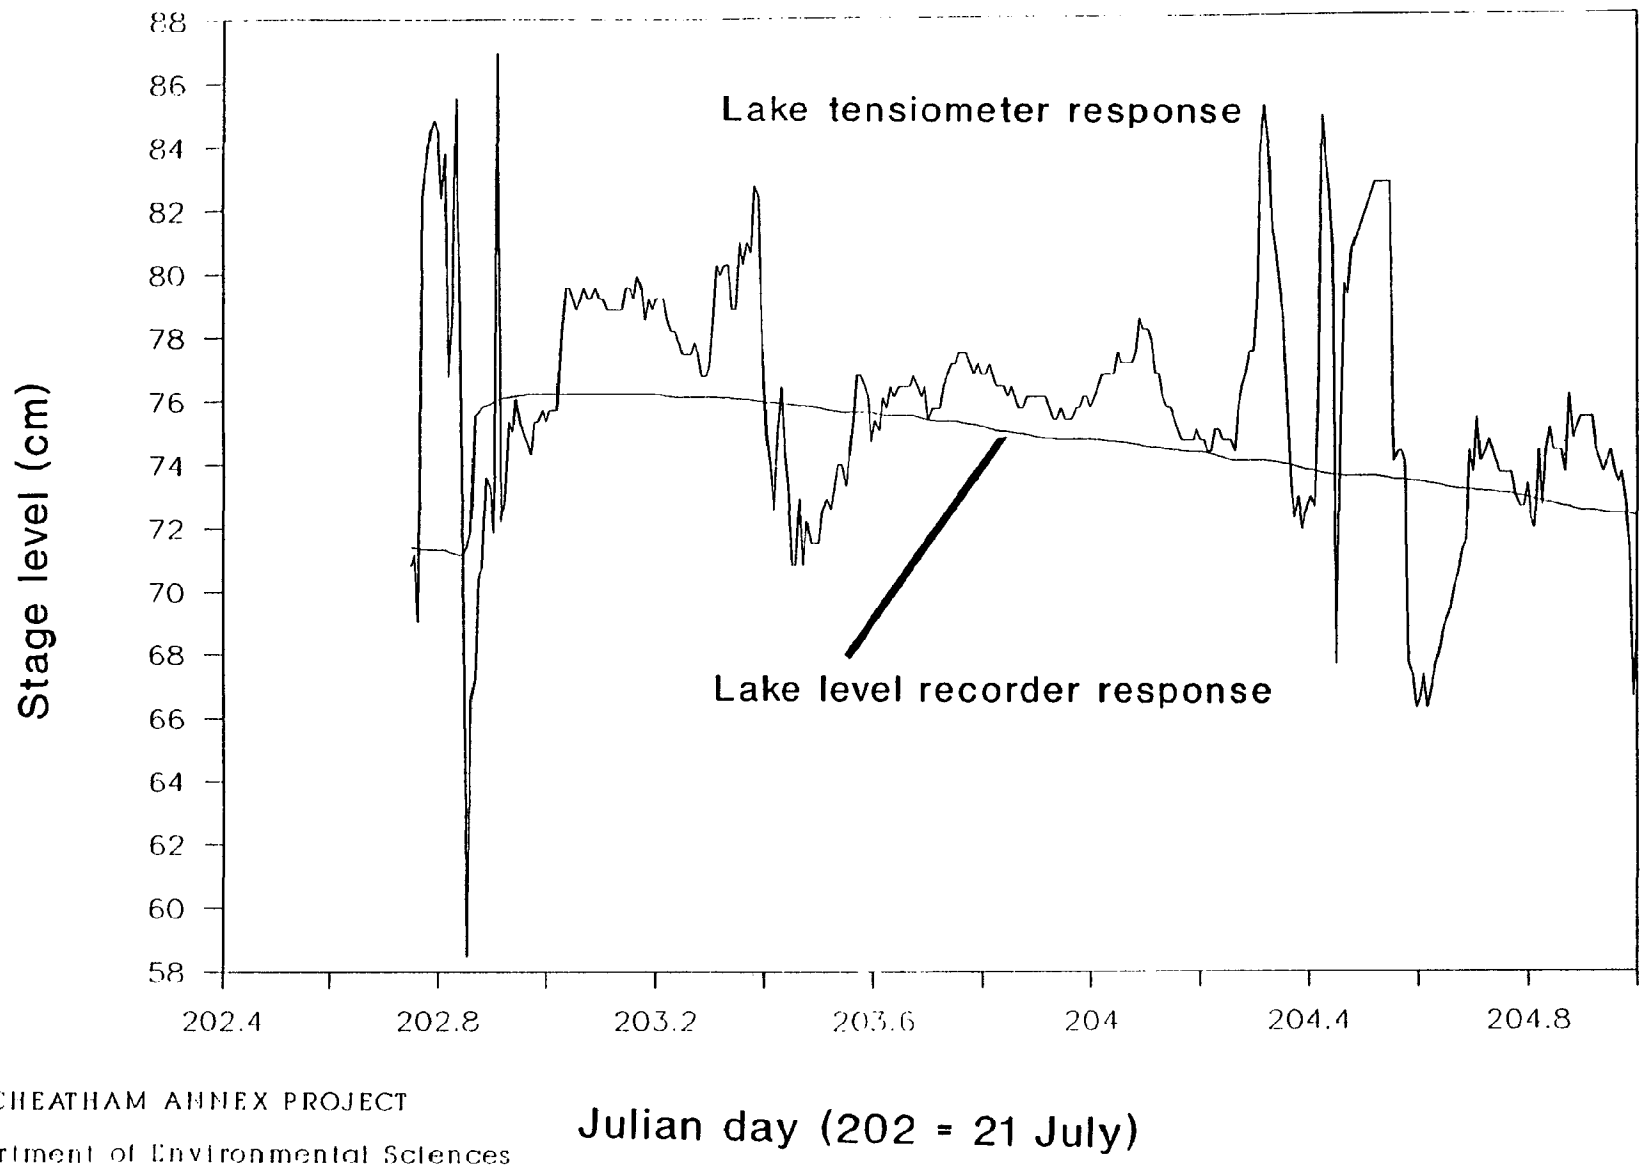
We also sought to evaluate the buildup of groundwater gradients at the pond margin from the tensiometer records of soil water pressure. Although we had hoped to establish a control for removing temperature biases in the digital output from the transducers, each transducer behaved differently in response to thermal and solar loading. These thermal and solar factors were found to exert more control on the output than actual changes in soil water/lake level pressure changes (Figure 2.7). The large excursions in the output followed quite closely the ambient air temperature fluctuations (Figure 2.8). The variability of transducer output with respect to environmental factors was too great for accurate reconstructions of soil pressure gradients to be made.

Figure 2.7. Comparison of response traces during and following a storm event. The wide variability of the tensiometer record against the "actual" lake response is evident.

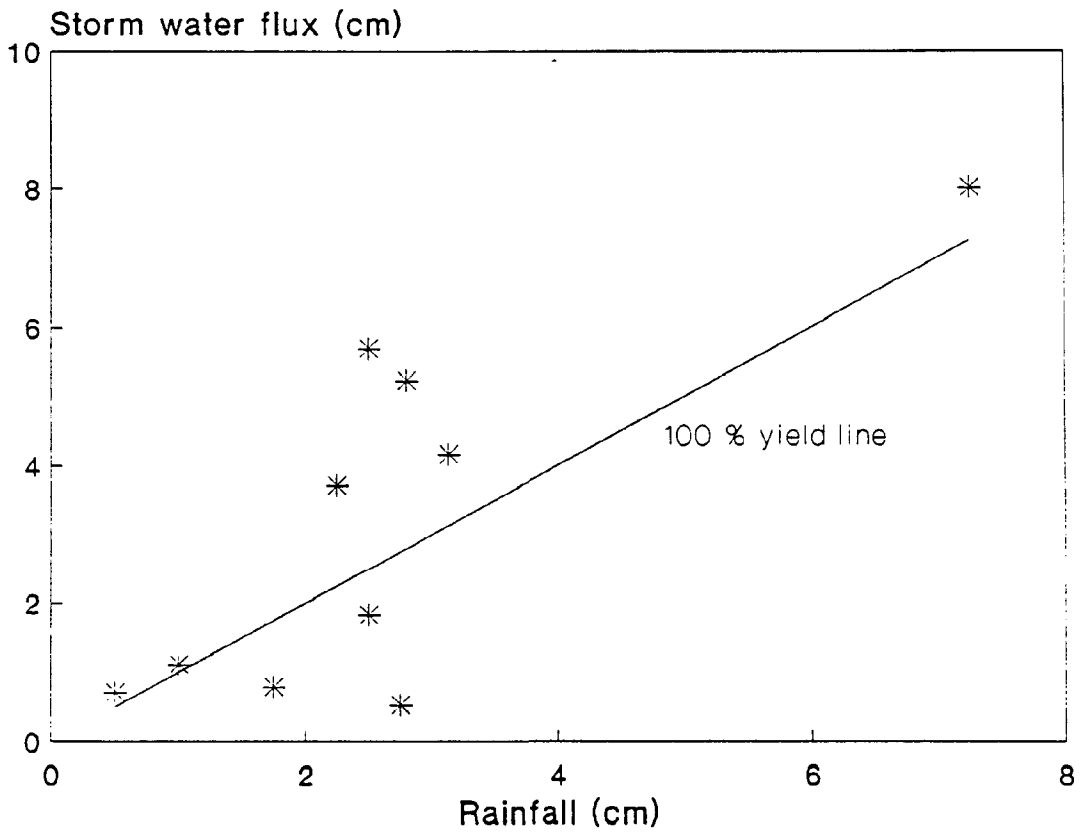
Storm volumes expressed as fluxes across the floodplain area above the North Branch suggest that storm yield was not highly variable (Figure 2.11). The sediments of hillslopes bases and the floodplain drain rapidly and most likely return to pre-storm conditions within two days.

Figure 2.11. Runoff yields from the North Branch floodplain above the flume for a series of storms.

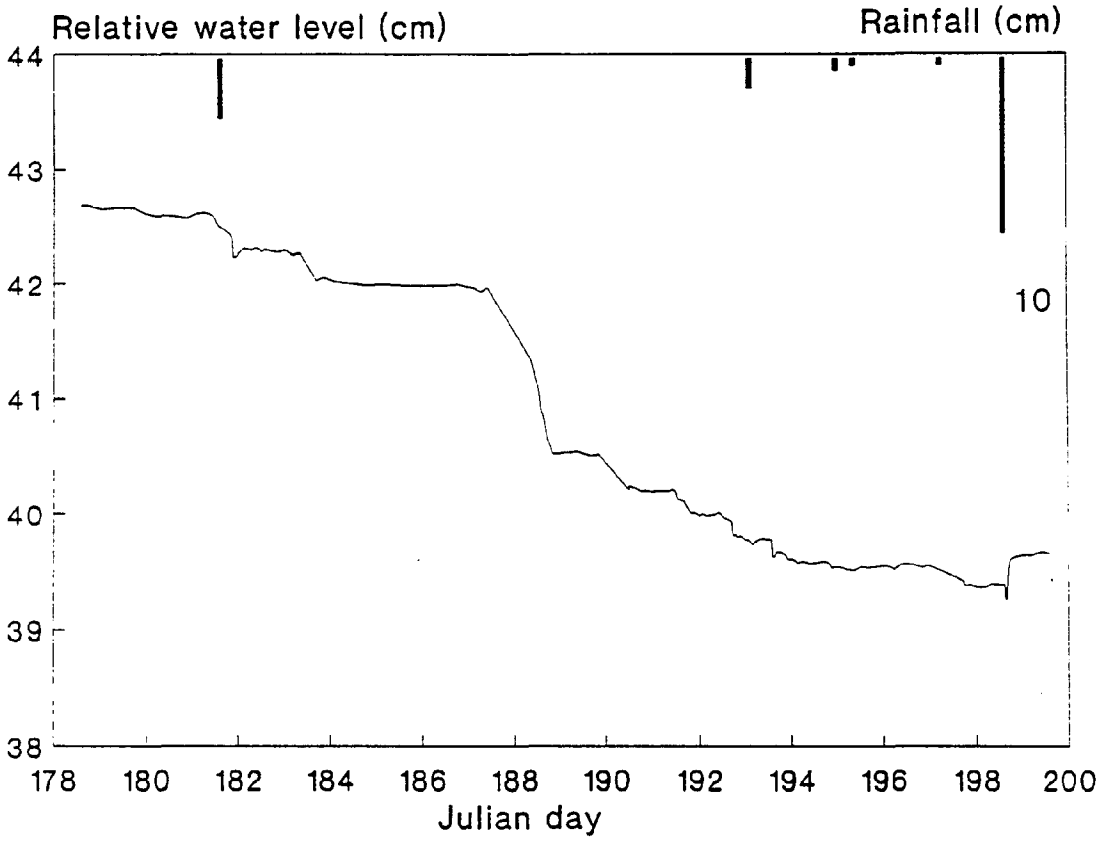
Figure 2.12. Water levels records from well UVAPZ-1 during a series of storms. Even during the largest storm, the water level rise is relatively minimal compared to weekly drawdowns.

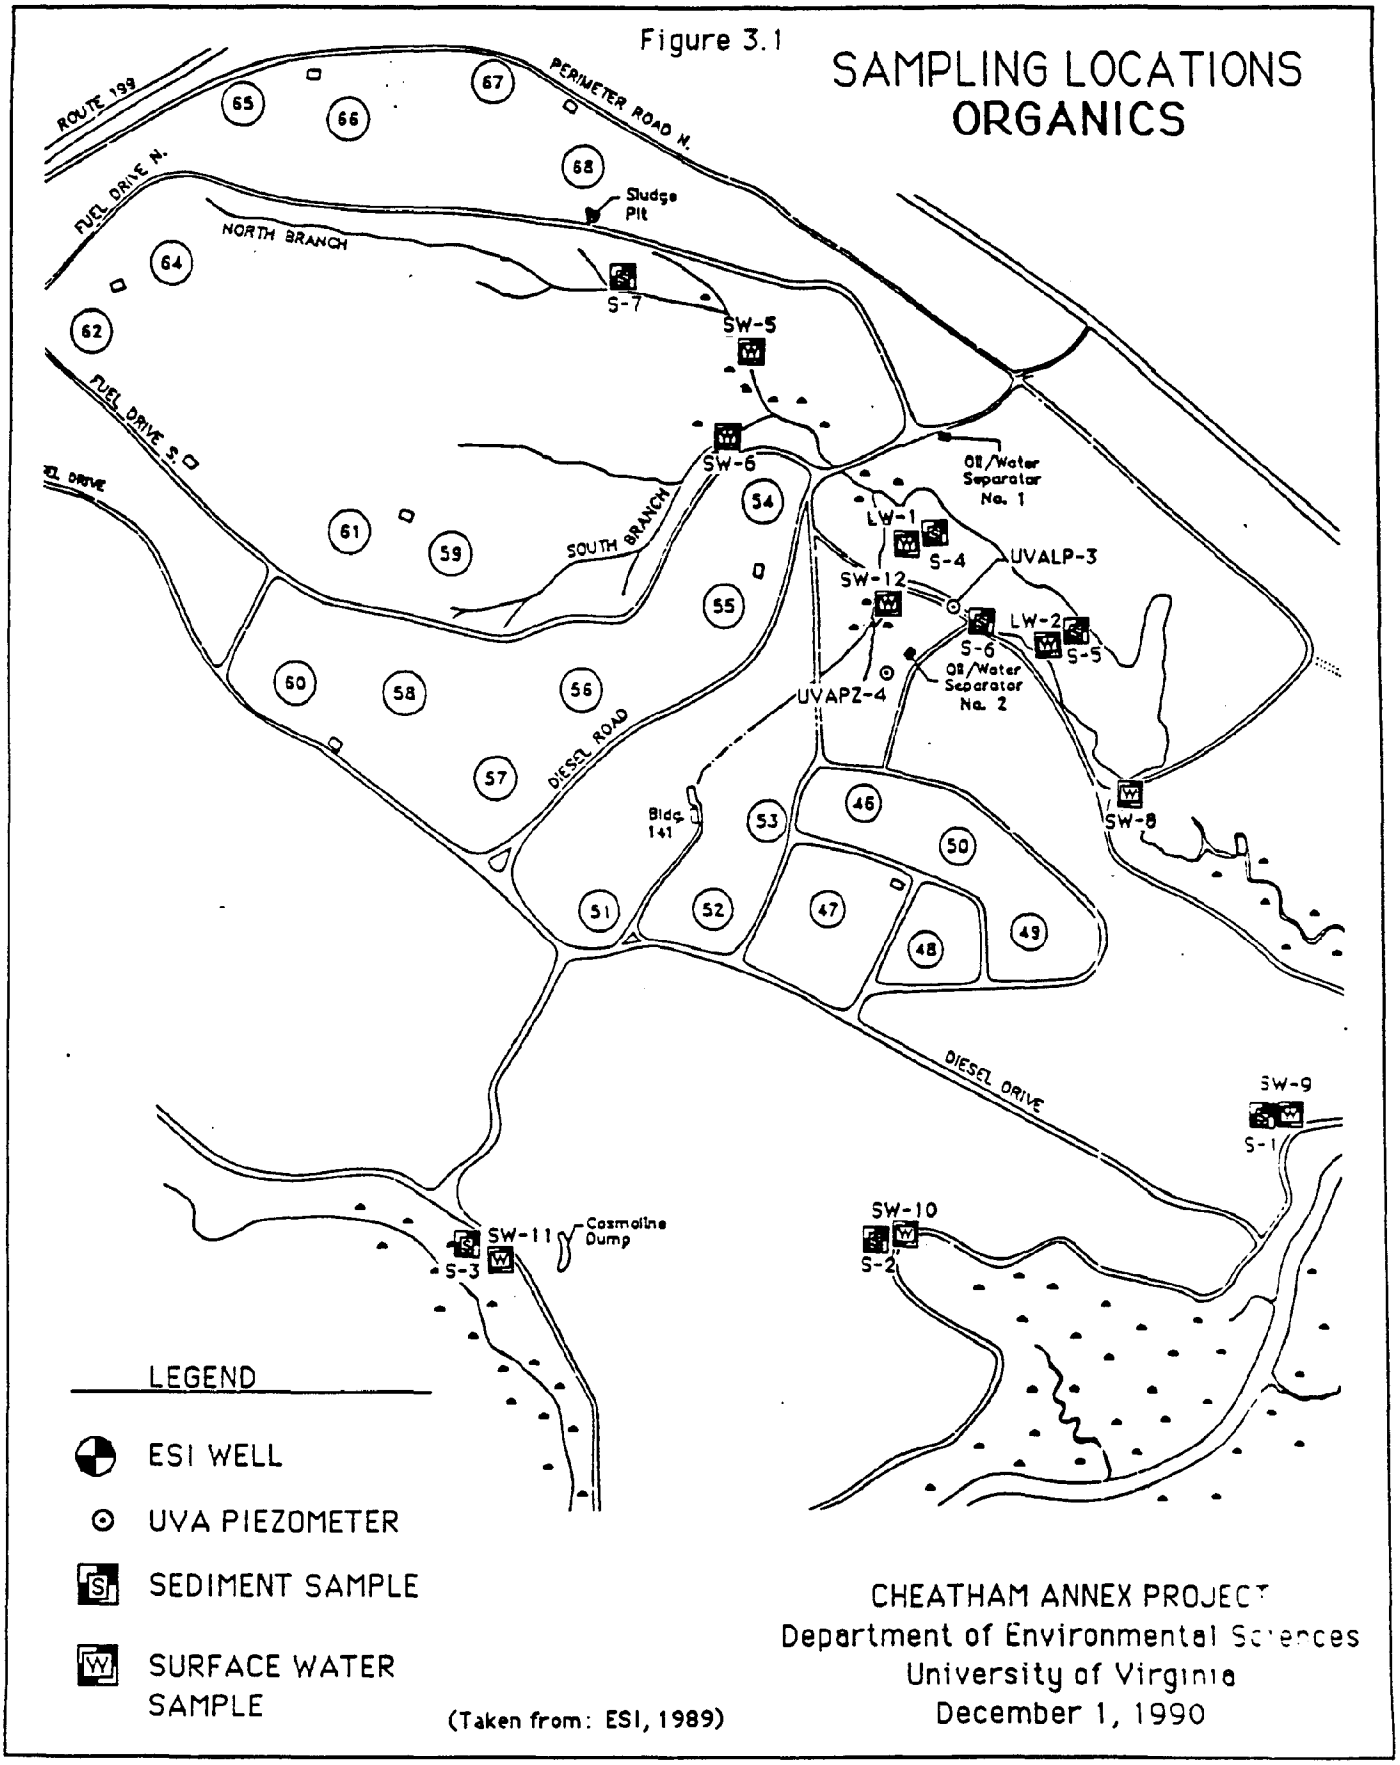
Figure 3.1

Water samples SW-9, SW-10, and SW-11 were collected from seepage faces from the southeast quadrant of the Cheatham Annex site along Perimeter Road (Figure 3.1). Analyses indicate that PNA's are not present in samples SW-9 and SW-11 (Table 3.7 and 3.8, respectively). However, detectable amounts of acenaphthylene, phenanthrene, benzo(a)anthracene, indeno(1,2,3-c,d)pyrene, and dibenzo(a,h)anthracene were found in sample SW-10 (Table 3.8)

Water samples were collected from wells UVAPZ-4 and UVALP-3 and given the same ID number (Figure 3.1). All PNAs were below limits of detection for sample UVAPZ-4 (Figure 3.9) but small amounts of naphthalene (0.37 ppm) and acenaphthylene (0.52 ppm) were found in UVALP-3.
