# HOMEOWNER'S HANDBOOK TO PREPARE FOR NATURAL HAZARDS

REPUBLIC OF THE MARSHALL ISLANDS

By  
 Don Hess  
 Dennis Hwang  
 Karl Fellenius  
 Ian Robertson  
 Mark Stege  
 Ben Chutaro

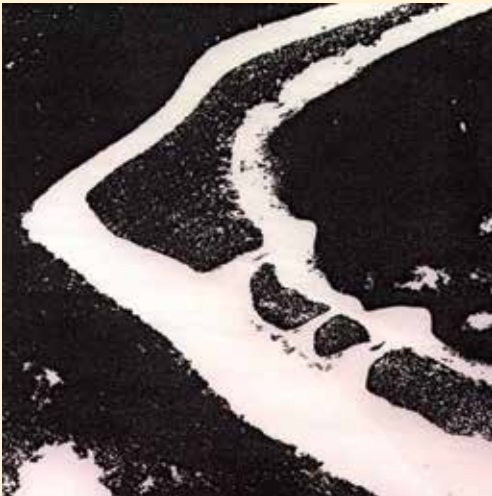
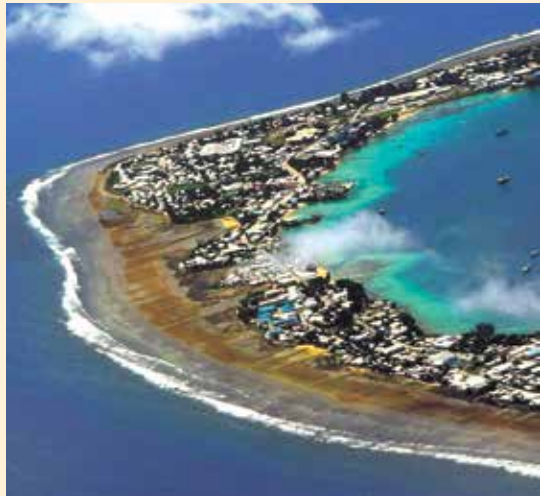
**Figure 1-1. Lagoonal openings in D.U.D. were closed in 1944, followed by rapid development. (Images Courtesy of Marshall Islands Visitors Authority and D. Hwang)**

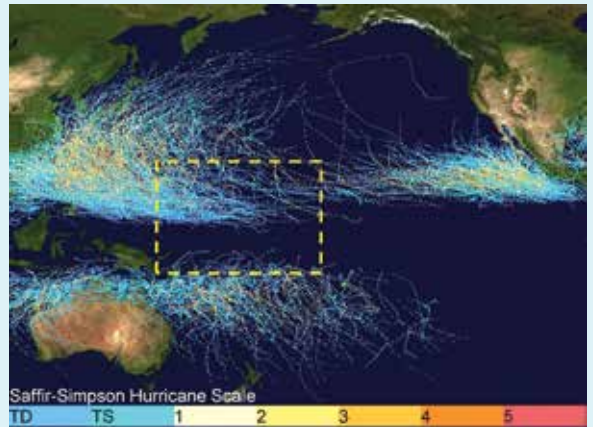
**Figure 2-1. The history of tropical cyclones near the Marshall Islands (yellow dashed box) between 1985 and 2005. Although the Marshall Islands is not in the most intense region for typhoon exposure, there is still considerable risk. Note the even greater risk of typhoons to the west and north of the middle of the yellow dashed boxed area.**

shown later, history indicates that typhoons are rare in the Marshall Islands, but frequent enough so that the threats must be planned for by the entire community (see Figures 2-1, 2-2, 2-4, and 2-5).

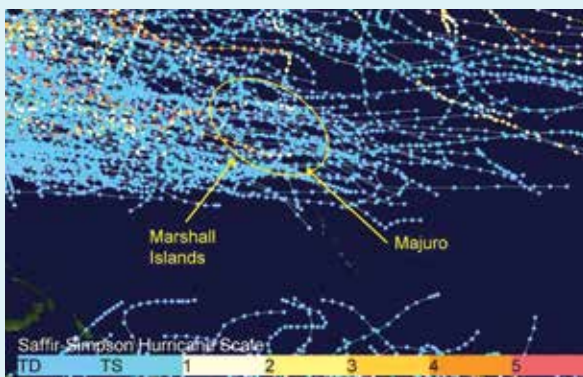
**Figure 2-2. In an enlargement of the yellow dashed box in Figure 2-1, there were two typhoons that passed by the Marshalls from 1985 to 2005. During the same period, there were many tropical depressions and tropical storms that affected the Marshall Islands**

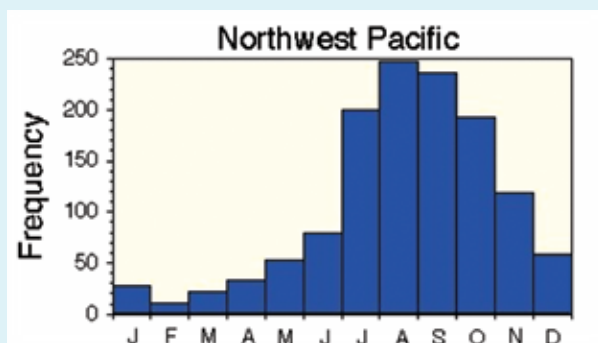
Figure 2-3. Frequency of tropical cyclones in the northwest Pacific by month (Pidwirney, 2012). The main season for tropical cyclones in the Northwest Pacific basin runs from July to November with a peak in late August/early September.

The area around the Marshall Islands is unlike other storm basins worldwide in that it produces tropical cyclones all year round, save for an “off season” with a distinct minimum in February and the first half of March (Figure 2-3).

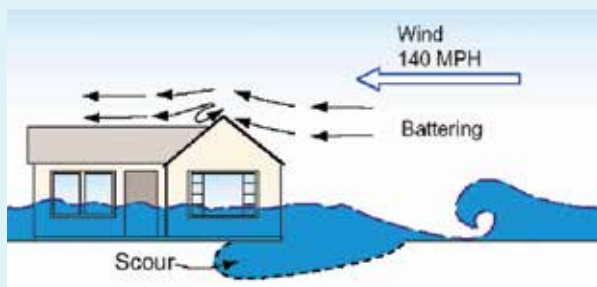
Figure 2-4. With any typhoon, there will be four key impacts that overlap. There can be Erosion/Scour of the coastline. In addition, there is Wave Inundation and Flooding. Finally, the impacts of High Winds must be planned for. Some of the impacts, such as erosion, scour and wave inundation may diminish for inland locations.

The evacuation measures in Part 3 of this book are primarily driven by potential wave inundation and flooding from a typhoon which can threaten life and property (see Figures 2-4 and 2-7). However, a tsunami may also drive the evacuation. The home retrofits in Part 4 of the book are driven by the wind impacts from the typhoon (see Figures 2-4 and 2-6). In addition, the elevation measures in Part 4 are meant to address more frequent, less intense flooding associated with weather events smaller than a typhoon or a tsunami.

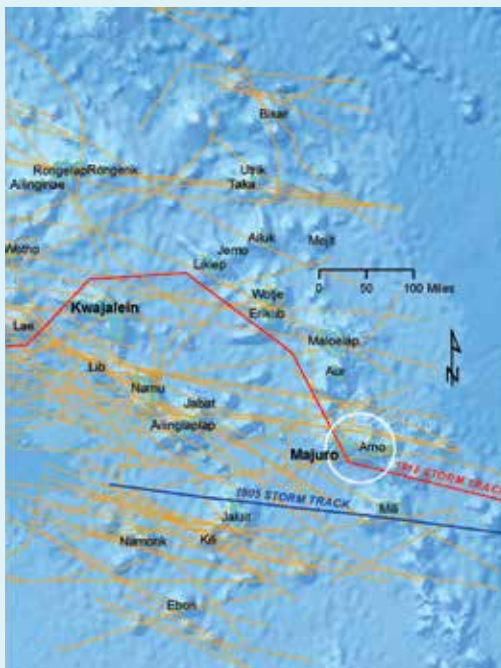
**Figure 2-5. Climate researcher, Mark Stege, overlaid the work of Dr. Spennemann with IBTrACS storm tracks from 1958-2012 (see Knapp et al., 2010). The composite map shows the 1905 Typhoon (blue), 1918 Typhoon (red), and all storms 1958-2012. Majuro is circled. See the impacts of these storms in Figures 2-6 and 2-7.**

The two typhoons that caused the most damage in the Marshall Islands occurred in 1905 and 1918 (Figure 2-5), when many of the islands were directly hit and there was significant property damage and loss of life. Dr. Dirk Spennemann used 20<sup>th</sup> century documents such as captain’s ship logs and missionaries’ letters to approximate the location and wind speed of the 1918 and 1905 storms.

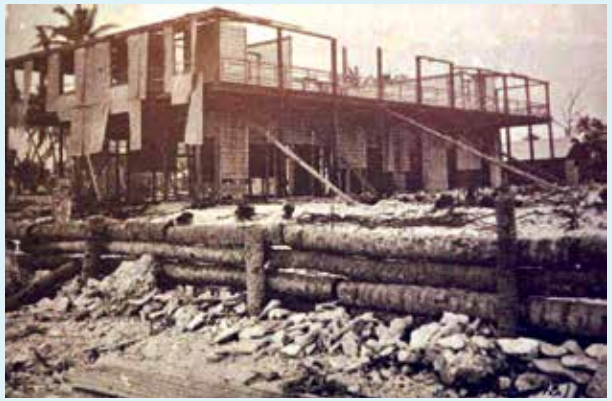
**Figure 2-6. Typhoon Wind Impacts - Damage to the Catholic Girl's and Nuns' Living Quarters building in Jaluit after the 1905 typhoon. Note the blown off roof, which is common from the strong winds of a typhoon. In addition, there is water damage or inundation that overtopped the log seawall and eroded or scoured sediment behind the wall (Photo Micronesia Area Research Center).**

Blown off roofs from a typhoon demonstrate the need for strong roofs and attachments to the wall and foundation. How to do this is shown in Part 3 for emergency shelters and Part 4 for houses.

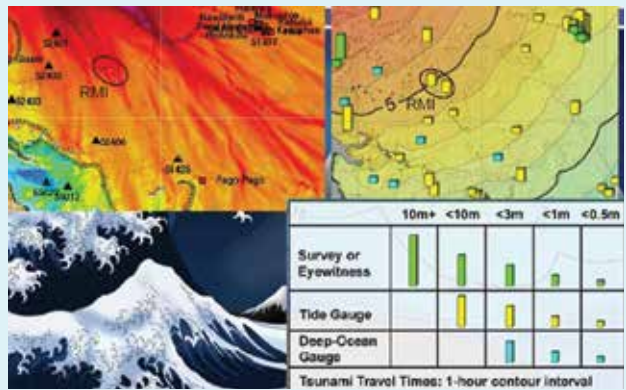
Figure 2-10. For the Tohoku Tsunami, the estimated water height at the Marshall Islands was under 1 meter or 3 feet (see Robertson, 2015). The Marshall Islands were fortunate since the time of the tsunami coincided with a low tide of 3 feet.

Because it was low tide in the Marshall Islands at the time the tsunami struck, there was limited inundation. Experts at the Weather Service Office feel the outcome could have been much worse if the tsunami struck during a high tide, with the potential for significant inundation and flooding damage.

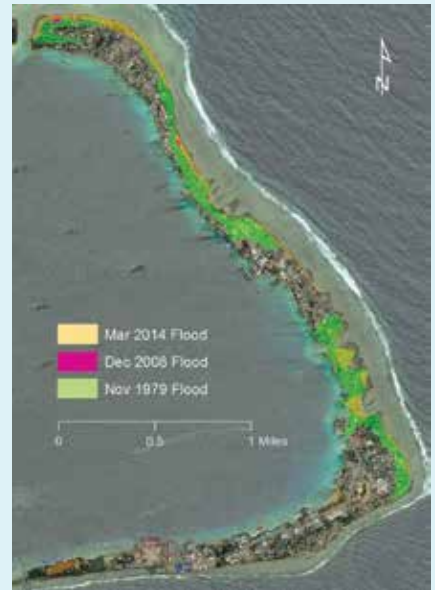
**Figure 2-11. This map shows the estimated extent of flood inundation from extratropical storms in November 1979; December 2008; and March 2014. The 1979 event was the largest and in several locations, the inundation crossed the island.**

Extratropical storms are mid-latitude storms (outside tropical latitudes) that can produce long-wavelength (swell) which can travel great distances and impact the Marshall Islands. Some of the most notable flooding events from extratropical storms occurred in November 1979, December 2008, and March 2014 (see Figure 2-11).

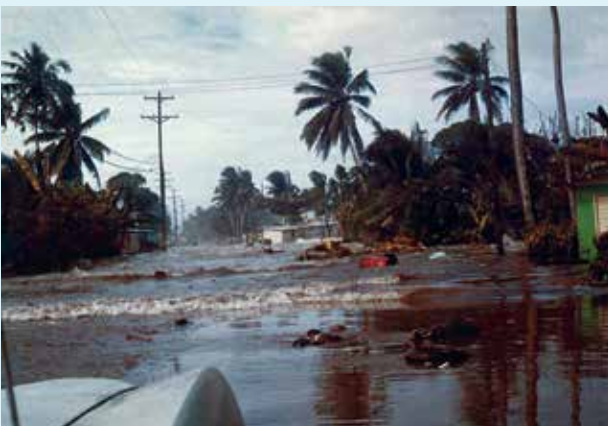
**Figure 2-12. Wave inundation and flooding during the 1979 extratropical storm in Majuro. Flooding at this location crossed the atoll. In some locations a channel was cut into the atoll. Photo courtesy of Hamilton Library, University of Hawai'i Pacific Collection.**

In late November and early December 1979, there was an extratropical storm that caused huge waves which traveled far distances and washed water over the island causing much damage (see Figures 2-12 to 2-15). The water was able to cut channels in the atoll. Because the area of wave generation was far away, it was actually clear sunny weather in Majuro.

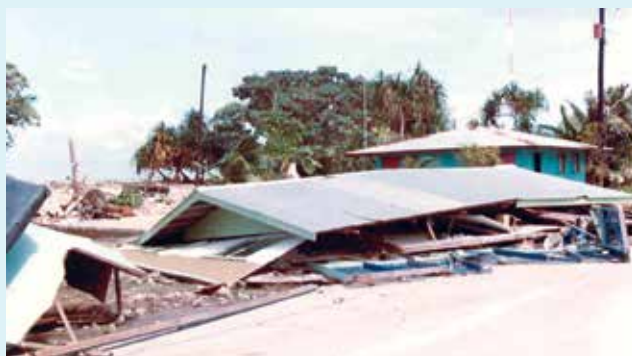
**Figure 2-13.** During the 1979 inundation event, there were 100 to 300 houses that were destroyed. Many more were damaged. Wave inundation such as this is the reason elevating houses is covered in Part 4 of this book in order to reduce the risk of damage. Photo courtesy of Hamilton Library, University of Hawai'i Pacific Collection.

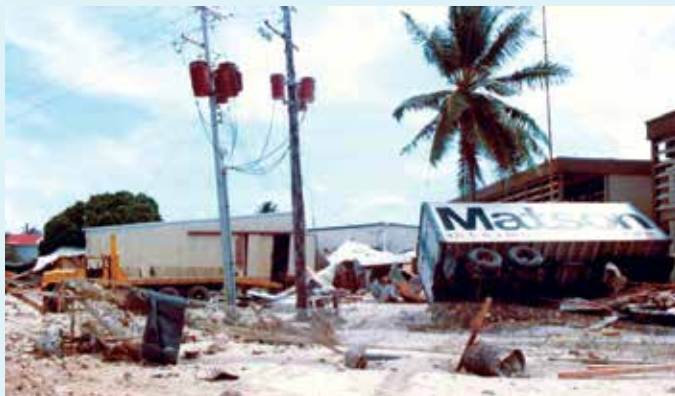
**Figure 2-14.** During the 1979 event, there was an estimated \$26 million in property damage and major portions Djarrit and Delap were covered in sediment. Photo courtesy of Hamilton Library, University of Hawai'i Pacific Collection.

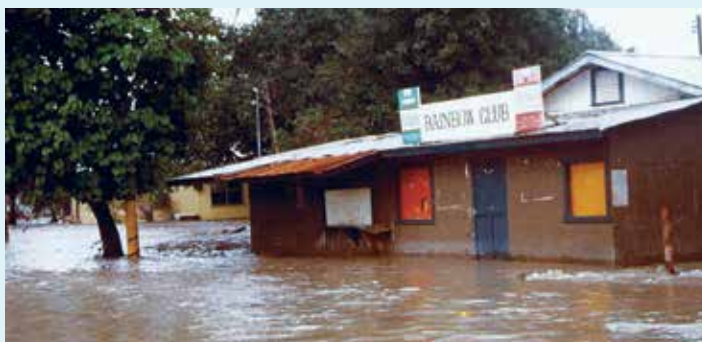
**Figure 2-15.** Also during the 1979 event, over 5,000 people lost use of their homes due to flooding (Hoeke et al., 2013). Photo courtesy of Hamilton Library, University of Hawai'i Pacific Collection.

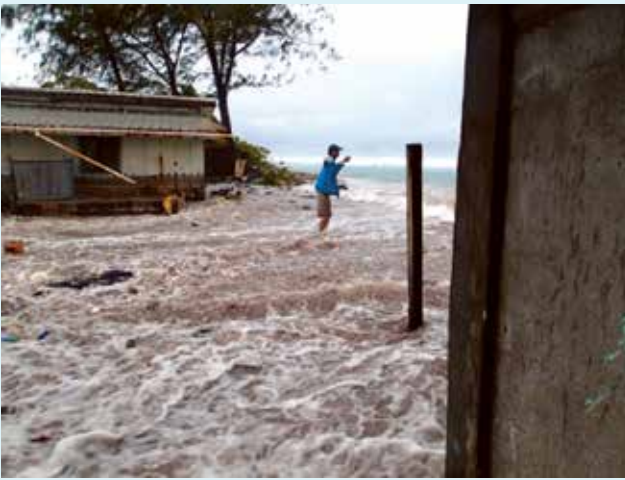
**Figure 2-16.** Inundation in March 2014 was a result of swells generated by an extratropical storm raising water levels above normal. This made the shoreline of the Marshalls especially susceptible to further inundation and flooding from King Tides. This made the shoreline of the Marshalls especially susceptible to swell generated by an extratropical storm. The high waves inundated parts of Majuro, the Capital, as well as other communities in the outer islands, including Arno and Mili.

In March 2014, there was again a significant inundation event that resulted from a combination of swells from an extratropical storm and a "King Tide" (see next Section 2.4). Inundation and damage started occurring several hours before the King Tide. The damage from this event can be seen in Figures 2-16 to 2-18.

Note that using this forecast tool, inundation would have been predicted with the greatest threat between the afternoon of March 2, 2014 and the late afternoon of March 3, 2014. This is reflected in the actual damage seen in Figures 2-16 to 2-18. The figure shows the inundation was a combination of high tides and extratropical swell. This tool can help emergency managers and the public plan for potential inundation events days in advance.

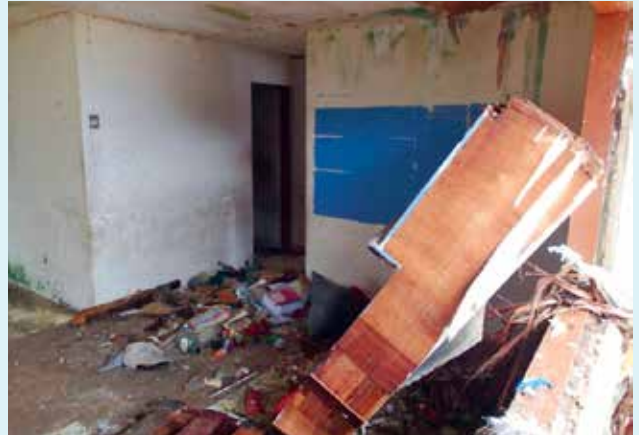
**Figure 2-17.** During the March 2014 event, about 110 homes were damaged and about 940 family members were displaced and sought sanctuary in government-designated shelters and churches. It is because of damage such as this that Part 4 of the handbook covers tools to reduce damage such as elevating of structures or building with flood resistant materials.

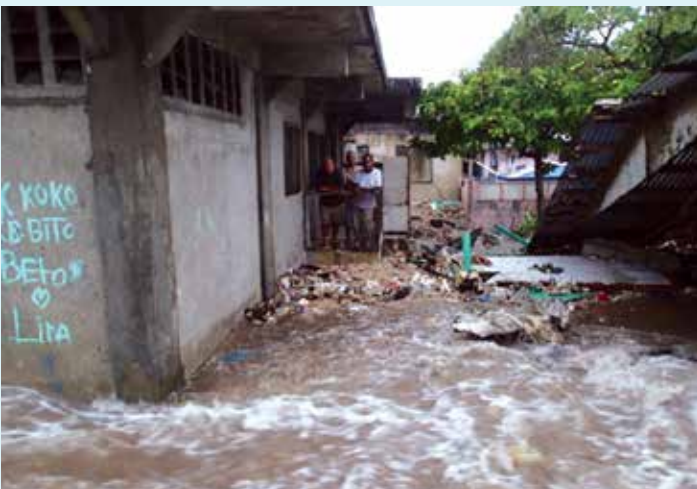
**Figure 2-18.** Even if a structure is elevated or built with flood resistant materials, during a typhoon or major tsunami, shelter should be to structurally sound buildings such as covered in Part 3 of this book. It may be acceptable to shelter in place for smaller events, such as the March 2014 floods, however, it is more than likely that inundation will be unpredictable (larger or smaller than anticipated). Thus if in doubt, evacuate to designated shelters.

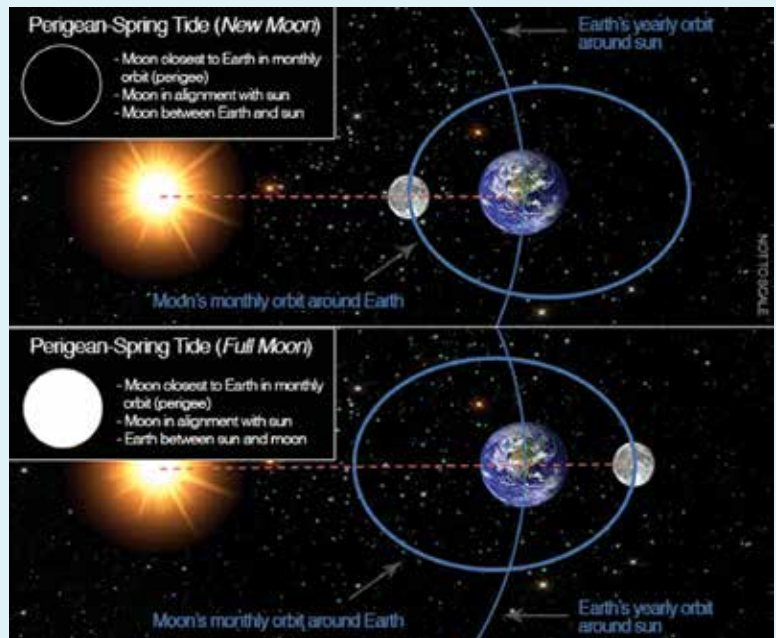
**Figure 2-19. The highest tides of the month occur during the new moon (top) and the full moon (bottom). Then gravity from the moon and sun combine to create the strong tides. Even higher tides occur 3 to 4 times per year when the moon is full or new, and the moon is at its closest position to the earth. The moon's distance to the earth varies since its orbit is not circular but elliptical. This creates a large variation in gravitational pull. At the moon's closest distance during a new or full moon is when there are King Tides. Image courtesy of NOS and NOAA.**

King Tides are simply the highest high tides of the year. They are also associated with the lowest low tides of the year. Figure 2-19 explains how King Tides develop.

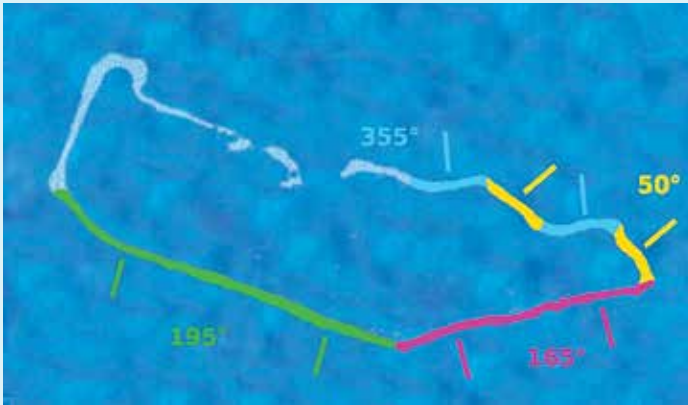
Figure 2-20. Majuro has been color coded into four shoreline sectors, depending on the orientation of the coastline with incoming waves. The shoreline sectors are perpendicular to waves coming in at 50, 165, 195, and 355 degrees of the compass. Each color represents a forecast of potential inundation. No forecasts are explicitly provided for the gray-shaded land areas.

associations of the U.S. Integrated Ocean Observing System ([www.pacioos.org](http://www.pacioos.org)). PacIOOS has a forecast inundation tool for sea level that includes tides and swells. The tool for the Marshall Islands is available at: ([http://pacioos.org/data\\_product/SLpred/Maj\\_Exc.php](http://pacioos.org/data_product/SLpred/Maj_Exc.php)). The inundation tool is explained in Figures 2-20 to 2-21.

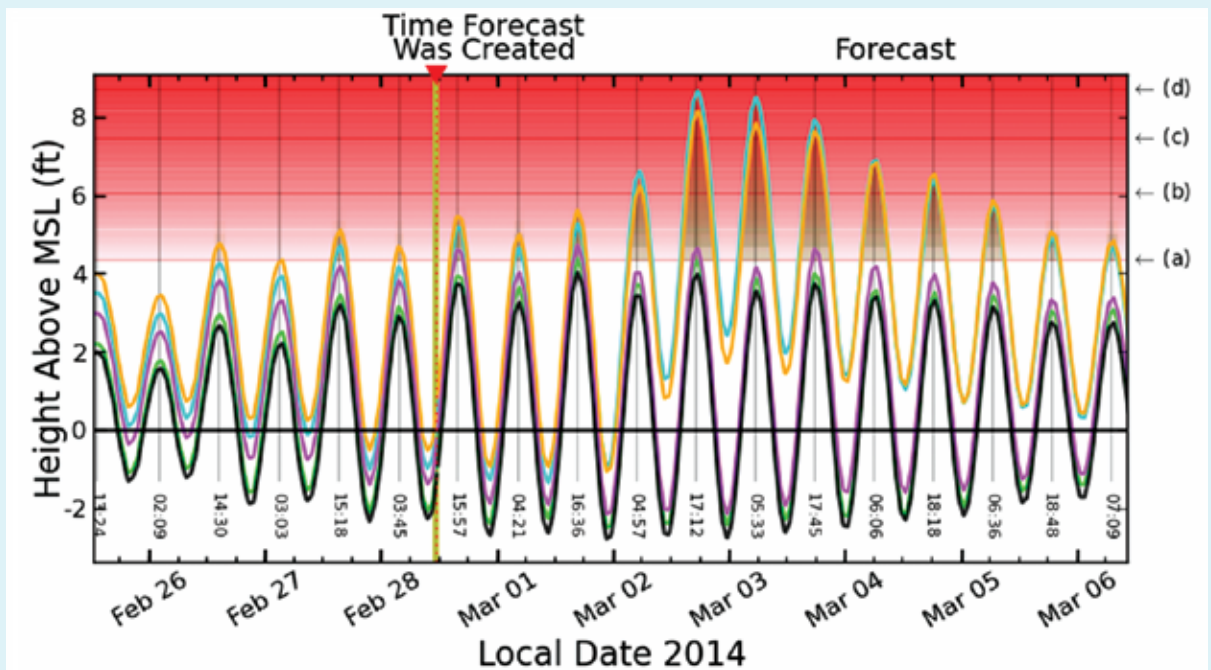
Figure 2-21. The black curve is a sea level forecast that does not include effects due to swell waves. This curve will reflect primarily the large spring tides and larger King Tides discussed in Figure 2-19. On top of the black curve are the Cyan, Orange, Magenta, and Green curves which will show the Inundation Height that indicates the potential for inundation of the land for the different sectors of Majuro due to swell waves (e.g., extratropical storms) added to the tides (high and low). If the forecast inundation height extends into the red shaded area, inundation is likely in low-lying areas. For the three days prior to the “Time Forecast Was Created,” the colored curves are showing the last valid forecast for each date/time. The forecasts are updated hourly.

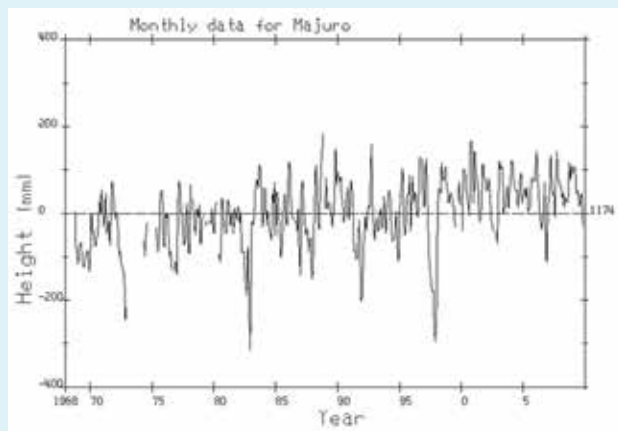
**Figure 2-22.** Tide gauge data for Majuro from 1968 to 2010 shows sea level has been rising in the area at a rate of about 3 mm per year. Data from NOAA Center for Operational Oceanographic Products and Services. The extreme lows in 1998 and 2003 are associated with El Niño events.

Another factor adding to the hazard risk in the Marshall Islands is sea-level rise. Sea-level rise is due to global warming, the melting of ice sheets, and the expansion of warmer water. Tide gauges on Kwajalein and Majuro have been used to document the extent of past sea-level rise (Figure 2-22).

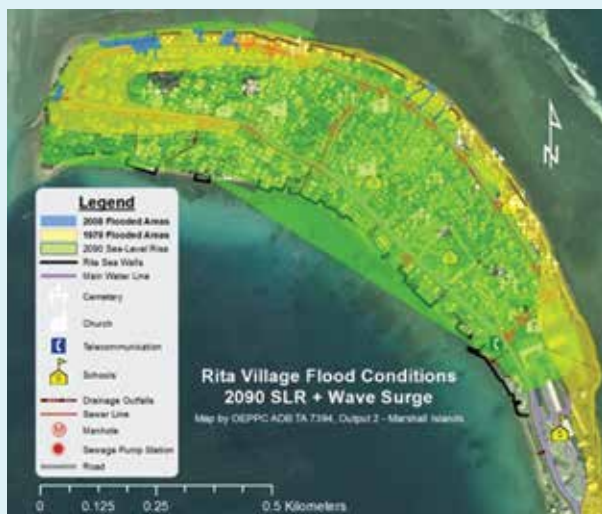
**Figure 2-23.** The extent of wave inundation is mapped for extratropical storms in 1979 (in yellow) and 2008 (in blue). In addition, there is a projection for sea-level rise in the year 2090 using an estimated rise of 0.62 meters or 2.40 feet (in green). This is an example of flooding or wave inundation being caused by numerous events (extratropical storms and sea-level rise). Other risks for wave inundation and flooding can come from a tsunami or typhoon. Map courtesy of the Office of Environmental Planning and Policy Coordination and created by the MarTina Corporation.

Sea-level rise is expected to accelerate in the future, but the exact amount is not certain. A projection of the impacts of sea-level rise is compared with inundation from the 1979 and 2008 extratropical storms in Figure 2-23.

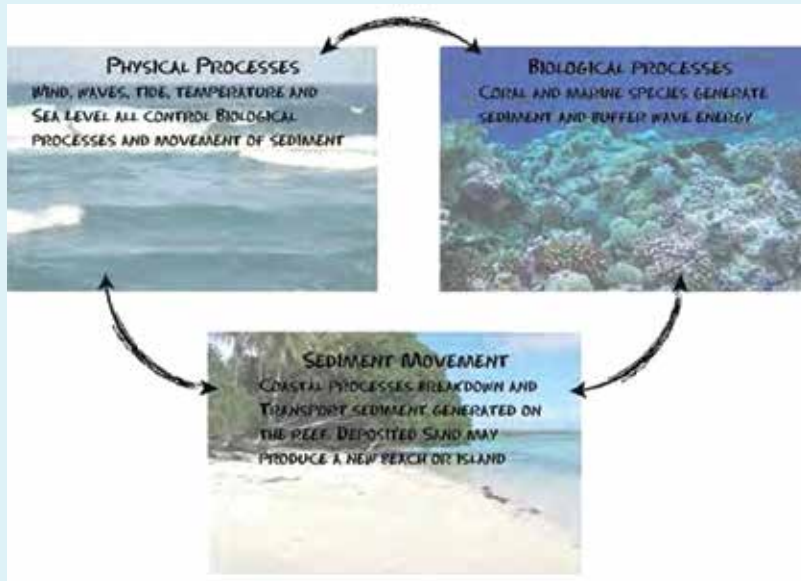
**Figure 2-24. Some physical coastal processes include wind, waves, currents, tides, temperature, and sea level. They continually drive the sediment produced via biological processes and result in sediment movement that builds and erodes islands. Marine deposition on geological timescales and terrestrial deposition from episodic flooding are the overriding large-scale processes that determine where sediment accumulates over time.**

Coral reef islands are naturally dynamic features, with their shoreline moving as a result of changes to the physical and biological environment. Reef islands are made up of sediment that is generated by the breakdown of living material on the adjacent reef. Coastal processes are physical and biological mechanisms that operate along a coastline, bringing about various combinations of sediment transport, erosion, and deposition. Human use of Majuro requires space and produces waste, which affects these natural processes and changes the location and relative proportions of erosion and accretion that would otherwise be present if it was an unpopulated area. Physical and biological processes are involved whether a coastline is eroding or accreting (Figure 2-24).

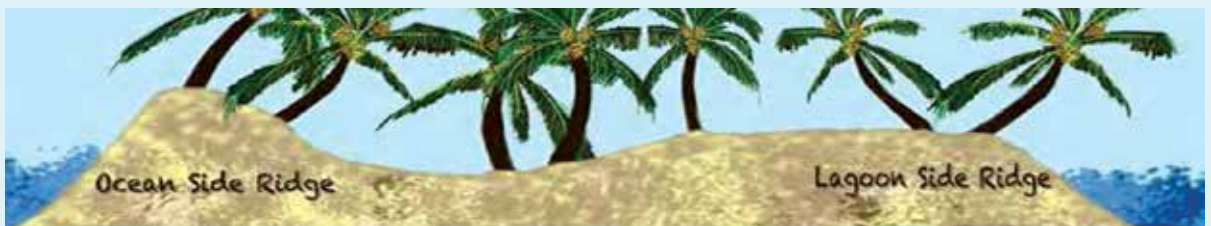
**Figure 2-25. The ridges of an atoll serve the important function of protecting inland areas from wave inundation and flooding. Thus they should be maintained and enhanced if possible.**

Tides allow higher waves to reach the island at high tide. Island morphology shows that the highest elevation of an atoll island is on the ocean side berm (ridge), which is made up of coarse coral sediment and larger shingles (Figure 2-25). Lagoon shorelines are exposed to smaller waves, resulting in smaller berms made up of fine sediment.

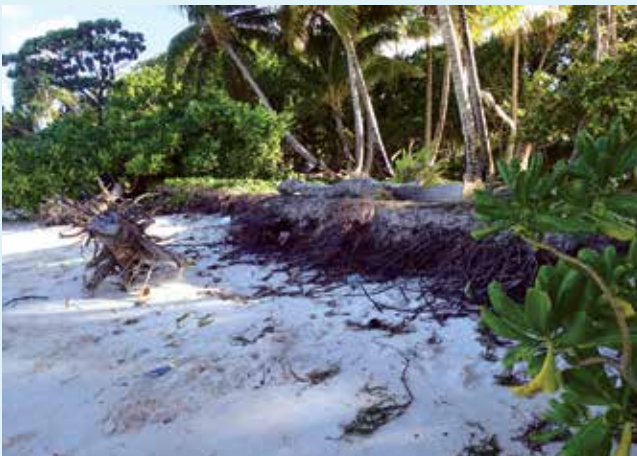
**Figure 2-26. Erosion of the coastline at Laura, Majuro. Erosion is a serious hazard as it causes the shoreline to move inland and thus makes houses and buildings at increased risk from wave inundation and flooding. Erosion can be caused by physical processes associated with a tropical cyclone, tsunami, extratropical storm, and/or sea-level rise.**

**Erosion** - When more sediment leaves a shoreline area by physical processes than is deposited by biological and physical processes, than erosion of the coastline occurs. This is typically seen by retreat of the shoreline and a vertical cut in the vegetated dune (Figure 2-26).

The biological processes on Majuro's reef are significantly degraded due to the developed shorelines and nearshore herbivore fishing pressure in proximity to the urban center. Therefore, physical processes are likely more eroding rather than depositing sediment from biological processes over time (Figure 2-26). Coastal protection services from the ecosystem are slowly diminishing via bioerosion. Nutrient loading from run-off and sewage discharge is the primary local point source cause for the reduced ability of the reef to calcify as it becomes more algae-dominated than coral.

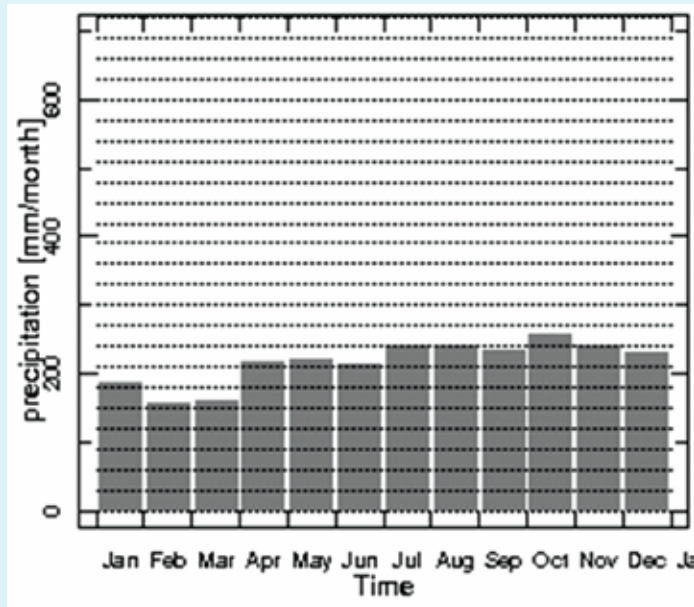
**Figure 2-27. Average monthly rainfall for Majuro Weather Station is indicative of the entire Marshall Islands, where historically the dry season has been most prominent in January and extending into March, and possibly April during severe conditions. Compiled by climate researcher Mark Stege.**

Drought is directly related to the amount of rainfall the Marshall Islands receive. Weaker trade winds in the summer from April to October coincide with greater rainfall in those months, while stronger trade winds during the winter from November to March coincide with decreasing rainfall and the dry season most prominent starting in January (see Figure 2-27).

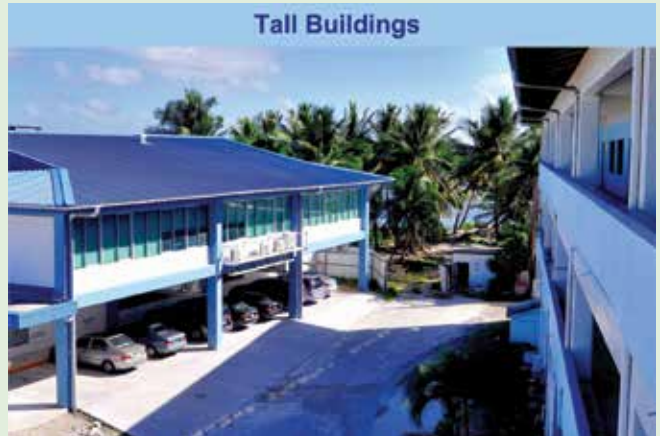
**Figure 3-2. For a strong tsunami or typhoon, evacuation to buildings with two floors or more is required. All things being equal, the taller the building the better. This photo taken from the third floor of the Assumption School (right) is of the two floor Administration Building for the College of the Marshall Islands (left). Both buildings are considered shelters for only the second floor or above.**

Because of the low elevation in the Marshall Islands, a shelter must be a tall building with two floors or more (Figure 3-2).

| Criteria | Comments | ✓ |
|---|---|---|
| 1. Tall building | Use second floor or higher. The taller the building the better if in good condition (Figure 3-2). | |

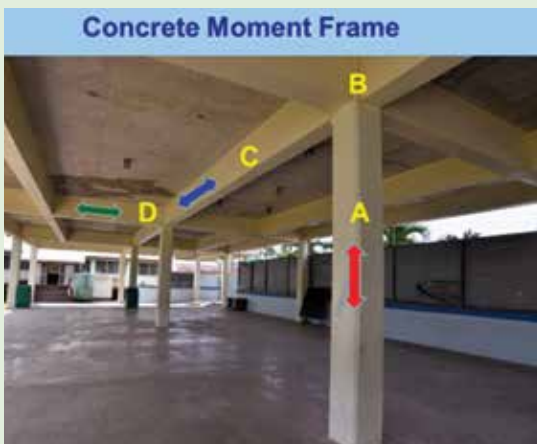
**Figure 3-3. A Concrete Moment Frame has: (A) columns of concrete that are reinforced with rebar and attached rigidly at beam-column joints (B) to reinforced concrete beams such as at (C) and (D). Forces from high wind or fast moving water are resisted by the strength of the beams and columns. For example, forces in the direction of the green arrow are resisted by beam (D), in the direction of the blue arrow by beam (C), and in the direction of the red arrow by column (A). In addition, the lower floor is open. This allows water from a tsunami or typhoon to pass under the building without applying large forces from the side to the structure.**

Another important criterion is for the building to have a strong structural system. The Concrete Moment Frame is structurally strong for both vertical loads (gravity) and lateral loads (wind, seismic, and flowing water) (Figure 3-3).

| Criteria | Comments | ✓ |
|---|---|---|
| 2. Reinforced concrete | <b>Best</b> – Beam-column moment frame with open lower floor (Figure 3-3);<br><b>Good</b> – Moment frame with CMU infill on first and second floors (Figure 3-4);<br><b>Acceptable</b> – CMU walls – (solid grouted – concrete and rebar fill the holes) and <b>under 20 years old</b> (Figure 3-5). | |

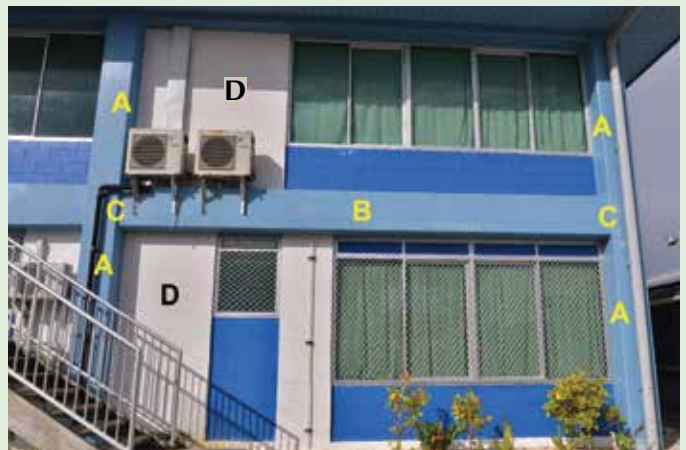
Figure 3-4. Many buildings identified as shelters have the Concrete Moment Frame – with columns (A), beams (B), and column-beam joints (C). They also have CMU blocks on the 1st and 2nd floors as infill (D) (see also Figure 4-39). While it is preferable that the first floor be open air as in Figure 3-3, this is still a strong structure if well maintained. This is the College Center at the CMI.

Examples of strong buildings with a Concrete Moment Frame and Concrete Masonry Unit (CMU) block infill are at the CMI (Administration Building, Learning Center and College Center only) (Figure 3-4), Rita Elementary School and the Marshall Islands High School. Many buildings in Majuro, including many residential houses are built with this design (see Part 4 of this book - Figures 4-1 to 4-3). However, houses cannot be used for shelter for a strong tsunami or typhoon because they lack elevation.

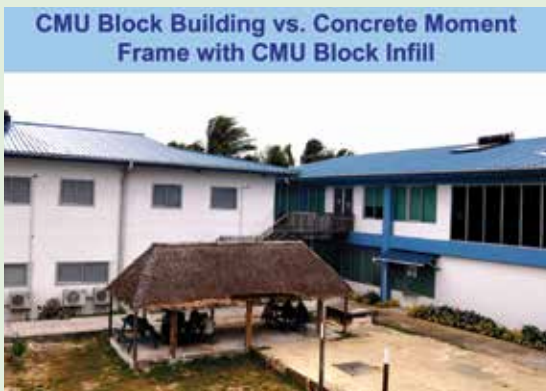
Figure 3-5. The building on the right has a Concrete Moment Frame as shown by the blue columns and beams and CMU block infill (Administration Building at CMI). Compare that with the building on the left with only CMU blocks (Tole Mour Hall at CMI). The building on the right is stronger because of the Concrete Moment Frame.

There are also buildings in the Marshall Islands with no Concrete Moment Frame and are CMU block infill (Figure 3-5).

Examples of buildings with just CMU block are Tole Mour Hall, Wapepe Hall, Debrum Hall and Rebbelip Hall at CMI (Figure 3-5). These buildings can be used as a shelter if well maintained although they are not as strong as the Administration and Student Center Buildings.

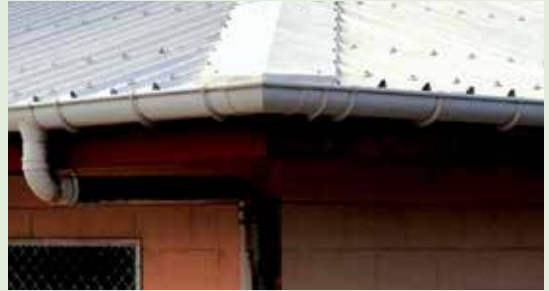
**Figure 3-6. Marshall Islands High School has many of the criteria looked for in a shelter. Note corrugated metal roof with sufficient fasteners and large washers to hold the metal roofing down during high wind events. The fasteners should be ring-shank nails or screws that are well-embedded into the supporting roof trusses, rafters, or purlins.**

winds during a typhoon. The structural factors required for a sound roof are: good condition roofing that is well attached to the roof framing members (Figure 3-6); strong roof trusses (Figure 3-7) or roof beams (Figure 3-8); and a strong connection of the roof framing to the supporting columns, beams, or walls of the building (Figure 3-9).

| Criteria | Comments | ✓ |
|---|---|---|
| 3. Tie down roofing | Secure roofing material to the roof (usually plywood over the trusses or rafters) with sufficient number of fasteners and large washers (Figure 3-6). | |

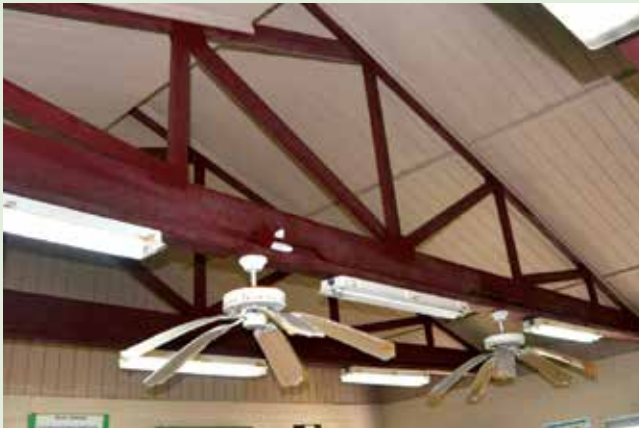
**Figure 3-7. The roof trusses should be engineered and pre-manufactured. This will be standard in newer government buildings, especially schools. It will not be for older buildings. This photo shows a typical roof truss at Marshall Islands High School.**

| Criteria | Comments | ✓ |
|---|---|---|
| 4. Roof framing tied down | The trusses should be pre-manufactured and engineered for uniformity and strength (Figure 3-7). Roof trusses must be bolted to the beams, columns or walls to prevent lift-off during high wind events (Figure 3-9). Alternatively, ridge beam, and large sloping rafters should be connected to walls, columns, or beams with steel metal connectors (Figure 3-8). | |

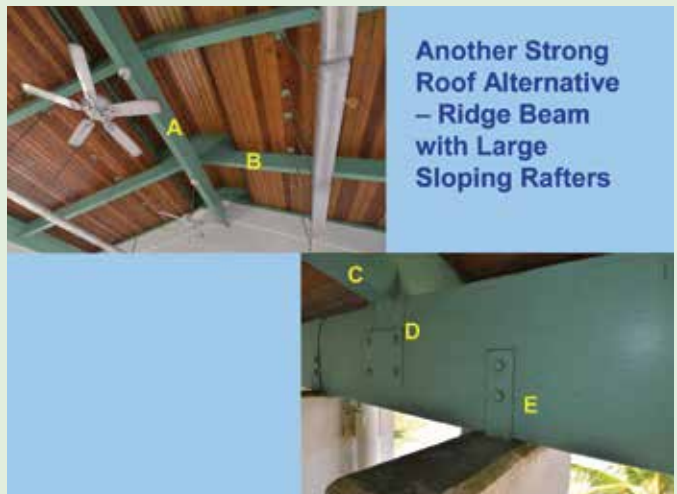
**Figure 3-8. Another strong roof design is to have a ridge beam (A) attached with steel connectors to large sloping rafters (B) (top left photo). The sloping rafter (C) then connects to a horizontal beam (D) with a steel plate (bottom right photo). The beam is connected to the concrete column (E) with another steel connector. Photo from Marshall Islands Middle School.**

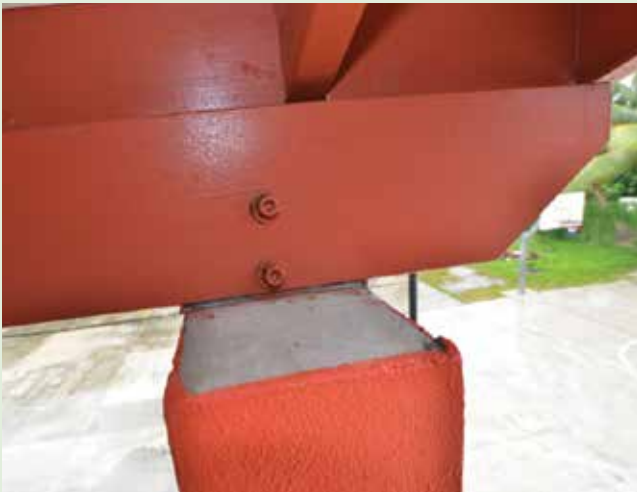
**Figure 3-9.** This roof truss is connected to the CMU column with a bolted plate to prevent roof uplift during strong winds. Connection of roof trusses to the walls, beams, or columns is also important for residential houses and is covered in Part 4.

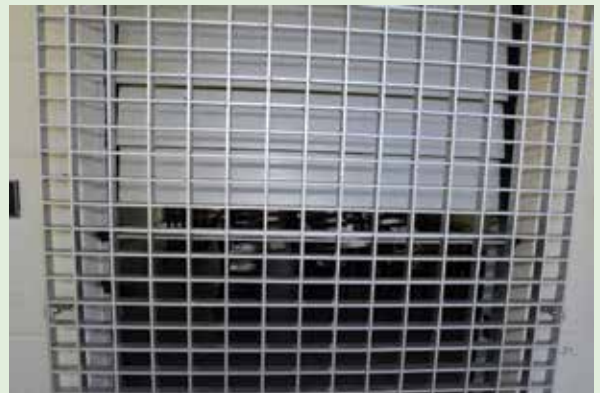
**Figure 3-10.** This screen at the Marshall Islands Middle School is made of strong aluminum bars in both directions and is attached to the CMU or concrete walls with embedded anchor bolts. The louver behind the screen can still be struck by small flying gravel, so should be made of shatterproof glass, glass with protective laminate, or aluminum slats for additional safety for those inside.

| Criteria | Comments | ✓ |
|---|---|---|
| 5. Window protection | Windows protected from debris impacts (Figures 3-10 and 3-11). Window behind screen should be shatterproof or laminated. | |

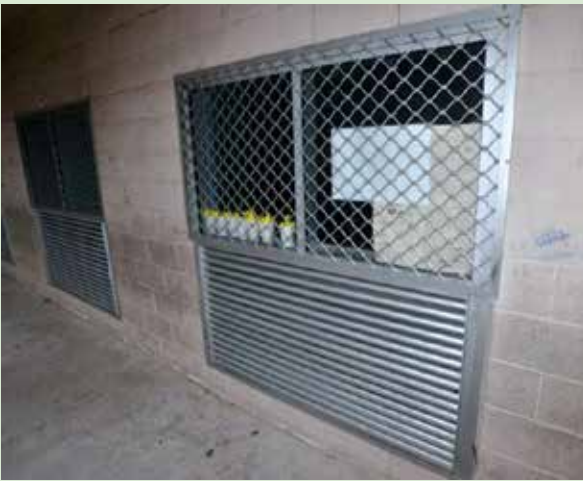
**Figure 3-11.** Security screen at Rita Elementary School helps to prevent breakage of the window by large debris. Behind the screen, the window should be shatterproof and/or a protective laminate added to the glass. Window protection is needed for any room that is a shelter on the second and third floors. All floors that are higher do not need window protection because the risk of wind-borne debris above 30 feet is less.

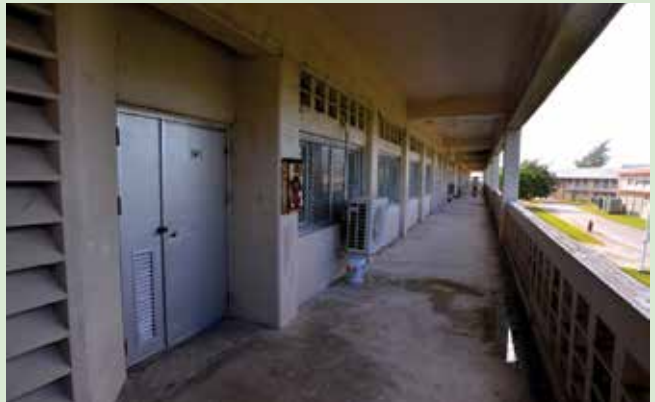
**Figure 3-12.** All exterior doors leading to the shelter areas should be sturdy metal or solid wood doors, with quality hinges and door latches to secure the shelter during high winds with potential debris impacts

During a typhoon there will be a lot of flying debris carried by high winds. It is important that this debris does not break any of the doors or windows at the shelter, otherwise wind will enter and add to the uplift pressure on the roof. It will also bring rain and flying debris into the shelter where it could injure occupants. Any room that is used for a shelter on the second and third floors must have a strong door and window protection so that wind, rain, and debris do not break through. Thus screens such as those shown in Figures 3-10 and 3-11 should be on all the second and third floor windows. The protection is not needed for the fourth floor and above because the wind-borne debris will not get that high up. Figure 3-12 shows a strong exterior metal door at the second floor of Marshall Islands High School.

| Criteria | Comments | ✓ |
|---|---|---|
| 6. Sturdy doors | The shelter doors should be made of metal or solid wood with quality latches and hinges to prevent their opening in high wind (Figure 3-12). | |

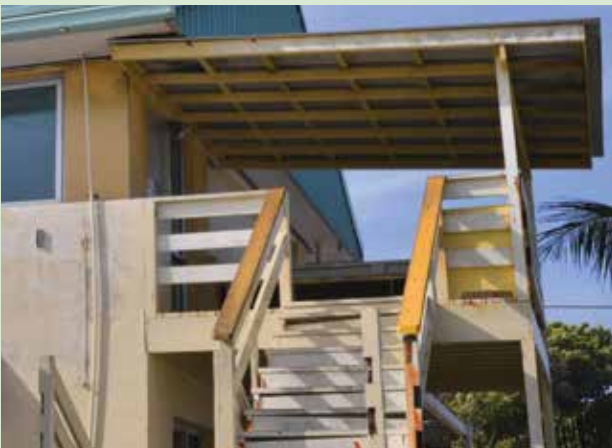
**Figure 3-13.** Some sturdy reinforced-concrete buildings have wood stairs to the second floor. They are likely to be damaged or washed away during heavy wave inundation. Such contingencies need to be planned for by having an emergency ladder readily accessible on the second floor. Note that the roof over this upper landing is also likely to be damaged or blown away during a typhoon. Photo of the Majuro Youth Center.

| Criteria | Comments | ✓ |
|---|---|---|
| 7. Strong stairs | Some sturdy buildings have exterior wood stairs to second floor. These can be washed away during inundation events. Are there contingencies? (Figure 3-13) | |

| Building | # | Comments | Photo of Building |
|---|---|---|---|
| Majuro Youth Center | 45<br>Future | Reinforced concrete and CMU building in acceptable condition, but access to second floor via poor condition wooden stairs. There are other issues that need to be addressed for building to serve as shelter. | |

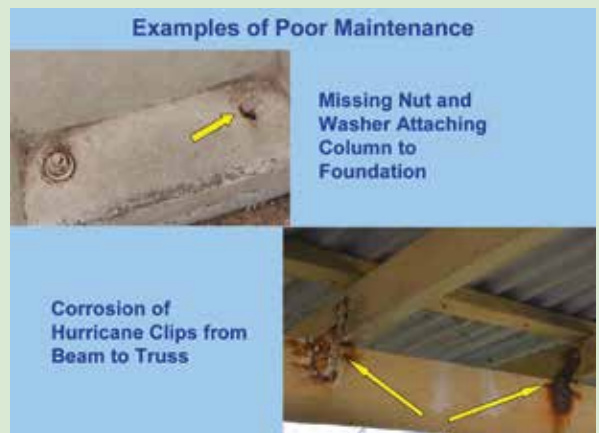
Figure 3-14. A potential shelter must be properly maintained. Here are examples of maintenance issues which could weaken the structure. Top left – missing washer and nut attaching waffle-crete column to the foundation. Bottom right – corrosion of hurricane clips attaching roof trusses to beam. As buildings get older, maintenance becomes a bigger issue.

| Criteria | Comments | ✓ |
|---|---|---|
| 8. Well maintained | Look for newer building (under 20 years for CMU construction), no corrosion of fasteners, and no missing connections (Figure 3-14). | |

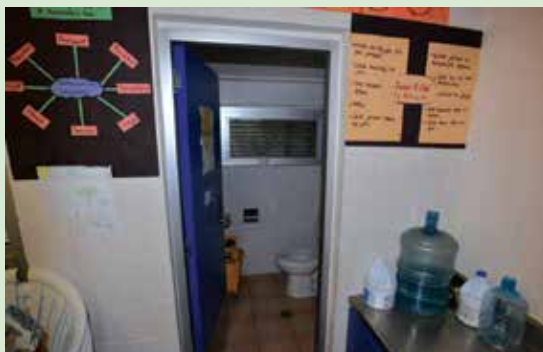
Figure 3-15. An ideal shelter will have toilet facilities available on the same floor as the shelter. This is common in newer elementary schools. Other comfort criteria include minimum space standards such as 10 square feet per person. In an emergency, these criteria may be compromised in the interests of accommodating more people in the shelters.

| Criteria | Comments | ✓ |
|---|---|---|
| 9. Comfort | In the shelter rooms (second floor or higher) there should be toilet facilities and 10 square feet of space per person (Figure 3-15). In an emergency this criteria may be compromised. | |

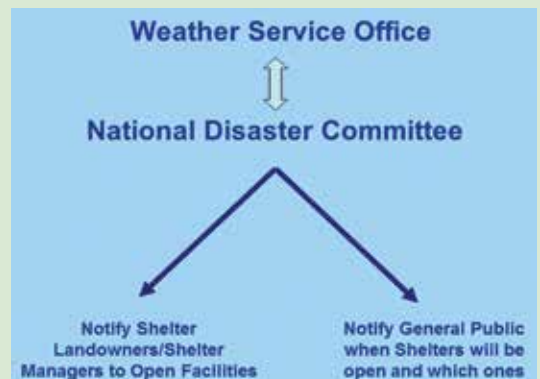
Figure 3-16. During a typhoon or tsunami, the WSO will be analyzing data from across the Pacific and will be in communication with the NDC. The NDC will decide if evacuation is in order, what shelters are open and when. They will communicate this to the shelter landowners and managers, as well as to the general public. Warning times may range from a few hours for a tsunami, to a day and a half for an incoming typhoon. The WSO uses a satellite communication device called a “Chatty Beetle” for early warning for people in the outer islands.

| Criteria | Comments | ✓ |
|---|---|---|
| 10. 24/7 access | During an emergency – the shelter spaces must be open. There must also be redundancy in case the person who opens the building is not available (Figure 3-16). | |

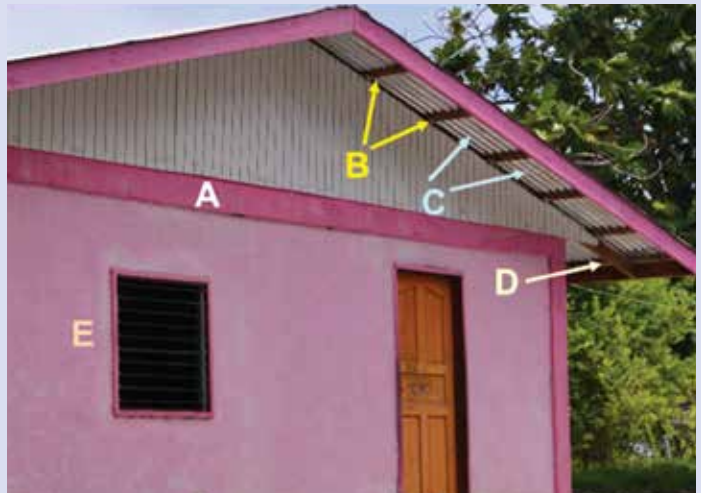
**Figure 4-1. Common parts of a Marshallese home from the outside. (A) Concrete structural bond beam. (B) Purlins typically run parallel to the length of house and are 2 inch by 3 inch lumber. (C) Aluminum or steel corrugated metal roofing. (D) Trusses typically running parallel to the width of house and consist of 2 inch by 6 inch lumber. (E) Windows and doors typically framed by 2 inch by 4 inch lumber.**

A typical house in the Marshall Islands has concrete walls that are fairly strong against wind forces. As was discussed in Part 3, and shown in Figure 4-1, the houses commonly have a moment frame consisting of concrete poured corners and a structural bond beam. The weak link is often the attachment of the roof to the concrete walls. Thus many of the options given deal with strengthening the entire roof structure.

In the urban areas of the Marshall Islands, building with concrete is common. There are advantages and disadvantages to building with concrete. First reinforced concrete is a very strong material. When built as shown in Figure 4-1, with poured concrete corner posts and a concrete structural bond beam, it is very resistant against wind and water forces. In fact this design is typical of American Samoa where wind speeds are often greater than 125 miles per hour. As further evidence of the strength, it is the type of building configuration (reinforced concrete moment frame) that makes the best emergency shelters identified in this report (see Part 3 on Evacuation Planning and Emergency Shelters and Figures 3-3 to 3-5).

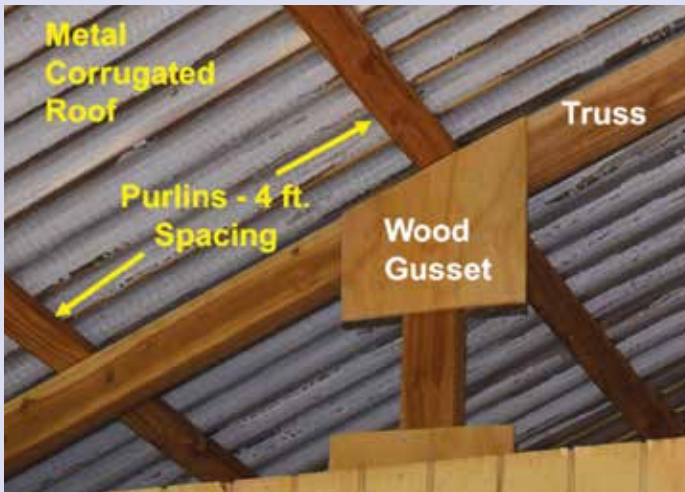
**Figure 4-2. As shown in Figure 4-1, the trusses typically run parallel to the width of the house and are made of 2 inch by 6 inch lumber. On top are purlins, consisting of 2 inch by 3 inch lumber, typically running parallel to the length of the house. Attached to the purlins is the metal corrugated roof.**

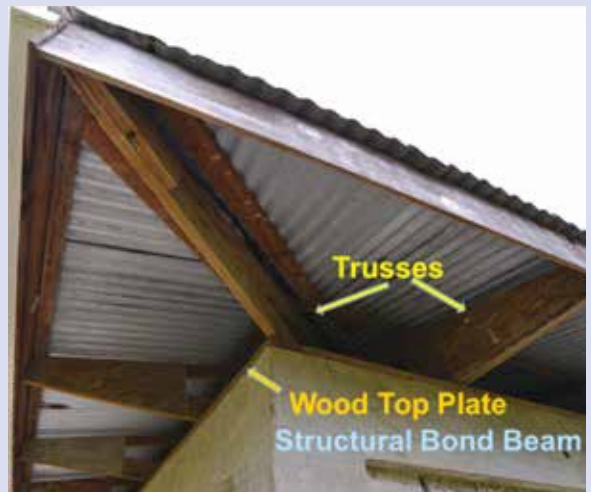
**Figure 4-3. On top of the concrete structural bond beam is commonly a wood top plate, consisting of 2 inch by 4 inch lumber. On top of the wood plate are the trusses. To prevent wind damage during a storm, there must be a strong connection from: (a) the wood top plate to the structural bond beam; (b) the trusses to the wood top plate; (c) purlins to the trusses; and (d) metal corrugated roof to the purlins.**

For a strong roof and house against the wind and rain there must be a strong connection or tie from the: (a) wood top plate to the concrete structural bond beam (Figure 4-3); (b) trusses to the wood top plate (Figure 4-3); (c) purlins to the trusses (Figure 4-2); and (4) metal corrugated roof to the purlins (Figure 4-2). It is possible, depending on access, for existing houses to be retrofitted so that some or all of these connections are strengthened. This is covered in Figures 4-4 to 4-27. These connections can be considered for existing homes in a retrofit application, depending on feasibility (access, cost, etc.). They should definitely be considered during new construction, when access is not a problem.

Even if wood is sitting on masonry (for example, a wooden sill plate on a concrete foundation - similar to a wood plate in Figure 4-3), but on the foundation and usually transitioning to wood framing, this may be too close to the ground and extra protection may be in order. The extra protection is often in the form of using treated lumber. Some articles suggest keeping wood sills and foundation walls at least 8 inches above grade.

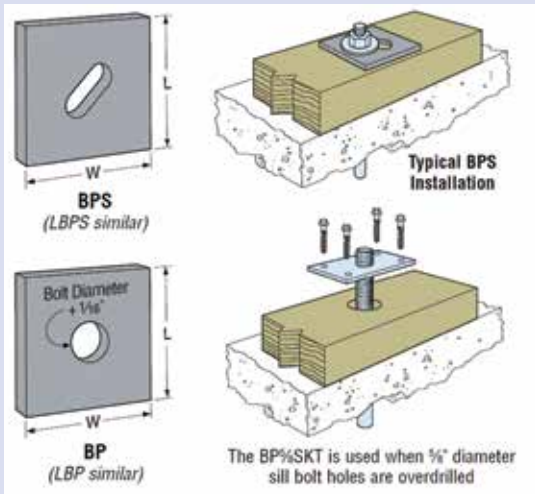
Figure 4-4. Typically, there is a 2 inch wood top plate over the concrete structural bond beam. In new installations and possibly in retrofit applications, a metal bearing plate should tie the wood plate to the concrete beam. Bearing plates and load bearing plates that are on Page 40 of the 2015-2016 Simpson Strong-Tie Wood Construction Connectors Catalogue (SWCCC) can be used (see: <http://www.strongtie.com/literature/c-c-2015.html?source=halfblock>). The bolts are embedded in the concrete at the time the wall is poured.

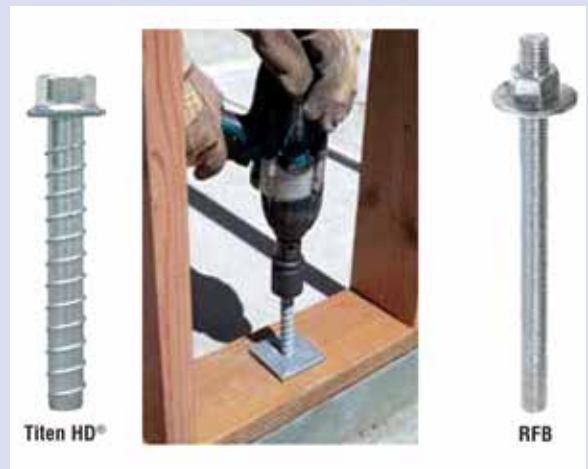
Figure 4-5. For retrofit of existing structures, where a strong connection between the wood top plate and concrete structural bond beam is needed, sill plate anchors such as on page 42 of the SWCCC can be used. Bearing plates can also be used. This retrofit requires sufficient access under the roof. A right angled impact driver may be needed. For the screw on the left (Titen HD), pre-drill the hole to the size of the shaft, with a hammer drill using a concrete bit. Then screw in with an impact drill. For the fastener to the right, drill with a 1/8 inch oversized hole, then fill in with structural epoxy.

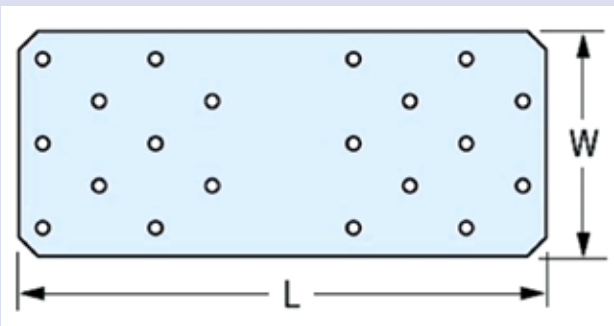
Figure 4-6. Another way to tie the wood plate to the concrete beam is to use the HTP37Z Metal Plate. This plate is 7 inches long and 3 inches wide. Five of the 1 ½ inch long 10d nails attach to the wood (see Table 4-1) and page 22 of the SWCCC. For the concrete, use five masonry screws such as a Titen Hex Head on page 173 of the SWCCC in order to match the loads. In installation, the plate is oriented with the long axis vertical. To use this, either the interior or exterior of the wood plate and wall must be flush.
