# HOMEOWNER'S HANDBOOK TO PREPARE FOR NATURAL HAZARDS

REPUBLIC OF THE MARSHALL ISLANDS

By  
 Don Hess  
 Dennis Hwang  
 Karl Fellenius  
 Ian Robertson  
 Mark Stege  
 Ben Chutaro

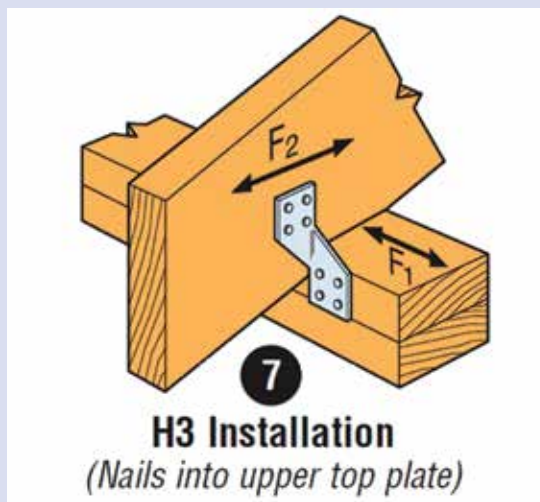
Figure 4-7. To tie the Truss to the Wood Plate, H3 clips are very useful. The H3 allows 455 lbs of upload resistance per Truss. It is useful when there is only one wood plate on top of the concrete wall (see Figure 4-3). Four 8d Common nails go into the truss and four into the one wood plate. **The H3 clip is inexpensive, readily available in Majuro and suitable for retrofit applications.** For other methods to tie the truss to the wood plates or wall (see Figures 4-8 to 4-14). The advantage of the H3 clip is that it provides an engineered solution to resist high winds.

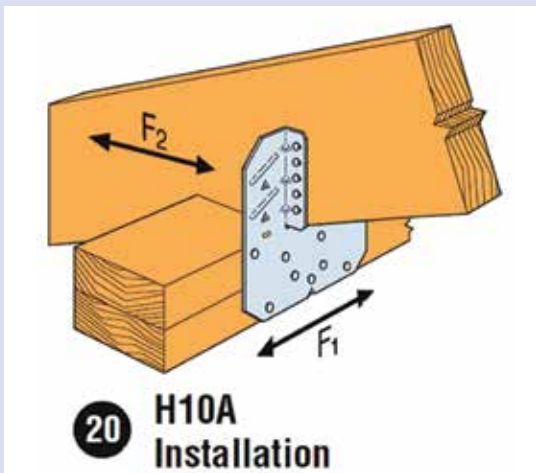
Figure 4-8. Sometimes there are two wood plates over the concrete beam. In this case the H10A clip can be used. This tie offers more than twice the upload protection compared to the H3. Follow the nailing pattern on page 196 and 197 of the SWCCC catalogue. Nine 10d by 1½ inch nails are in the truss and nine 10d by 1½ inch nails are in the wood plates. The Homeowner has the choice to use the easier to install, and less expensive H3 or the H10A, which offers more protection. Either the H3 or H10A can be used in new or retrofit applications, depending if there is access.

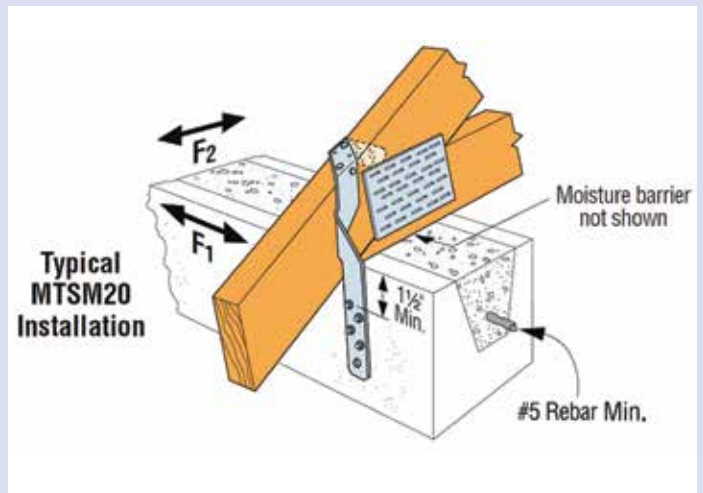
Figure 4-9. For new installations, the MTSM/HTSM strap offers 860 to 1175 pounds of uplift protection per truss and is suited when there is no wood plate and the connection is from the truss to the concrete wall. This can be found on page 182 of the SWCCC. Masonry screws – 4 quarter inch wide and 1¾ inch long go into the concrete and seven 10d nails go into the wood truss.

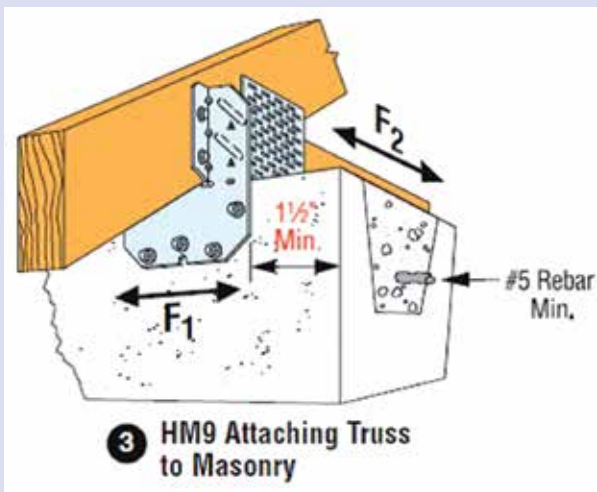
Figure 4-10. The HM9 is a connector made especially for the situation where there is no top wood plate and the attachment is directly from the truss to the concrete structural bond beam. This is good for retrofit applications and requires 4 of the SDS ¼ inch wide and 1 ½ inch long screws for the truss and 5 of the ¼ inch wide by 1 ¾ inch Titen screws for the concrete. See page 178 and 179 of the SWCCC.

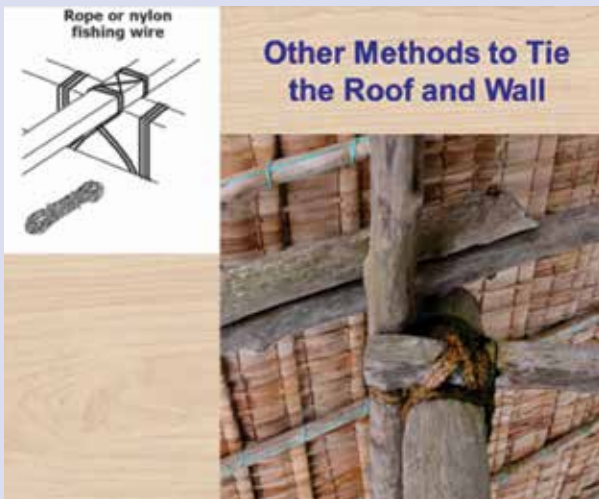
Figure 4-11. Tying roof members to post with coconut fiber rope. This is a traditional Marshallese way of tying roof members to the supporting beams. It is stronger than just toenailing wood members, which can be easily pulled apart in tension by high winds. Image in top-left corner from Sheltercluster.org.

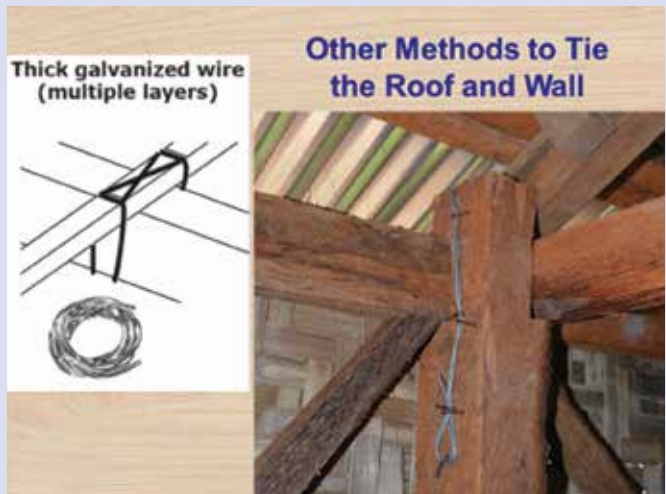
Figure 4-12. Attaching roof members to a beam with multiple layers of galvanized wire. Image in top-left corner from Sheltercluster.org.

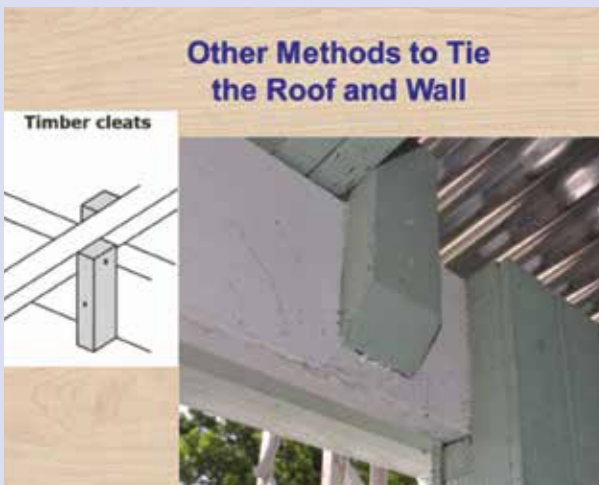
Figure 4-13. Attaching truss to beam with timber cleats. The cleats are ground contact, termite treated 2 by 4's made of Douglas fir. 8 inch pieces are beveled at the end for aesthetics and painted with 2 coats of indoor/outdoor primer and 1 coat of paint to match the wall. Three – 3 inch screws attach the cleat to the white beam. Three – 3 inch screws from the opposite side of the truss attach it to the cleat. The process is repeated if two cleats are used per truss. Photos courtesy of Ben Chutaro. Image in top-left corner from Sheltercluster.org.

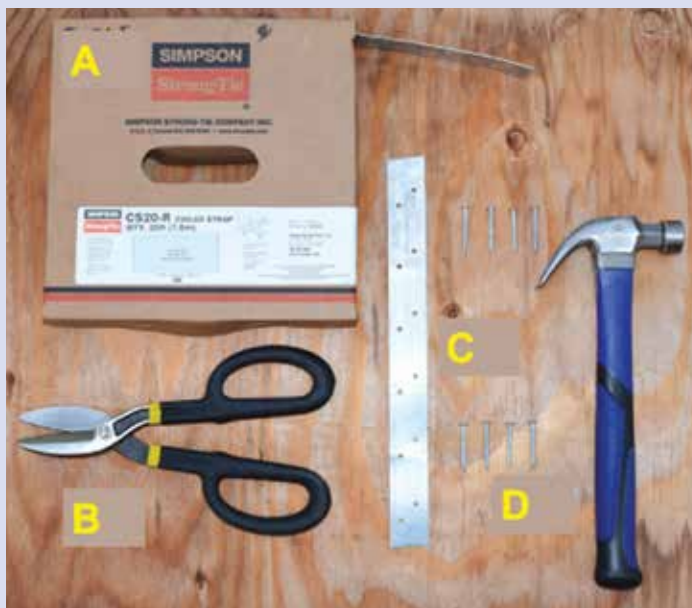
Figure 4-14. Attaching roof members to the beam with galvanized metal straps. (A) Structural straps in a coil and with different lengths and thickness are available locally. (B) The strap is cut to the desired length with a metal snippet. (C) Metal strap cut to desired length. (D) Six 10d or seven 8d common nails can be used to attach each end (page 189). The length is cut as needed, or the table in SWCCC can be followed for specific design loads. This is a general purpose connector for members that are flush. For those at right angles to each other, bends may be needed, and thus other connectors may be more useful. The advantage of the coiled straps is low cost and the flexibility to adjust the length. CS-16 straps are available in Majuro at a cost of \$138 for a coil of 150 feet.

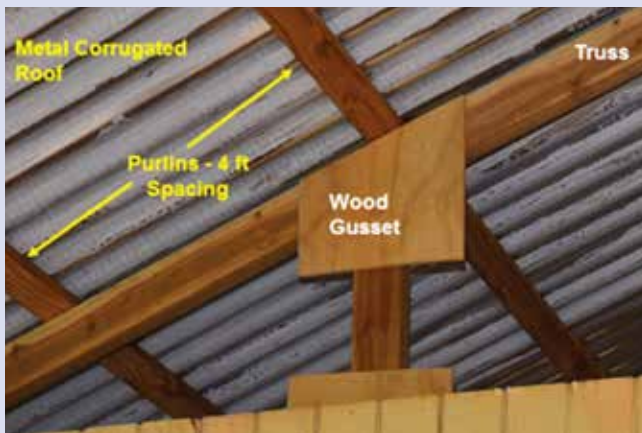
Figure 4-15. Typical roof structure can be strengthened for new construction and in retrofit applications. To tie the roof trusses, sometimes nails are used in tension, which pull out easily in high winds. Stronger is the use of wood gussets, instead of nails to tie the truss together in shear. Note the purlins are spaced 4 feet apart. If the purlins were 2 feet apart the roof would be stronger.

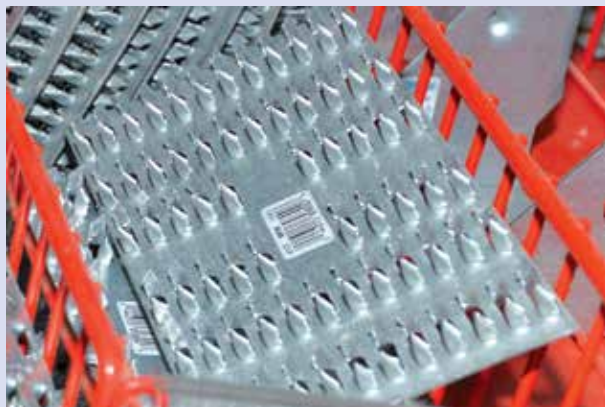
Figure 4-16. Strong truss connections come from the use of metal plates or wood gussets. Both the metal plates and/or wood gussets can be used for new construction or could be used for retrofit applications if the roof structure is not covered by a ceiling. Mending plates are readily available at the hardware stores in Majuro. They come in different sizes so make sure they are designed for trusses.

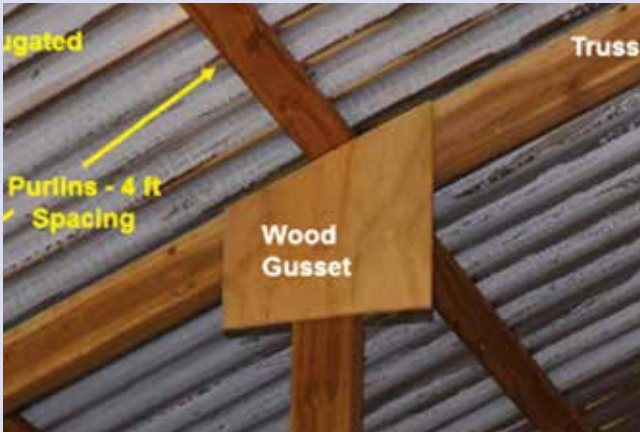
Figure 4-17. In an enlargement of Figure 4-15, on top of the trusses, are wood purlins (2 by 3's) running perpendicular to the trusses and parallel to the length of the house. The metal corrugated roof is attached to the purlins. It is important that the purlins are strongly fastened to the trusses. This can be done for new buildings and in retrofit, if a ceiling does not cover the roof structure.

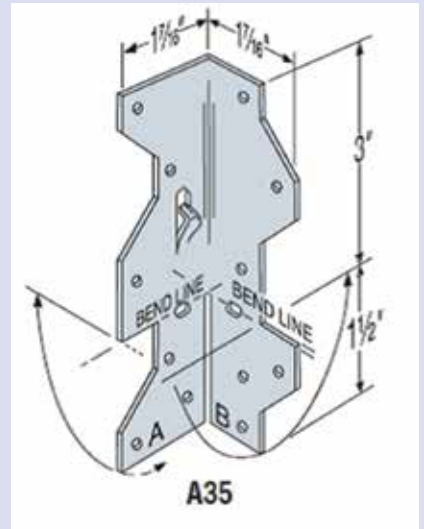
Figure 4-18. The A35 clip can be used to fasten wood at right angles, such as for the truss-purlin connection. The A35 plate pictured here and on page 206 of the SWCCC has bend slots which allow instant, accurate field bends for all two- and three-way ties. The reversible design permits the A35 to secure a great variety of connections. Nine 8d 1.5 inch nails are used to make the connection. The clip is readily available in Majuro. It is important that similar metals be used. For example, use stainless steel nails for stainless steel A35 clips. Use hot dipped galvanized nails with hot dipped galvanized A35 clips. Do not mix the metals for the clip and fastener.

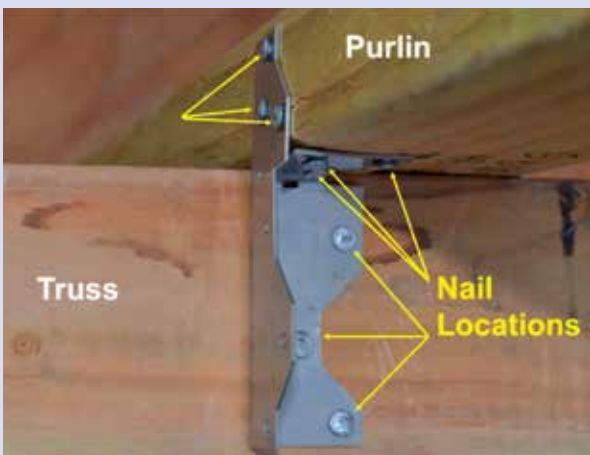
Figure 4-19. The A35 plate can strengthen the connection between the truss and purlin. This Figure shows how the A35 clip can be configured. The A35 clip is bent so that one tab and 3 of the 8d 1.5 inch nails are on the side and bottom of the purlin. Another tab with the similar fastener configuration is in the truss.

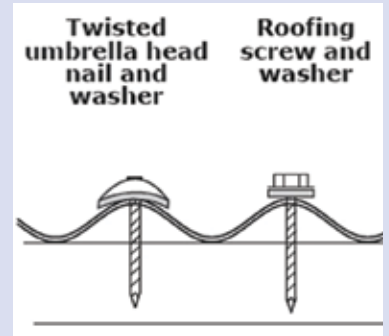
Figure 4-20. Typically corrugated metal roofing is attached to the purlins with nails. Even stronger is to use a twisted umbrella head nail and rubber washer. These are made in New Zealand. This is the connection recommended by Sheltercluster.org for their manual in the reconstruction of the Philippines after Typhoon Haiyan/Yolanda. Alternatively, a roofing screw with washer can be used. These fasteners can be used for: (i) new roofs, (ii) the retrofit of existing roofs, if the current roof is damaged, or (iii) as additional fasteners on an existing roof. For any screw or nail, the material for the fastener and the roof needs to be the same. For example, use aluminum screws to attach the aluminum roof to the purlins.

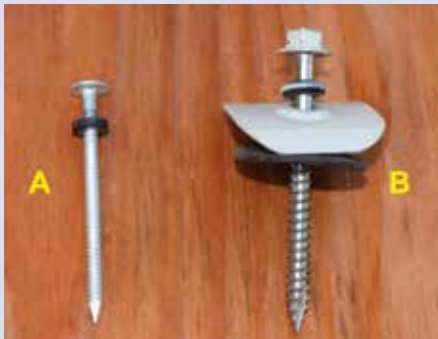
Figure 4-21. Different fasteners to tie the metal corrugated roof to the Purlins. (A) Aluminum ring shank nails with rubber washer is a strong method to attach the aluminum roof. Material is readily available in Majuro. (B) Aluminum screw with rubber washer, aluminum metal cap and another rubber washer is an even stronger method to tie the metal roof to the purlins. Unit cost is about \$1. The Majuro Department of Public Works ordered these in bulk to attach the roofs for the local schools.

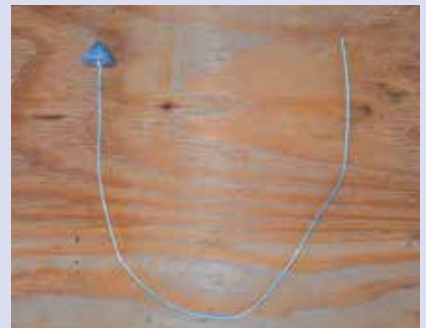
Figure 4-22. Roof ties with a metal wire are an inexpensive but strong method of attachment. The ties are about 50 cents for 12 and consist of a metal cap with G1 wire. Once a hole is drilled in the roof, the wire is threaded through the hole and wrapped around a screw or nail that is attached to the purlins. The screws or nails are perpendicular to the potential uplift wind forces, as opposed to being parallel, when they can more easily be pulled out. Photo courtesy of Ministry of Public Works.

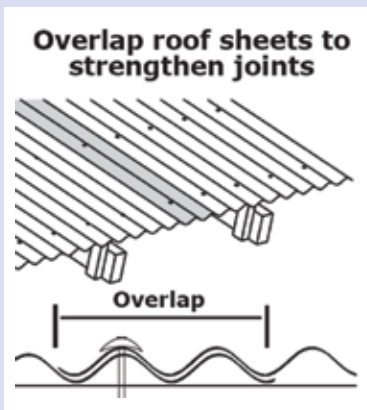
Figure 4-23. Additional measures to strengthen the roof include providing sufficient overlap of the corrugated metal sheets in order to strengthen joints (From sheltercluster.org). It is recommended that there be at least two ridges overlap. This should be done for new construction and in the repair or replacement of existing roofs.

**Figure 4-51.** An aluminum press and cutting sheet in Majuro can make metal corrugated roof and gutters of different dimensions. This can help to ensure proper overlap of aluminum roofing sheets (two ridges of overlap – see Figure 4-23). In addition, aluminum gutters can be created that are 4, 5, or 6 inches in width. The larger gutter width will maximize water capture during a rain event.

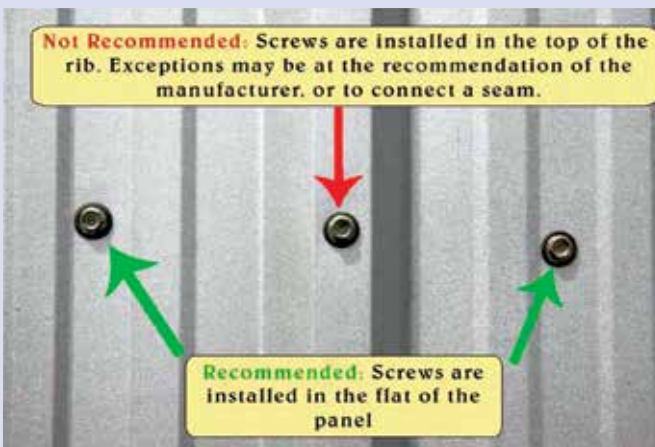
Figure 4-24. Some roofs in Majuro have flat sections that differ from undulating roof sheets shown in Figures 4-20 and 4-23. In this case, fasteners to the purlins should be in the flat lower flat portion of the panel. Photo courtesy of Christian Oakes, IOM.

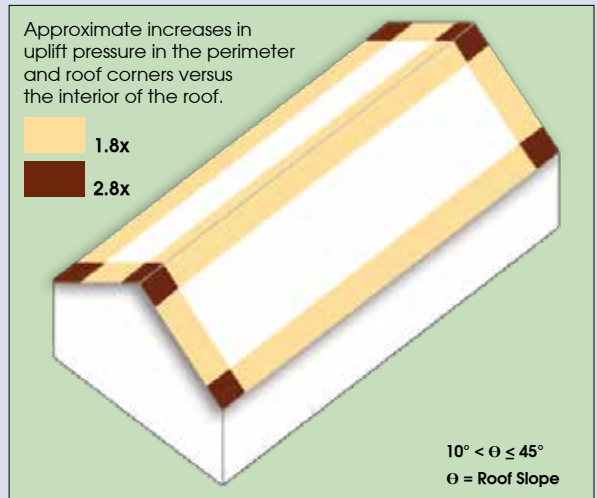
Figure 4-25. For high wind events such as a typhoon, uplift pressure to blow the roof off will be greatest at the corners, roof edges and ridges. At the corners it may be 2.8 times greater. At the edges and ridges, 1.8 times greater (from Homeowner's Handbook to Prepare for Natural Hazards – Hawai'i). For this reason, use more nails or preferably screws in these areas.

Figure 4-26. Due to greater uplift pressure on the roof edges and ridges as shown in Figure 4-25, more nails, or better yet, screws should be used to fasten the roof to the purlins at the roof edges and ridges. In addition, note the purlins are 2 feet apart to create a stronger roof (from Sheltercluster.org). This differs from the typical 4 feet spacing in the Marshall Islands.

Figure 4-27. Uplift pressure on the edges and corners of the roof is greatest (see Figure 4-25) due to overhangs. Limit the overhangs to 45 cm or 1.5 feet maximum (from Sheltercluster.org). This can be done in new design, or when roofs are repaired or replaced as a retrofit. It is very important to have the proper connections from the roof to the purlins (Figures 4-20 to 4-24) and limit overhangs. Without proper precautions, the roof can easily peel off in high winds. Providing plywood to cover the bottom of the rafter extensions will also reduce the uplift load on the roof sheeting.

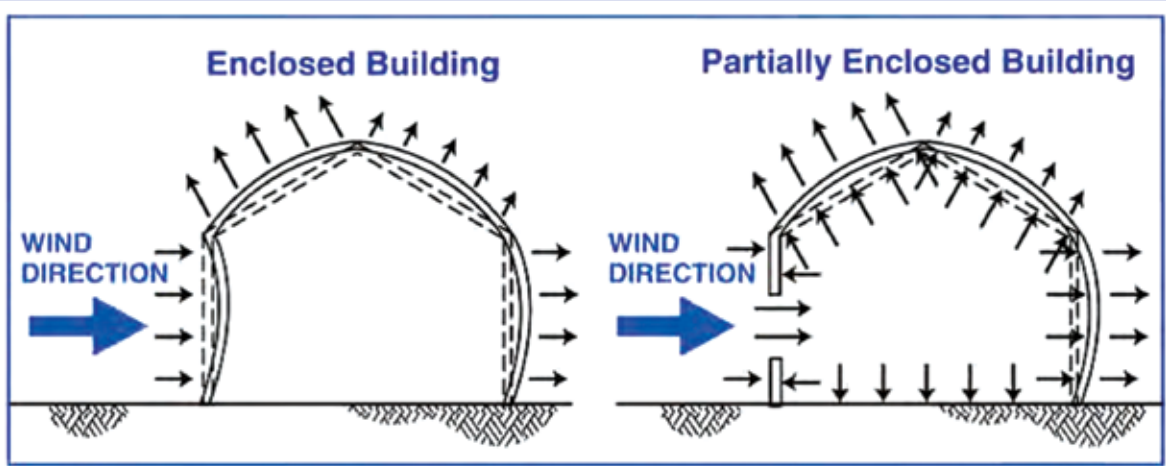
Figure 4-28. The house on the left has no openings. There is external pressure from the wind on the walls and roof only. The house on the right has an opening, either by design or because a window broke. Now there is external and internal wind pressure on the walls and roof, making it more likely for the roof to fly off. See Figure 2-6 for typical wind damage in the Marshall Islands from a typhoon, with roof blown off. This is why it is important to protect the windows with a covering such as plywood during a typhoon (see Figures 4-29 and 4-30).

During a typhoon, no wind or rain should penetrate the envelope of the house (see Figure 4-28). If a window breaks, it allows the wind to enter the house and cause internal pressure that increases the uplift on the roof. Thus it is important to protect windows with a shutter, most commonly plywood.

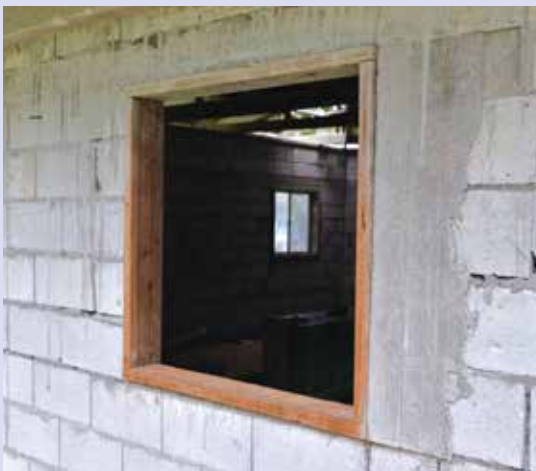
Figure 4-29. Typical window for a concrete house in Majuro has the window framed by 2 inch by 4 inch, or 2 inch by 6 inch termite treated lumber. If the window framing and concrete wall are flush, plywood can be cut to overlap the treated framing lumber by 1 or 2 inches. Then fastener holes can be pre-drilled in the plywood at a pre-determined spacing to hit the middle of the 2 inch by 4 inch or 2 inch by 6 inch, while staying away from the edge of the plywood. If the window framing is inset, the plywood must be precisely cut to insert in the inset. Fastener holes should still be pre-drilled into the plywood.

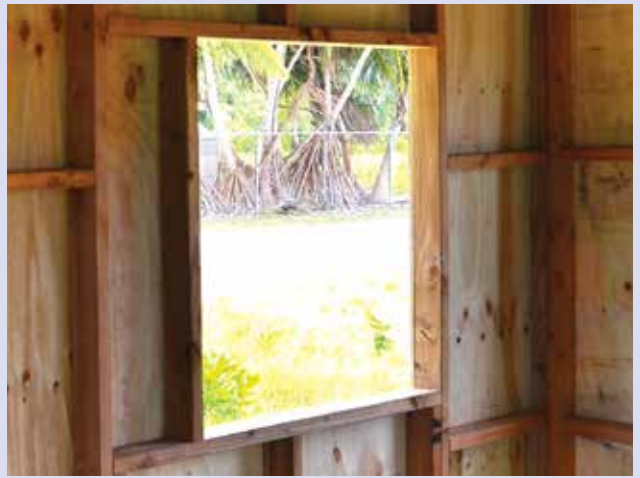
Figure 4-30. For this wood framed house in Majuro, the 2 inch by 4 inch or 2 inch by inch 6 inch lumber frames the window, as in Figure 4-29. Plywood panels should be pre-cut to the proper size to overlap the window. The fasteners must go into the framing lumber (2 inch by 4 inch or 2 inch by inch 6 inch) not the wood panels covering the side of the house. Follow the 4 P's (Figure 4-31) and suggestions below.

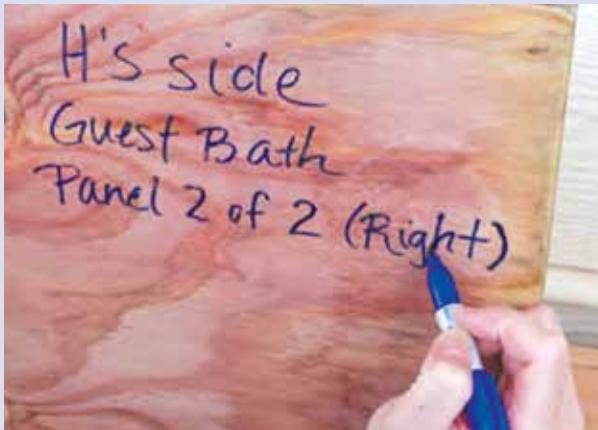
Figure 4-31. Remember the 4 P's in preparing plywood shutters. (1) Precut the plywood to the proper dimensions before an event; (2) Prelabel the plywood for the appropriate window; (3) premark the location of the fasteners on the plywood; and (4) Predrill the faster holes on the plywood. All this preparation needs to be done in advance, and generally cannot be done if there is an incoming typhoon.

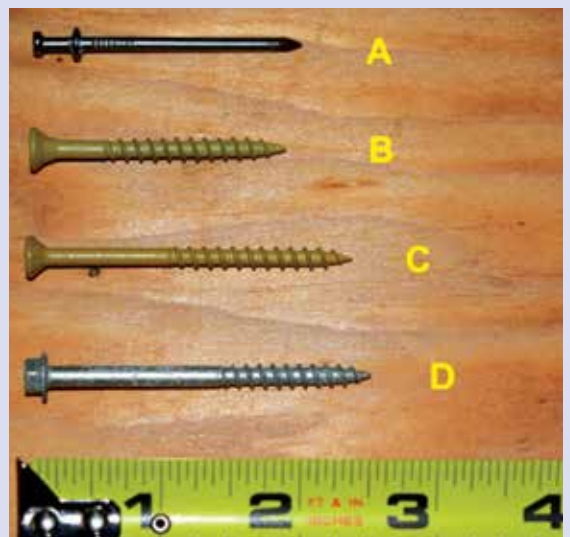
Figure 4-32. Fasteners that can be used to attach plywood storm panels. A) Duplex or two-headed 2 inch nails are used to initially attach the top left and right corners of the panel to the wood framing of the window. B) #8—2 inch wood driving screw. Allows 1 ¼ inch embedment; C) #9—2.5 inch wood driving screw. Allows 1 ¾ inch embedment; D) #10 Lag Screw—in this case, a 2.5 inch Simpson self-driving screw. Not all lag screws are self drilling (see Tables 4-2 and 4-3).

5. Duplex nails can be used to attach the upper corners of a plywood panel to the window framing – then 2 inch screws can be used to fasten the panels (Figure 4-32).

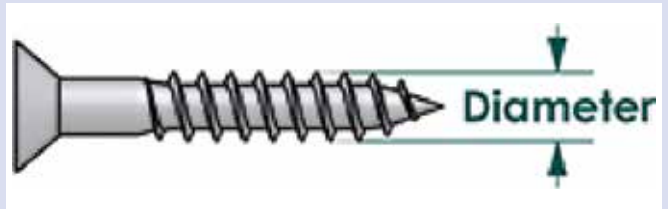
**Figure 4-33. Wood screw numbers are based on the thread diameter as shown. A given number screw will have the same diameter but can have different lengths. For most plywood applications in the Marshalls, two inch long No. 6 or No. 8 screws will suffice. The key is to have at least 1¼ inch penetration into the wood framing the window (see Tip 7). As noted previously, it may be difficult to find #6 Wood Screws with sufficient length.**

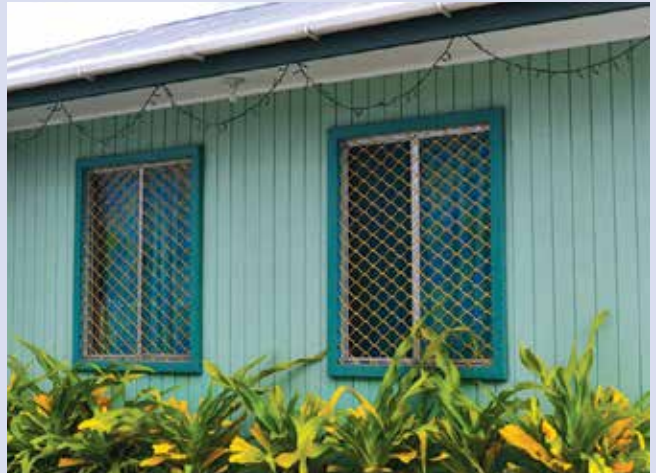
**Figure 4-34. Many schools in Majuro and a few houses have security screening. The advantage of the screening is that it is always on the window. The disadvantage is that small stones or debris can still penetrate the screening if the holes are sufficiently large and break the window, thus allowing in rain and wind. Security screens need to be securely fastened to the framing of the windows.**

If the homeowner does not want to prepare and store plywood, another option is security screening, which can serve the dual purpose of providing security, while preventing breakage of windows from flying debris (see Figures 4-34 and 4-35).

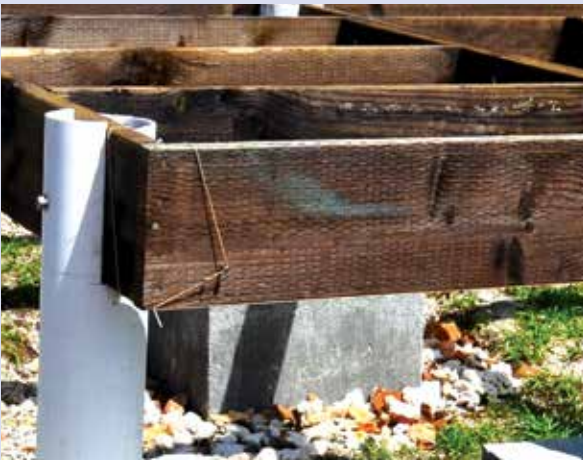
**Figure 4-36. Example of ACZA wood suitable for use in the marine environment. Note the cuts or incisions on the surface to increase penetration of the chemical treatment. Because the chemicals in this wood are very corrosive, as well as the marine environment itself, stainless steel fasteners are used to attach the column to the wood joists (support for the flooring). Photo courtesy of Ben Chutarro.**

***Ammoniacal Copper Zinc Arsenate (ACZA) Wood.*** Generally wood with arsenic has been phased out of residential construction. However, it can be found for commercial settings and exterior use. ACZA is resistant to leaching and thus suitable for waterborne systems (Figure 4-36). It is very resistant to termites, but also very corrosive. It is suitable for the treatment of hard woods such as Douglas Fir.

Figure 4-44. Better than treated wood in the ground (Figure 4-38), or a wood column with concrete spread footing (Figures 4-42 and 4-43), is the use of 6 inch PVC pipe extending to the base of the concrete spread footing. The PVC is reinforced with epoxy coated rebar that extends 6 feet below the surface. The rebar is also placed every 6 inches in a horizontal crisscross pattern through holes drilled in the PVC pipe. Concrete is then poured into the PVC. The only wood is 3.5 feet off the ground and is ground contact, termite treated ACZA Douglas Fir (Figure 4-36).

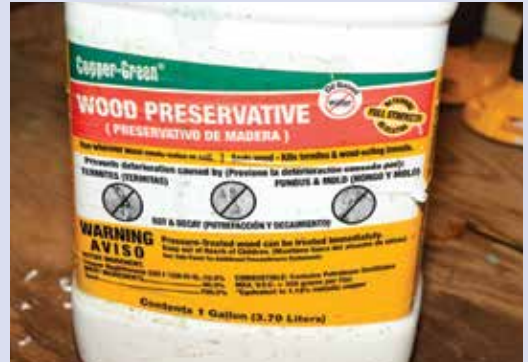
**Figure 4-37.** If you cut treated wood, the untreated interior may now be exposed to termites. Treat the exposed cut with Copper-Green, or another product which can be used to prevent termite damage, rot, decay, fungus, and mold. Ask your local hardware store for a suitable product.

- Treat wood that has been cut in the field (see Figure 4-37).
- Also ask assistants at your local hardware store about lumber.

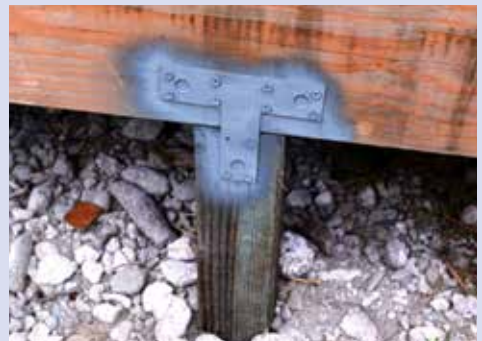
**Figure 4-38.** While it is a good practice to elevate the structure to reduce the chance of flooding, there is risk in putting a wood pier in direct contact with the ground. Treated wood can be subject to rot from wet or moist conditions. Leaching of the wood chemicals by water can expose the wood to termite risk. These impacts can be mitigated with the type of treated wood, or surrounding the pier with crushed rock or cement.

**Prevent Contact Between the Ground and Wood/Lumber.** It is preferable to never let wood products be in contact with the ground. For those thinking of elevating a structure for flood protection, caution should be taken if wooden posts are buried into the ground (Figure 4-38). Even treated wood in contact with the ground can be exposed to termites due to wood rot, or leaching of protective chemicals over time.

Although the method of elevation in 4-38 may be feasible, the preferred method for elevation is shown in Section 4.4.2 and Figures 4-41, 4-42, 4-43, 4-45, and 4-48. However, in cases where there may be lack of materials, such as no available aggregate or concrete, or there is limited funding for construction, the use of wood piers may come into play. In this case, the use of ACQ wood, or one with a higher concentration treatment such as ACZA should be considered to reduce termite risk. Termite risk can also be reduced by encasing the pier in crushed rock or a cement base.

- For any elevation scenario an experienced and qualified coastal engineer and architect should be consulted, if available.
- Piers or columns to elevate are generally made of wood or concrete. In the Marshall Islands, wood should generally not be used because of the issues with termites and water rot. If wood is used, it should not be for the portion in contact with the ground (see Figures 4-42 and 4-43). If cost is an issue, special precautions may be needed (see Figure 4-38).
- An effective pier or column should have a spread footing at the base (see Figure 4-42).

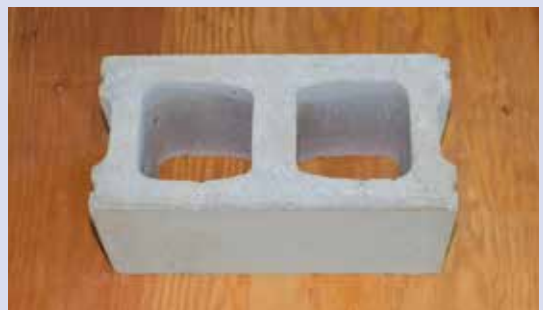
**Figure 4-39. CMU blocks are the building blocks for many houses, commercial and government buildings in the Marshall Islands. Sometimes, the holes are left empty, and then the CMU is ungrouted. Other times they add rebar and concrete in the two holes making the CMU grouted and reinforced. Whether grouted or not, CMU blocks are a highly flood resistant material.**

**Concrete Blocks** - Concrete Masonry Unit (CMU) blocks can be used for walls (Figure 4-39).

Figure 4-45. This design by the Ministry of Public Works in Majuro elevates the structure 3 feet off the ground on concrete masonry blocks (Figure 4-39). Grouting and rebar can be added to the CMU for added strength. The simple design is the cheapest and can reduce flood risk for small frequent events.

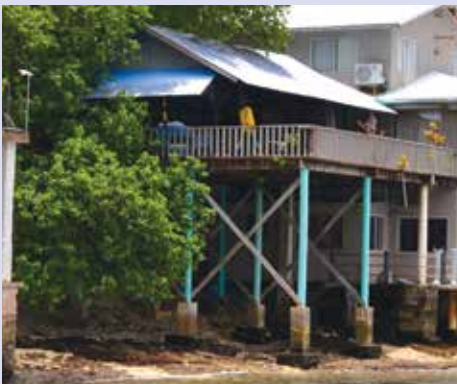
**Figure 4-40. This house in Majuro was elevated to prevent damage from wave inundation and flooding. This is an extreme example of elevation of structures. Many houses in Majuro have been elevated a more modest amount (see Figure 4-41). This house has a spread concrete footing (see Figure 4-42). The brown wood members forming the X pattern are cross bracing to provide additional lateral support of the structure.**

In Majuro, houses have been elevated from a few feet to over 10 feet to avoid flood and wave inundation damage. (Figures 4-40 and 4-41). Elevation is a time tested effective way to prevent property damage from coastal hazards **if designed and planned for properly**. The practice of elevation is an option for new houses and is generally not feasible for existing structures. Because it is primarily for new houses, only a few design suggestions are in this section for consideration by homeowners and government officials contemplating the more formal use of this option.

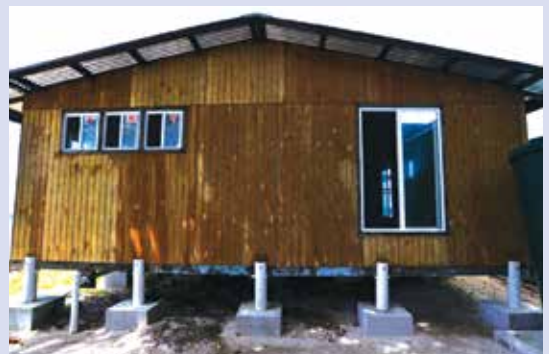
**Figure 4-41. Another house in Majuro was elevated about 3 feet above grade. A spread concrete footing (Figure 4-42) was utilized with concrete piers encased in PVC pipe. The piers extend into the footing and are reinforced with epoxy coated rebar. Photo courtesy of Ben Chutaru.**

Compare the houses in Figures 4-41, 4-45, and 4-48. These are just three different designs. But there are many ways to elevate a structure (see also Figure 4-38). Note with increased strength, comes increased costs. These are the tradeoffs. Someone building a new home can choose from the different designs, depending on their budget. Modification of the different designs is also possible to make them stronger and more expensive or cheaper. For example, it is possible to build the CMU piers in Figure 4-45 with epoxy coated rebar (Figure 4-47), grout the CMU (Figure 4-39), and bury the piers (Figure 4-42), which would add cost but be stronger. It is possible to build the house in Figure 4-41 higher, with wider piers, or ones that are more closely spaced, also adding strength and cost. Conversely, it is possible to reduce cost in Figure 4-48 by making a smaller, less elaborate structure. Thus there are many design variations of the three options provided, as well as other design concepts which are not covered in detail because the major emphasis of this book is retrofit of existing structures versus the design of new structures.

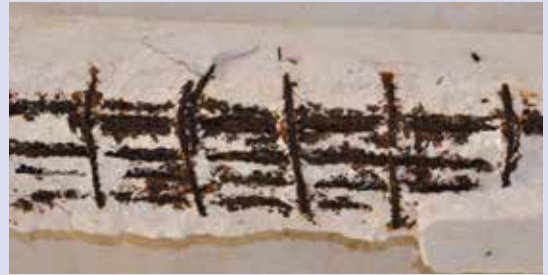
**Figure 4-46. Rebar in direct contact with concrete with salt content can cause corrosion of the rebar. Thus, there may be a need to epoxy coat the rebar.**

For the above house, treated wood is used and tied together with hurricane plates. This simple house cost is about \$2,500. It is very inexpensive but not as strong as other designs. One method to strengthen the design is to bury the CMU piers in the ground, and to reinforce the CMU holes with epoxy coated rebar and cement or grout. Examination of many buildings in Majuro indicates corrosion of rebar in concrete because it is in direct contact with the salt content in the concrete (Figure 4-46). For this reason, rebar in concrete should be epoxy coated (Figure 4-47).

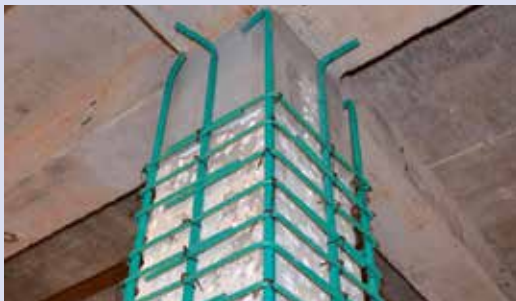
**Figure 4-47. Example of epoxy coated rebar about to be encased in concrete. Any bends or cuts in the rebar that cause the epoxy to come off should be recoated.**

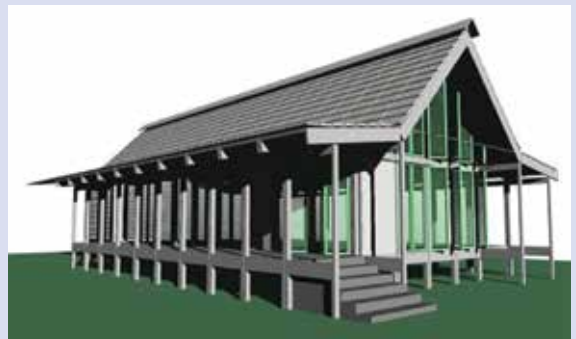
**Figure 4-48. This experimental, affordable house is designed to withstand typhoon and storm surge events. Elevation would be from 4 to 8 feet off the ground on reinforced concrete piers similar to those in Figure 4-40, 4-41 and 4-45. Once the pier foundation is set, wall frames are erected using stainless steel connection plates. Strong prefabricated panels are then used for the floor, walls and roof. The panels are made of cement, fly ash, sand and polyvinyl alcohol fibers to give it added strength (From Rockwood, et al, 2015 in Prep.).**

The rough cost of the modular house design in Figure 4-48 is about \$50,000 assuming the prefabricated panels can be mass produced. This house has the advantage of being as sturdy as concrete but elevated, to a sufficient level so it can withstand more than just frequent, smaller flood events. At this point, the house design is part of a research project, and something that is being explored in Majuro.

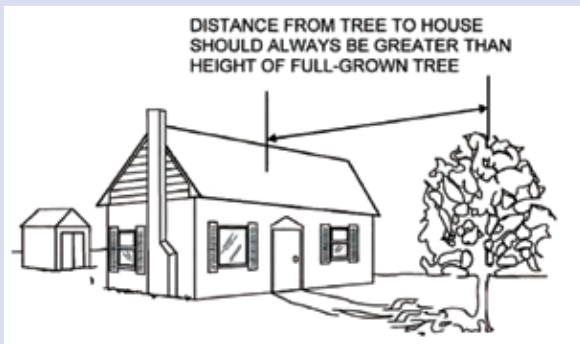
**Figure 4-49.** FEMA recommends keeping trees a distance greater than the height of a full grown tree. This will prevent roof damage from strong winds and also reduce risk that leaves will fall on your roof and enter the water catchment system.

**Your Surroundings** - Where feasible remove any trees or at least branches hanging over your roof to eliminate debris onto your roof, in your gutters, and into your water system. Keeping trees away also helps to prevent damage to the house if strong winds blow the tree over (see Figure 4-49).

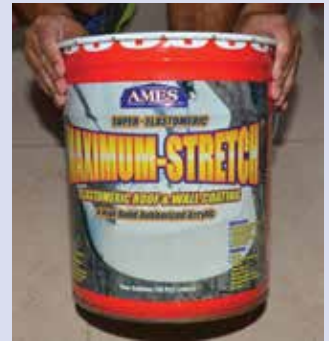
**Figure 4-50.** If it is decided to paint the roof to keep the house cooler, the paint must not pollute the water. It is recommended that an elastomeric paint be used. Check your local hardware store for a product that will seal the roof, keep it cool and not pollute the water. The National Sanitation Foundation in the U.S. has approved the use of elastomeric coatings for catchment systems (see Macomber, 2010).

**Roofs** - Roofs in Majuro are typically corrugated aluminum roofs or galvanized steel. They do not need to be painted. Yet there are benefits in painting the roof, including keeping the house cooler and preventing water leaks (see Figure 4-50).

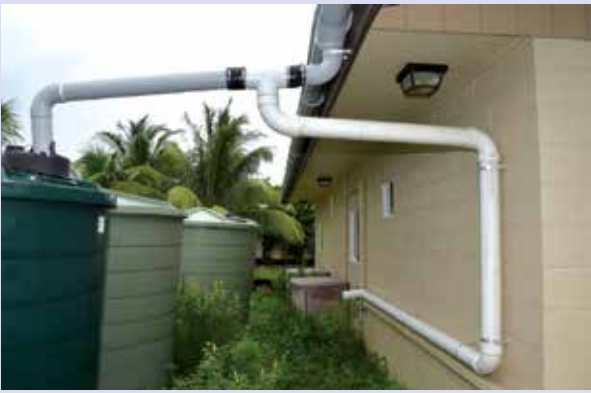
**Figure 4-52.** First-flush systems help to keep your water catchment system clean and reduce the need for maintenance. Dust, debris, or fecal matter that collects on your roof is washed off when it begins to rain and collects in the diversion pipe to the right. After a sufficient amount of rain has washed the roof, and the diversion pipe is full, either a pipe bend or a floating ball valve diverts water to the left where it is collected in the water tank.

**First-Flush System** - Combine the leaf screen with a first-flush diverter to help keep dust or microorganisms out of your water tank as rainfall begins (see Figures 4-52, 4-53, and 4-54). This information came from the EPA and also Jina David of the College of the Marshall Islands Land Grant Program.

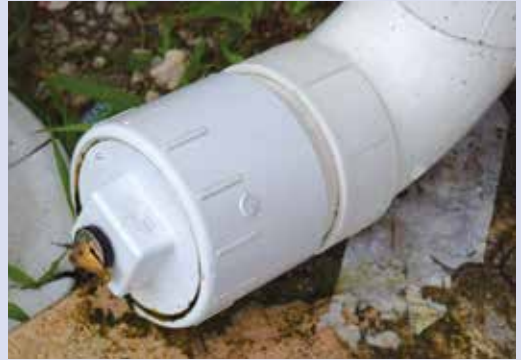
**Figure 4-53.** At the end of the diversion pipe is a small drain hole that allows the first flush water to slowly drain out so that the diversion pipe is empty for the next rainfall event. In addition, the threaded cap allows for the periodic removal of leaves or other debris.

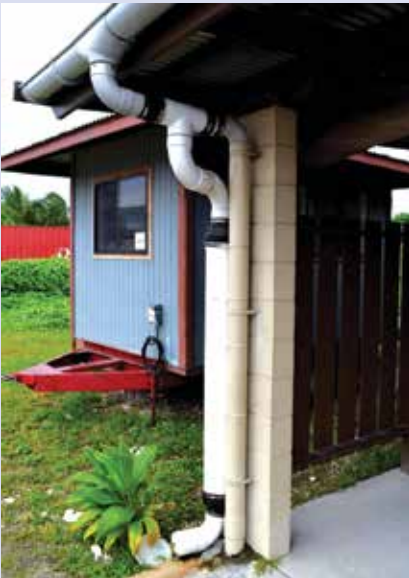
**Figure 4-54.** First-flush systems can be ordered or they are easy to create yourself. Ask your local hardware store if you have any questions about materials or how to build one. The systems are sized for the size of the roof. As a general rule, and from existing literature, the diversion pipe must catch 5-10 gallons of water per 1,000 square feet of roof area (see University of Hawai'i Mānoa pamphlet and website). See Table 4-5 to see the relationship between first flush diverter pipe diameter width, length and amount of water to collect.

Sample Sizing – A house has a roof area of 50 feet by 40 feet to collect water or 2,000 square feet (50 feet \* 40 feet =2,000 feet<sup>2</sup>). Therefore the first flush system should collect 10-20 gallons of water.

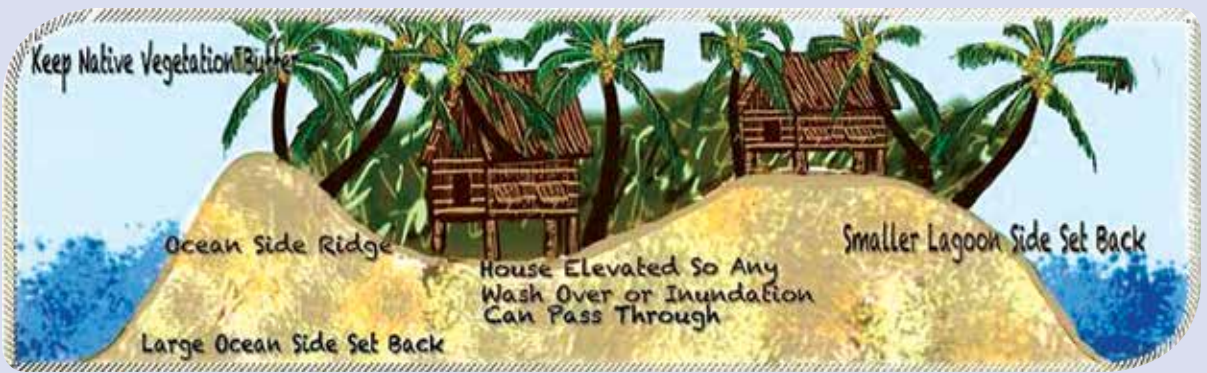
Figure 4-55. From the UH Sea Grant publication “A Landowners Guide to Coastal Protection.” The ocean side of the atoll receives more wave energy and consists of coarser grained and steeper ridges or berms. The lagoon side has smaller ridges and finer sediment. It is important to build and maintain migratory and fixed ridges or berms. Also re-vegetate the shoreline below the high water mark with mangroves and above with other suitable salt-resistant varieties.
