SEAWALL AND REVETMENT EFFECTIVENESS, COST AND CONSTRUCTION

by COURTLAND A. COLLIER

REPORT NUMBER 6

MAY 1975

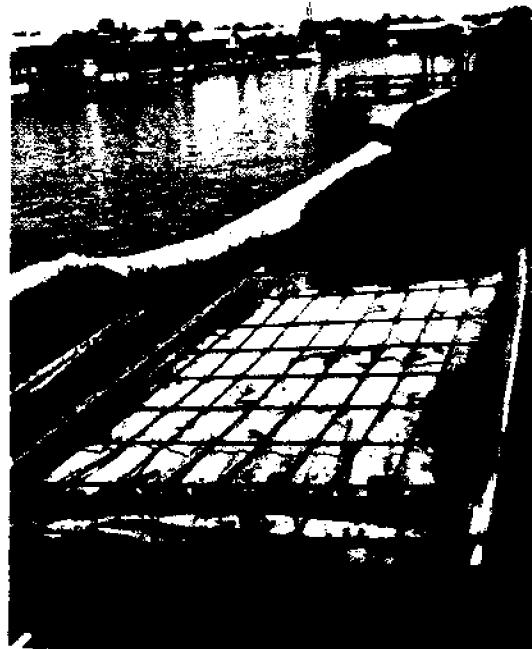
Fig. 20. Replacement slab

The anchor rods for this wall were adequate, but the toe of the wall had insufficient depth of penetration into the earth (Figs. 18 and 19). The pressure of the embankment caused the toe to swing seaward and the bank collapsed into the resulting cavity. Also shown is the formwork and reinforcing steel for replacement precast concrete slabs (Fig. 20). These will be jetted into place and a cap poured on top.

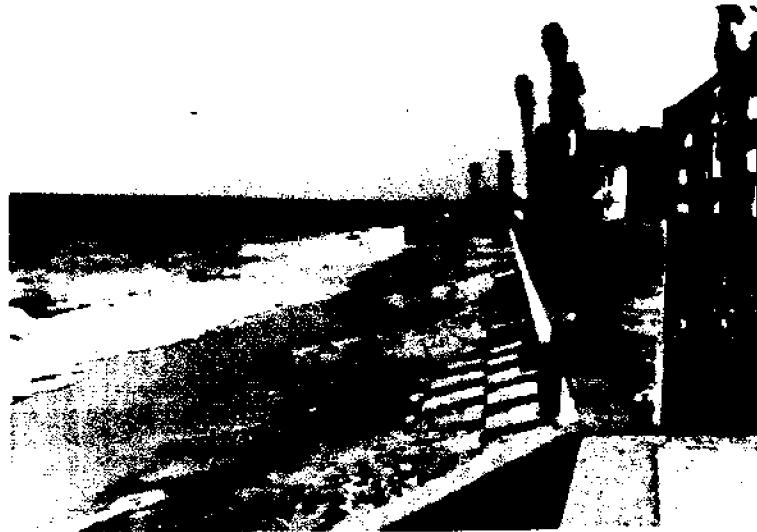
Along the eastern shore of Clearwater Harbor is a smaller sloped checkerboard revetment protecting a multi-unit residential complex (Fig. 37). This also has a toe wall which is largely covered with beach sand even though the installation is less than a year old. This revetment allows much easier access to the beach and water than does a vertical wall. The cost was approximately \$300 lineal foot.

Fig. 37. Concrete block revetment partially covered with beach
