THE POTENTIAL IMPACT OF A FLOATING TIRE BREAKWATER  
ON AREA WATER QUALITY AND FISHERY RESOURCES

IN PRESQUE ISLE BAY

FINAL REPORT - July 1983

Lake Erie Institute for Marine Science

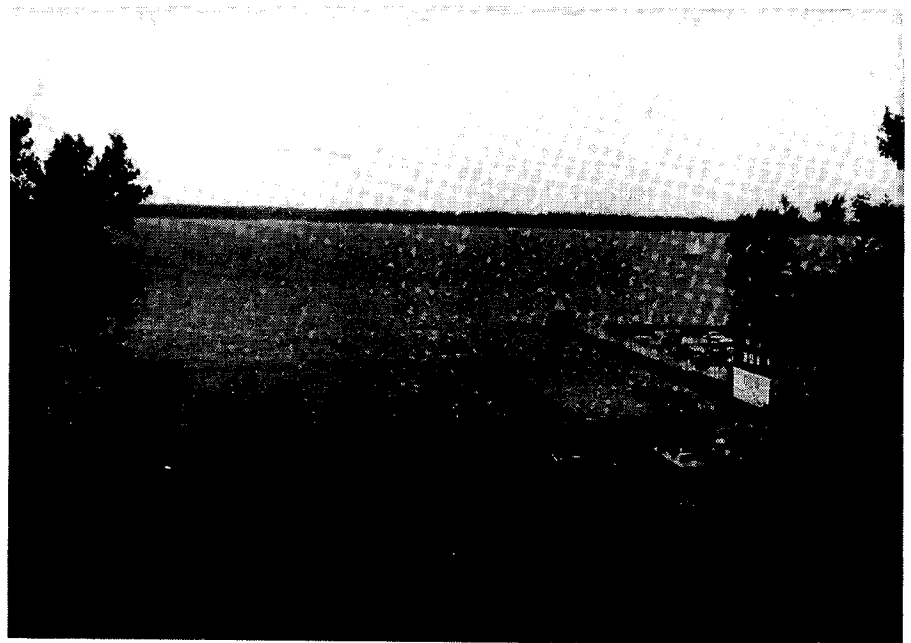
Figure 3. FTB site looking north - toward Presque Isle Peninsula.
