GLENLORD BEACH PARK

DEVELOPMENT PLAN AND SITE DESIGN

LINCOLN TOWNSHIP, MICHIGAN

ABONMARCHE CONSULTANTS, INC.
95 WEST MAIN STREET
BENTON HARBOR, MI 49022
(616) 927-2295
JULY, 1982

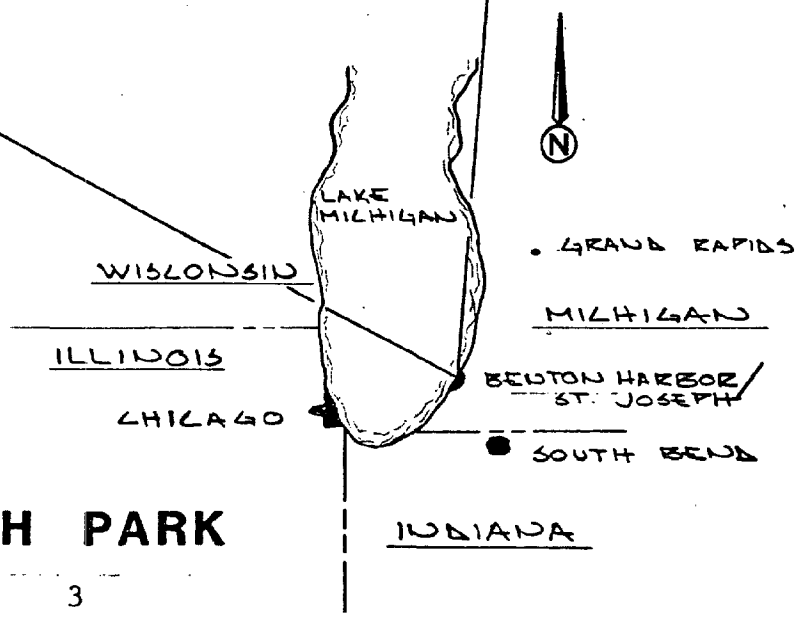
FIGURE 1

SITE LOCATION
GLENLORD BEACH PARK

Glenlord Beach Park is one of six Lake Michigan beaches in the Twin Cities metropolitan area. The metropolitan area contains approximately 90,000 people. Since there are relatively few beaches available to serve the resident population as well as tourists, Glenlord Park experiences heavy use. Glenlord Park's nearness to major roads provides a unique opportunity for the township to promote Glenlord Beach Park as a major Twin City tourist attraction. The regional and local location of the park is shown on figure no. 1 on page 3. An Existing Conditions Plan of the Glenlord Beach Park is shown on figure no. 2 on page 4.

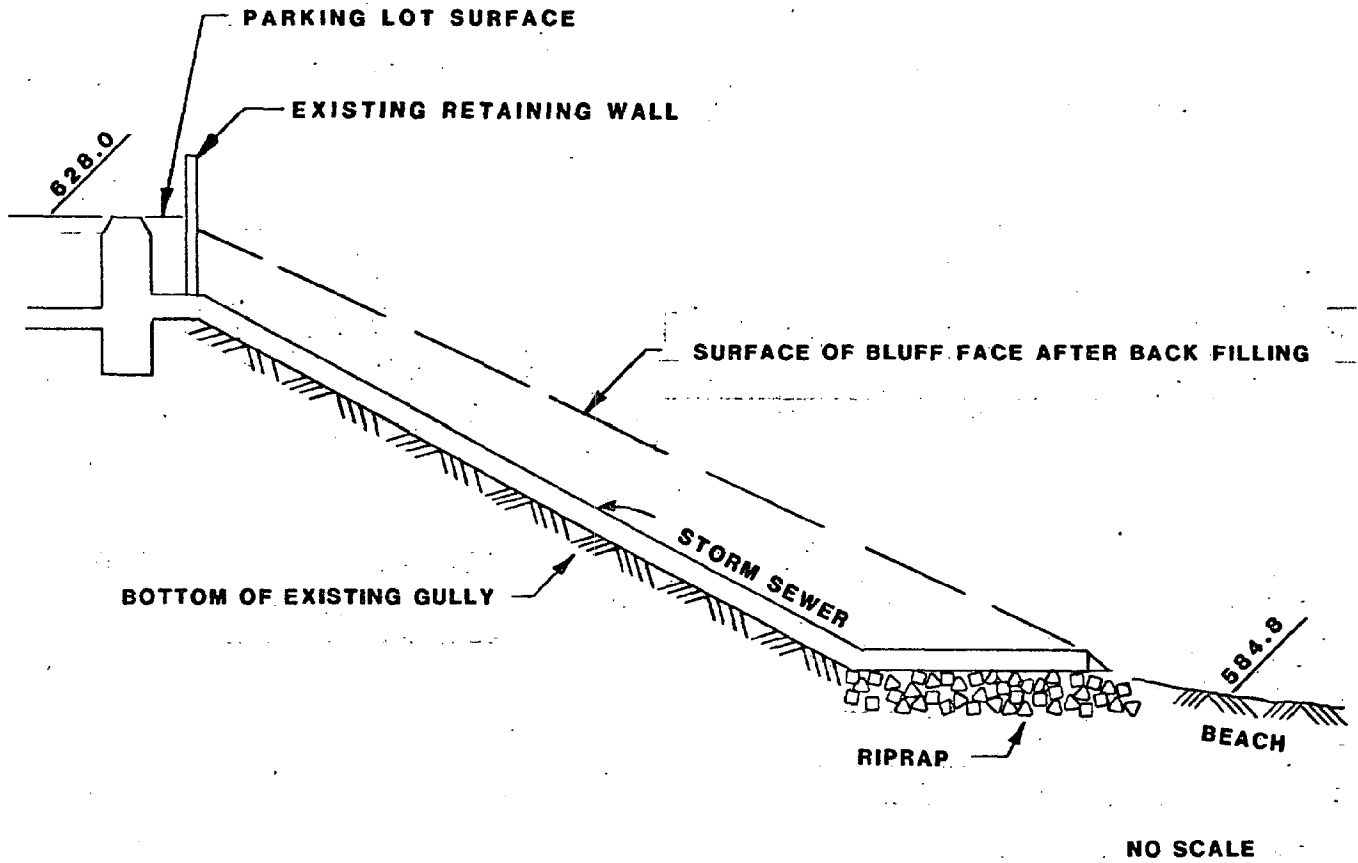
FIGURE 3

CROSS SECTION OF
STORM SEWER PIPE REPAIR

- Repair and proper installation of the storm sewer pipe. Details of the construction are given on figure no. 3 on page 12.
- Filling of all gullies with beach sand; especially the large gully at the north side, requires substantial filling. Lasting protection of this part of the bluff can only be achieved if the neighboring property owner will cooperate.
- Extensive planting of beach grass on the bluff face and brambles and juniper, or construction of a fence at the bluff toe to discourage foot traffic up the bluff.

Repair of the broken storm sewer must be performed to prevent further erosion in the northwestern corner of the park. Fill with dune grass plantings should be placed over the repaired pipe. Additionally, concrete rip-rap should be placed at the existing pipe discharge point on the beach. At the parking lot, two manholes with inlet covers should be constructed to improve the drainage. An extension of the storm sewer pipe would be provided between the manholes. Figure no. 3 on page 12 illustrates a cross section of the storm sewer pipe discharge down the bluff.

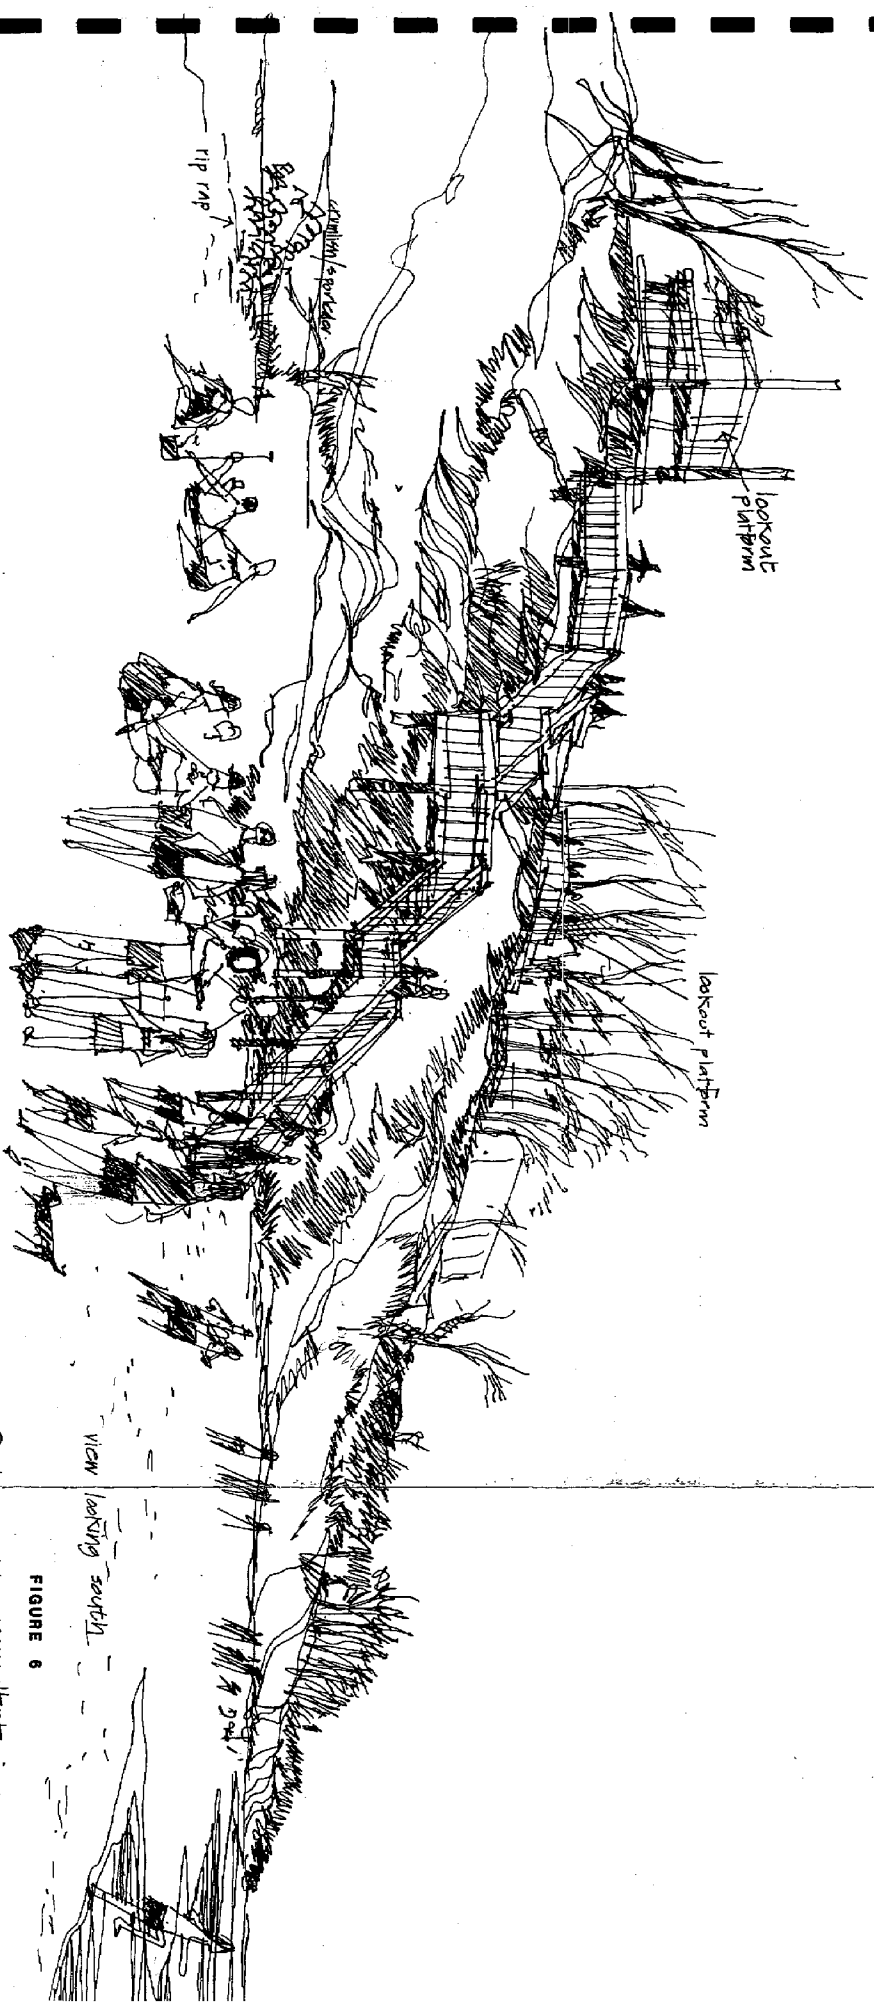
FIGURE 6
© Alburn Airsne consultants, inc
Beachon Harbor, Michigan

SCHEMATIC VIEW OF
BEACH AND BLUFF

The simplified design would more easily allow for structural repairs to the walkway should severe bluff erosion be experienced. This alternative is shown on the Master Plan and also on a schematic plan of the bluff (figures 6 and 9).

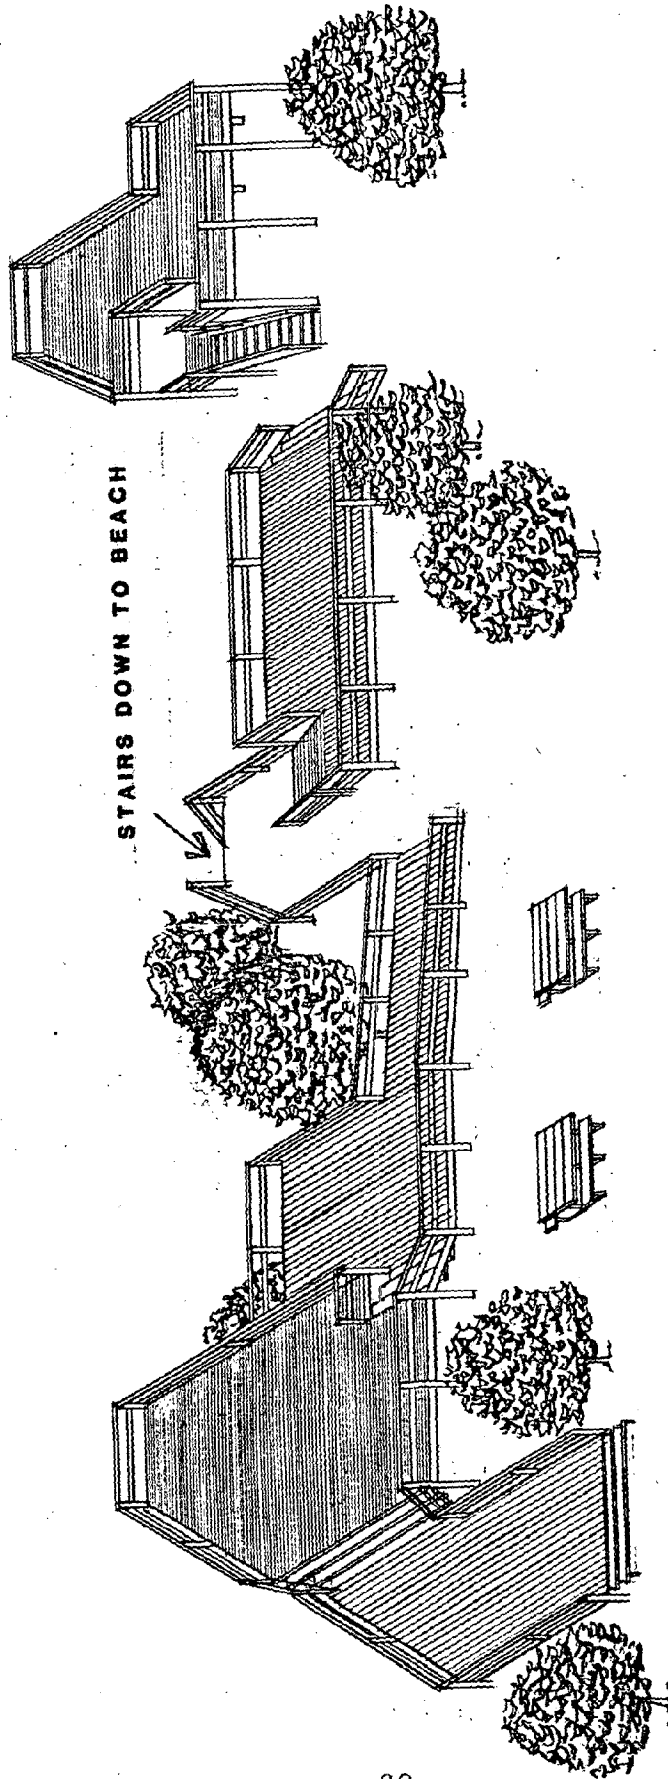
FIGURE 8

STAIRS DOWN TO BEACH

AXONOMETRIC - LOOKOUT PLATFORMS
SHOWING STEP UP/DOWN AREAS

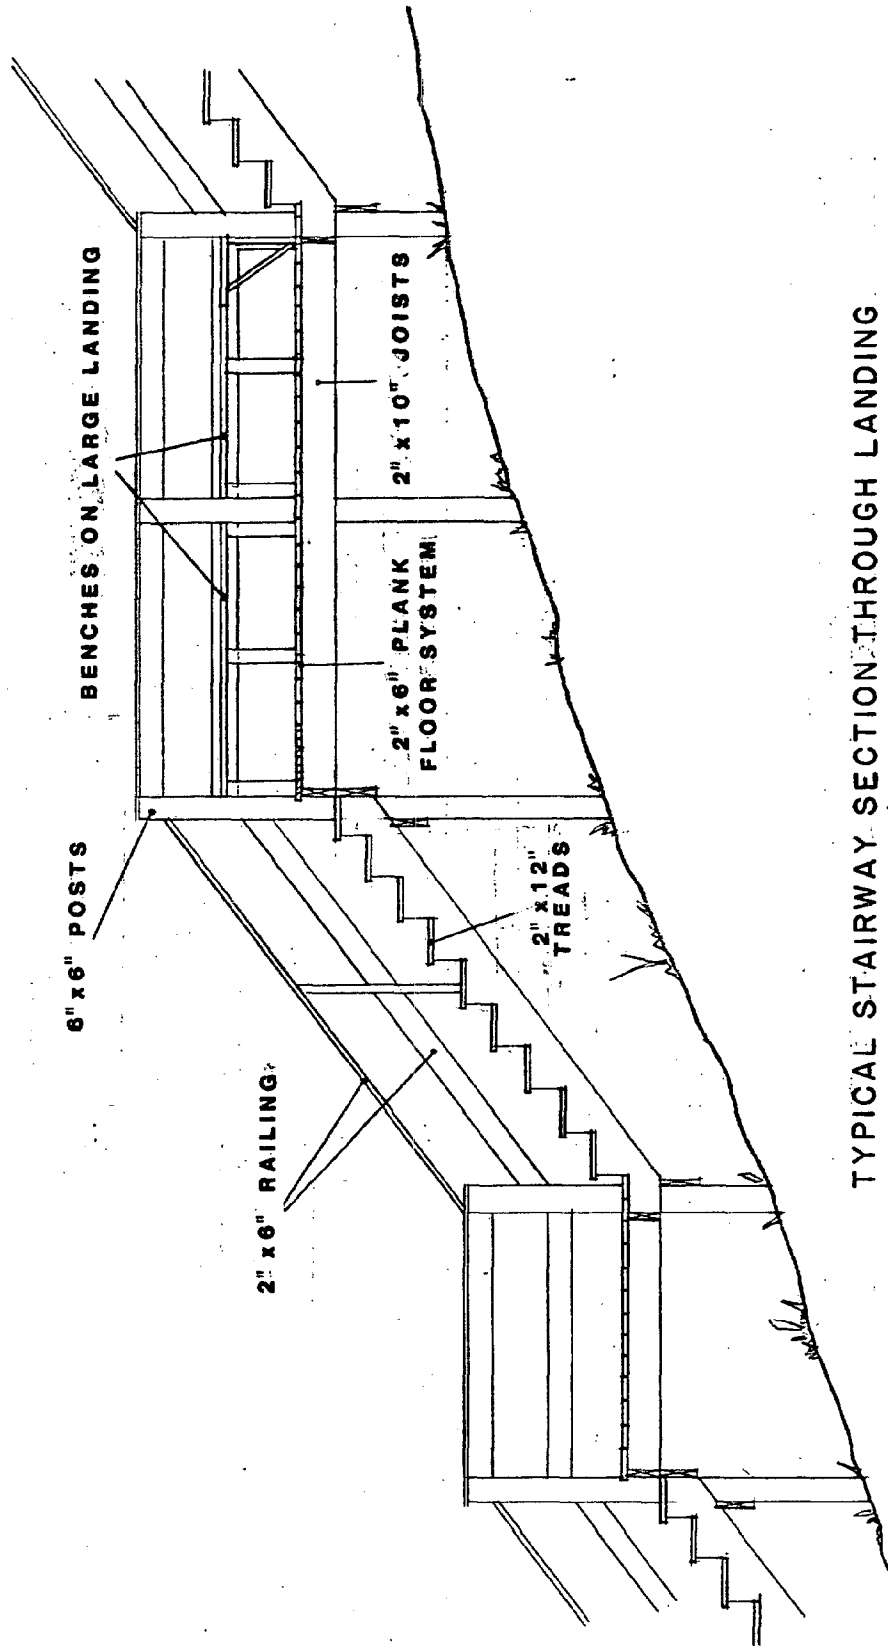
FIGURE 9

TYPICAL STAIRWAY SECTION THROUGH LANDING
