OKEANOS EXPLORER ROV DIVE FORM

Site Name	Paradise Valley							and a second	<u>)</u>	
ROV Lead	Dave Lovalvo								P	
General Area Descriptor	490 km NNE of Bitung, Indonesia					KÇ		Okeano Explore	is Ar	
UTC Date & Time	Deployment	7/5/2	2010 12:28 AM				C. W. C.	29	R.	
	Recovery	7/5/2	2010 1	12:	28 AM				8	
Bottom Time [HH:MM]	[03:20]						CTOLOCTATION COLOCTATION Delicitation Delici	ng ati agher MOA OEBCO Alte 02050	Google Eye #1 405555 mi O	
	UTC Time	03:13				Depth [m]		2700		
Landing Time & Location	Latitude	5	2			22.606		1	N	
	Longitude	126		⁰	46.017			'	E	
Off Bottom Time & Location	UTC Time		06:33			Depth [m]			2640	
	Latitude	5	<u>0</u>			22.478		'	N	
	Longitude	126		⁰	45.943			(E	
ROV Dive Name	Cruise	Cruise Season		Leg			Dive Number			
	EX1004		LEGU2							
Equipment Deployed	Camera Platfom		Phoenix Camera Platform							
ROV Measurements				Depth			Altitude			
	Scanning Sonar		USBL Position			Heading				
	🛛 Pitch	Roll			HD Camera

Description of the Dive:

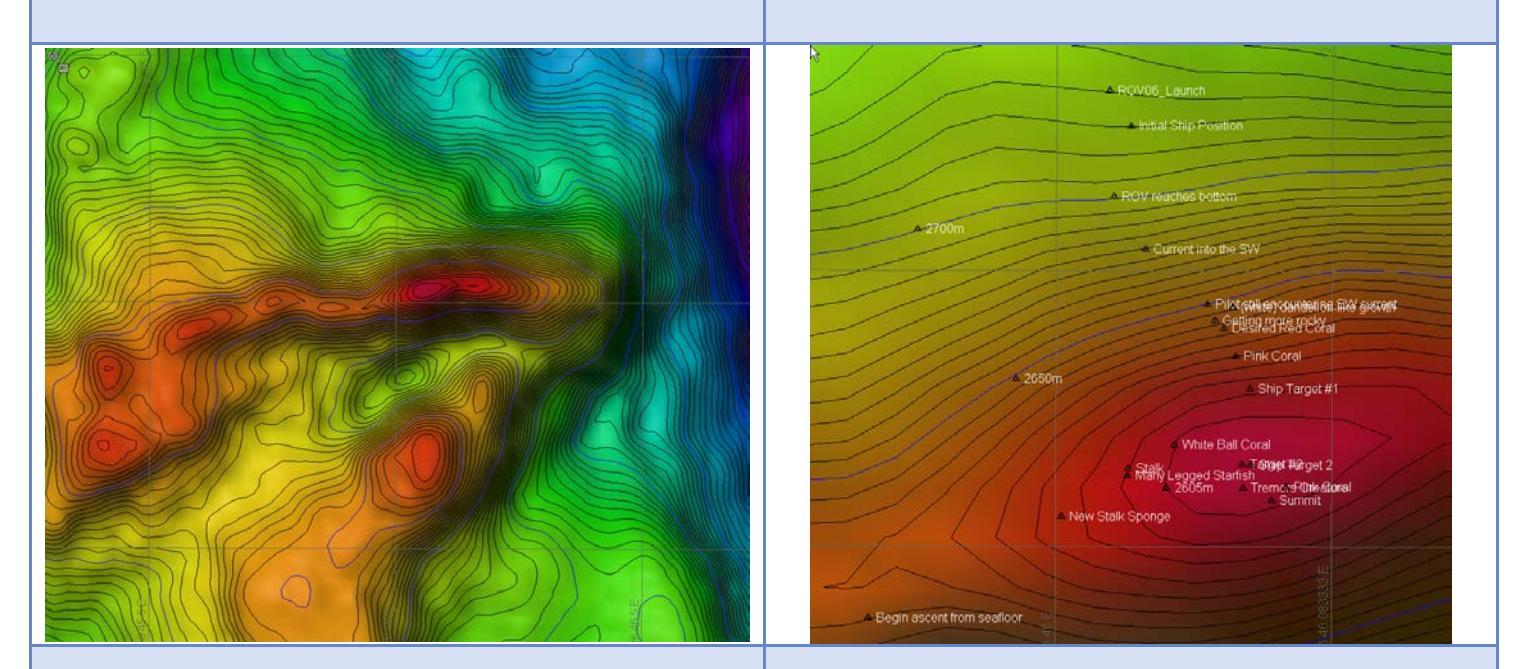
Overall Map of ROV Dive Area at Paradise Valley

Close-up Map of Main Dive Site

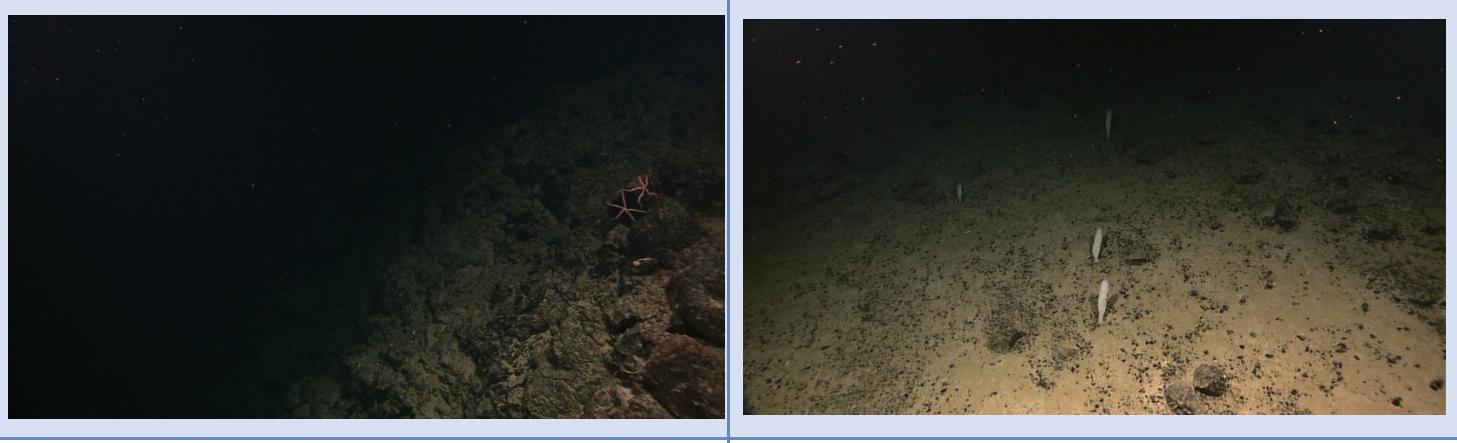
Representative Photos of the Dive

20100705_04h34m13s19_ROVHD_CORAL The seafloor was covered mostly with fine-grained pelagic sediment. The bottom ranged between mostly sediment with sparse rocky outcrops to steep slopes of broken pillows and talus. 20100705_04h56m15s24_ROVHD_LONG_CUCUMBER Epifauna were generally sparse but we imaged a number of hexactinellid sponges, sea whips, sea stars, some fish, and a variety of corals and sea lillies. We noticed many more sponges compared to previous dives.
