**Ship-Based Unmanned Aircraft System (UAS) Surveys of
the Bering Sea Pack Ice from the NOAA Ship *McArthur II*
(NOAA Cruise: MC2-09-02)**

13 May – 11 June 2009

NOAA – U.S. Department of Commerce
National Marine Fisheries Service
Alaska Fisheries Science Center (AFSC)
National Marine Mammal Laboratory (NMML)

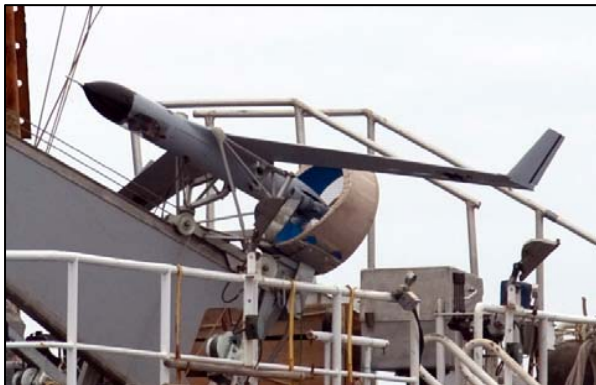
Figure 1. ScanEagle unmanned aircraft ready for launch with propeller guard in place.

Three UAS platforms were flown from the *McArthur II*. All platforms were ScanEagles (Figure 1) owned and operated by the University of Alaska, Fairbanks (UAF). One of the aircraft (#912) was developed with a quieter “hush” engine while the other two had standard production block D-V2 engines. The ScanEagle has a 4-ft long body and 10-ft wingspan, a cruising speed of 48 knots, and flight endurance of 20+ hours on 2 gallons of gasoline. They were launched by pneumatic catapult (Figure 2) from the winch deck and captured by a modified SkyHook system (Figures 3 & 4) where a clip at the end of each wing captured a line suspended from the starboard crane to a lower boom. The lower boom extended across the deck, under the rail, and out over the water approximately 25 feet from the ship and 10 feet above the water.

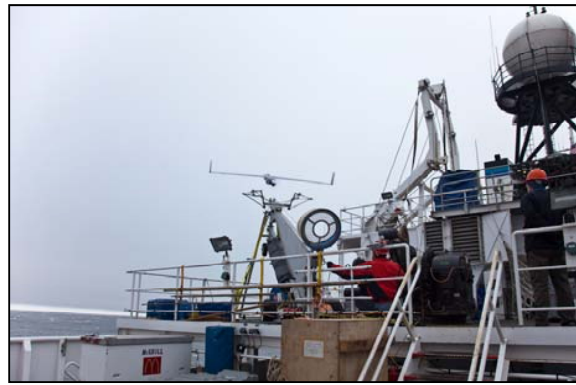
Figure 2. ScanEagle unmanned aircraft launched by pneumatic catapult from the winch deck of the NOAA ship *McArthur II*.

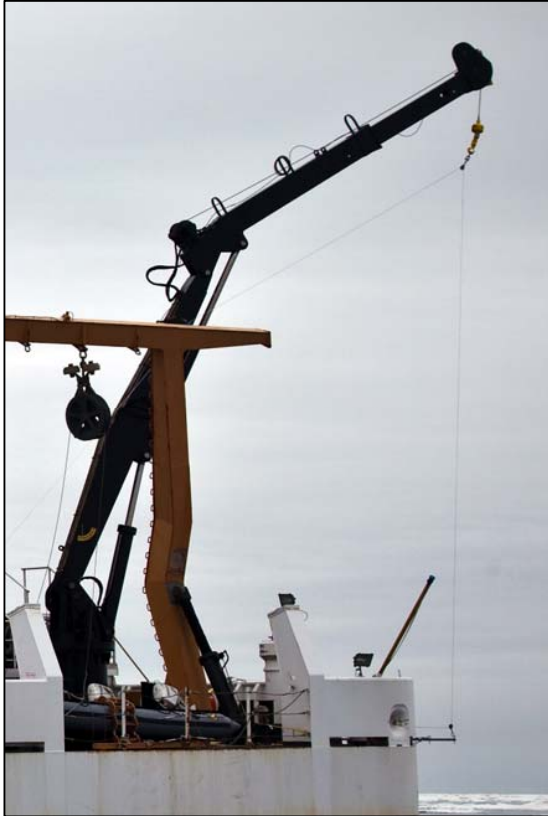
Figure 3. The SkyHook recovery system is composed of a line suspended between the ship's crane and a lower boom.

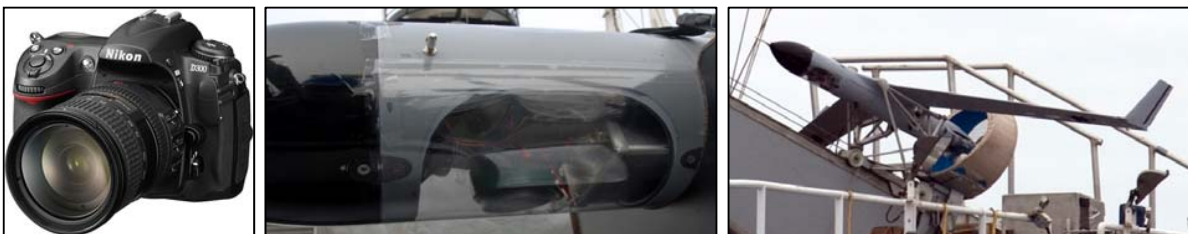
Figure 5. Nikon D300 payload mounted in downward facing ScanEagle bay.

Two of the aircraft carried a downward facing digital SLR camera, Nikon D300 with 35 mm lens, in a belly module of the aircraft body located aft of the nose cone (Figure 5). The camera was programmed to collect images every 4 seconds. All images were stored on a 16 GB camera card and downloaded after each flight. A fixed E/O video camera was mounted in the nose cone of one of these platforms. Video streamed to the Ground Control Station (GCS) real time (Figure 6). The third aircraft (AC912) had an integrated E/O video camera which was controllable from the GCS and did not carry the digital SLR package (Figure 7).

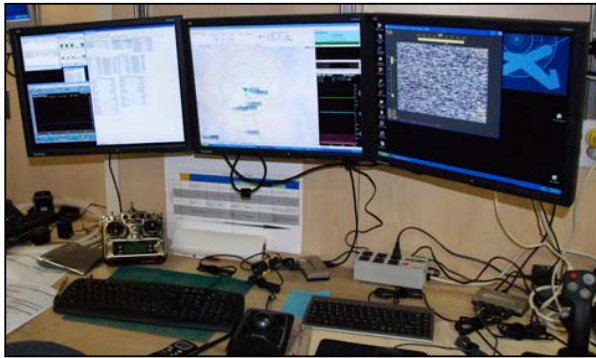
Figure 6. ScanEagle Ground Control Station in the dry lab of the NOAA ship *McArthur II*.

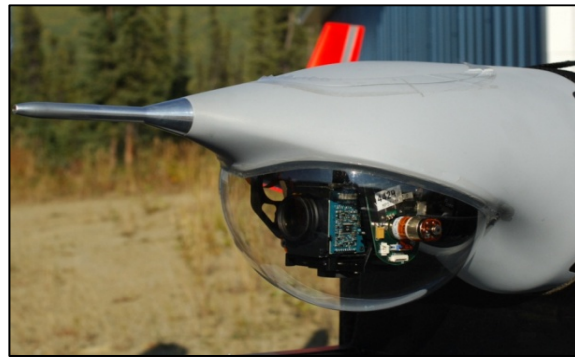
Figure 7. Standard E/O video camera ScanEagle payload.

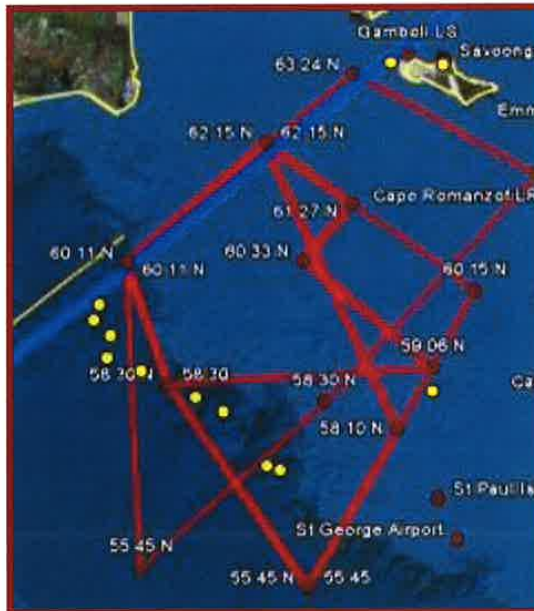
Figure 3. Historical Search and Rescue Missions (yellow)

SAR: The USCG provides SAR services in the Bering Sea. There is a USCG Air Station located in Kodiak. SAR missions originate from the closest available resource. Figure 3 displays SAR efforts represented by the yellow dots, over an undetermined time (1–5 years). Locations shown are approximate; however, the small frequency of SAR missions is of most importance. Ten occurred in or near the operating area—primarily near the continental shelf. SAR resources were responding to crises involving aircraft, person(s) in water, vessel fire, vessel sinking, minor vessel emergency, and other miscellaneous reasons. Responses are not necessarily all by aircraft and may include cutter or other boat rescue work. No USCG rescue aircraft were discovered in the May–June 2008 radar data.

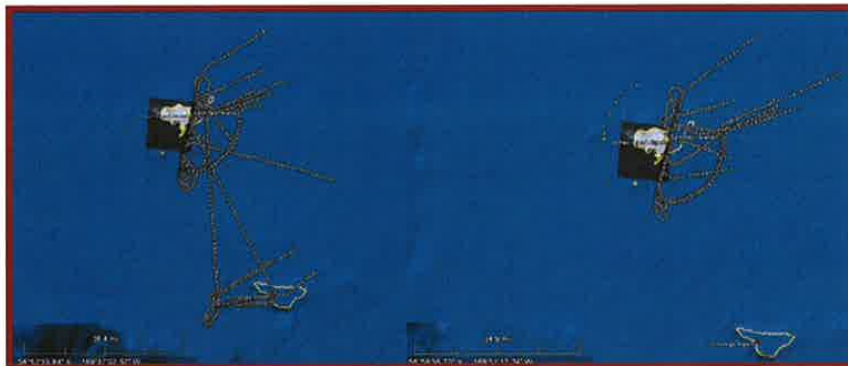
Figure 11. Pribilof (St. Paul and St. George) Islands Air Traffic Under 10,000 ft MSL. 11–15 June 2008 (left), 16–20 June 2008 (right)

Figure 11 provides details of St. Paul and St. Paul Island air traffic for two five-day periods in June. The left hand side shows air traffic from 11–15 June 2008, and the right hand side shows 16–20 June 2008. Air traffic is primarily east of or between the islands. Flight tracks end where aircraft are above 10,000 ft MSL. On one instance during June, an aircraft headed west. However, it rose above 10,000 ft MSL and never entered the proposed UA operating area.

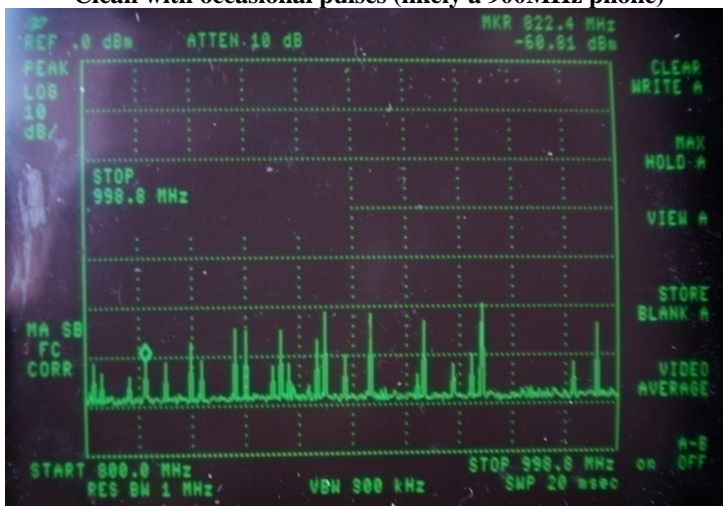
Figure 1. Example of frequency spectrum documentation.

Frequency Use	Sensitive Spectrum
Command and Telemetry	900 - 950 MHz
GPS L2 Band	1227.60 MHz
GPS L1 Band	1575.42 MHz
Video Downlink	2,300 – 2,500 MHz

800Mhz – 1.0GHz @ Oliktok Point
Clean with occasional pulses (likely a 900MHz phone)

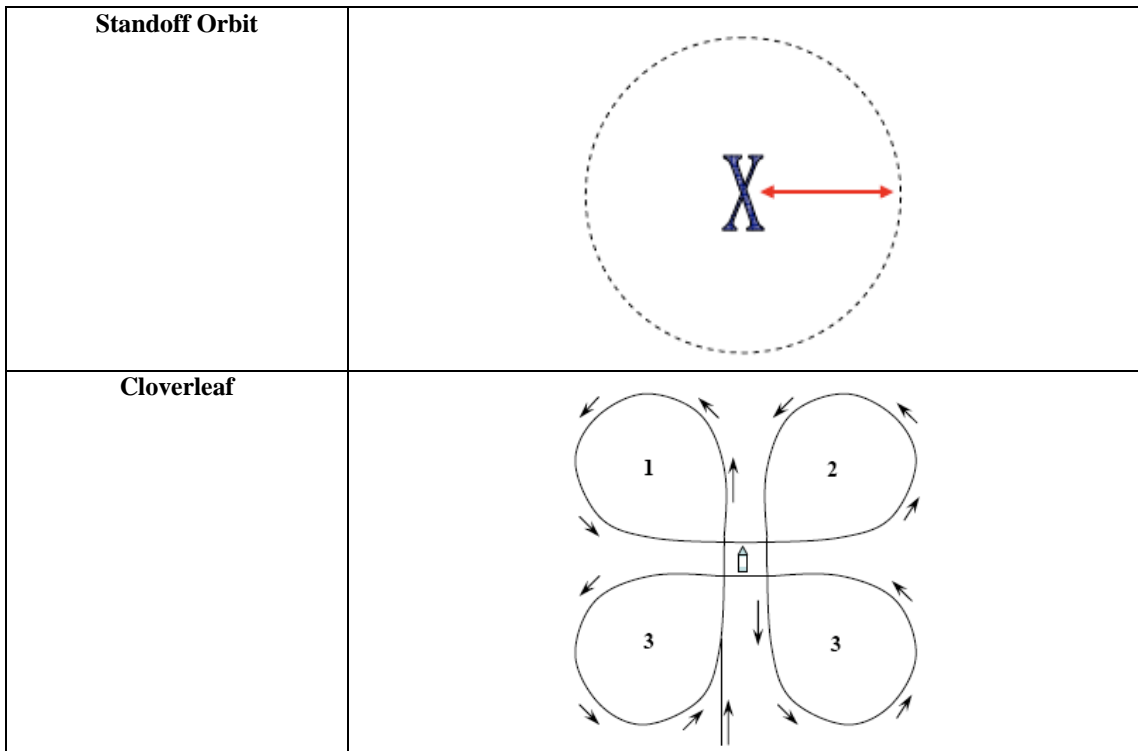
Figure 2 – Loitering maneuvers around the ship.

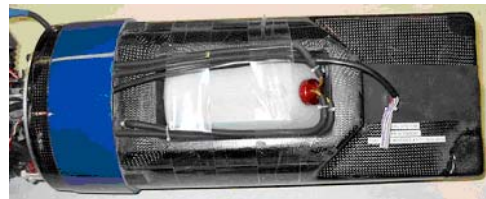
The fuel tank, shown in Figure 3 is a graphite composite lay-up that also serves as the primary structure of the propulsion system module. The fuel tank includes an integral engine mount, a mount for the ignition, and a mount for the engine control board.

Figure 3. Propulsion Module

The main tank has a capacity of 5.4 kg of fuel, and the propulsion module features in addition a maneuvering tank of .4 kg capacity, which can provide fuel flow to the engine for extended periods while maneuvering in unusual attitudes.

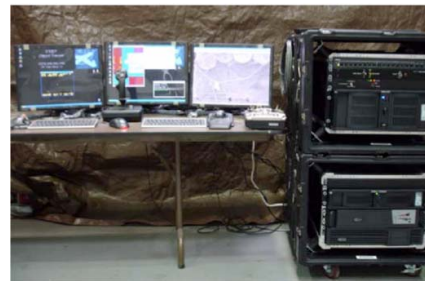
Figure 6. The GCS Hardware

The GCS consists of multiple (at-least two) MS-Windows based computer systems, figure 6, as well as a custom embedded interface controller. The MS-Windows flight software can be operated on the different computers allowing a high-degree of redundancy in the event of hardware failure in one of the MS-Windows computers. A schematic of these modules is shown in figure 7.

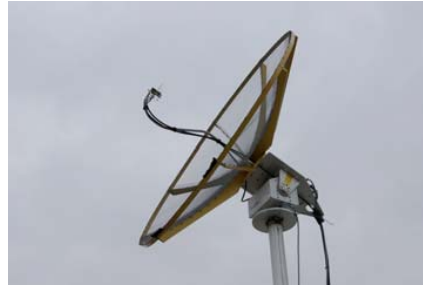
Figure 8.
Tracking Antenna

- Telemetry radio modems
- Tracking antenna, figure 8
- Skyhook GPS receiver
- Weather station
- Cleared-To-Land switch

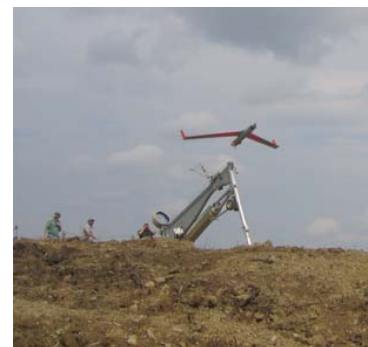
Figure 9.
An Insight A-20 Launch

The Insight A-20 is typically launched via the SuperWedge, a pneumatic catapult system, figure 9. The small, low pressure, launcher gives the Insight A-20 its initial velocity and rate of climb. The launcher propels the aircraft upward at an angle of 25 degrees in a 12g acceleration. This trajectory is beneficial in that it gives the aircraft a rapid increase of altitude, minimizing the risk factors associated with operating an unmanned aircraft extremely close to the ground.

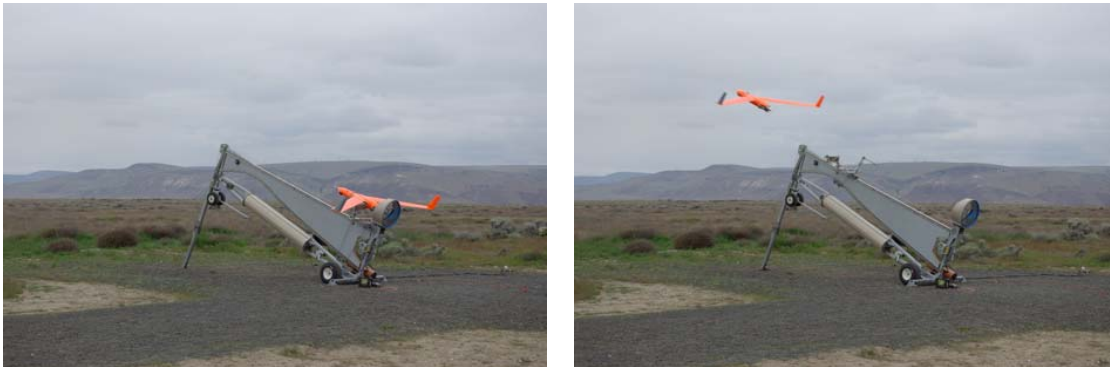
The SuperWedge launcher, shown in figure 10, is a third generation pneumatic catapult. The vehicle carriage is cranked by hand against the mechanical resistance of the wedge to the launch point. The catapult requires approximately 760 kPa/115psi. The trailer is approximately 5 m long.

Figure 10. SuperWedge 12g Catapult Launcher

The catapult uses an expanding wedge technique to achieve the necessary speed over a relatively short distance while maintaining a constant acceleration. Pneumatic pressure is used to drive the lower leg of the wedge away from the catapult track resulting in the shuttle being rapidly forced up the track. During preflight operations, a safety pin is installed to prevent inadvertent activation. Once the safety pin is removed, the catapult is manually activated using a pull trigger controlled by the launch/recovery technician.

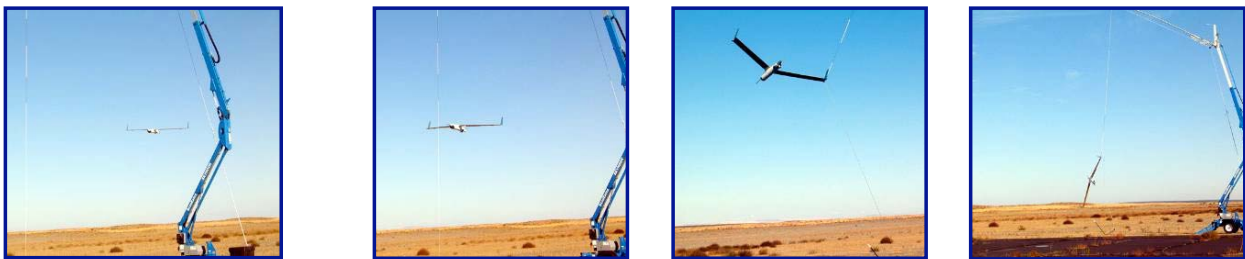
The SkyHook retrieval system captures the Insight A-20 providing runway-independent operations. The SkyHook includes a differential GPS unit and antenna, used to calculate the aircraft's exact position to within a few centimeters. The Insight A-20's wing is *snagged* on contact, by flying into the SkyHook rope, which is strung vertically approximately 50-feet above the ground. A hook on the wingtip grabs the line and quickly stops the aircraft. The Insight A-20 senses the yaw and decelerations and cuts the engine. The aircraft then hangs suspended from the rope, until lowered to the ground by the SkyHook operator. Figure 11 is a shows this sequence.

Figure 11. Recovery Sequence

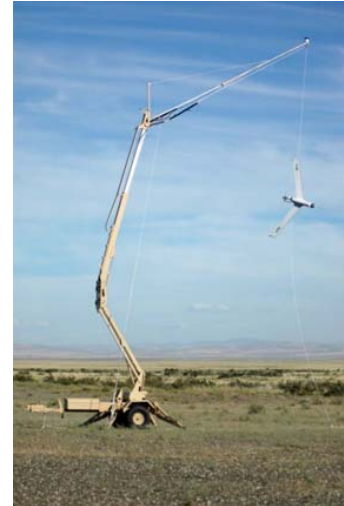
Figure 12.
Skyhook Recovery System

The Skyhook apparatus, shown in figure 12, can be deployed easily for land based recoveries and keeps the aircraft clear of hazards. If the aircraft misses, it goes around on a clear path.

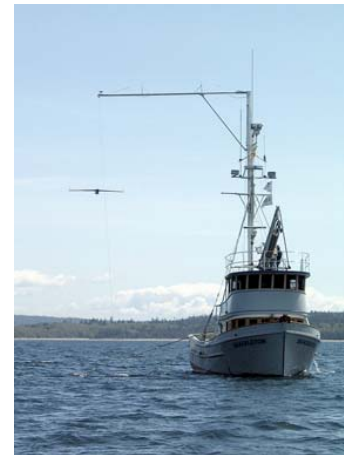
Figure 13.
SkyHook Installed Aboard Ship

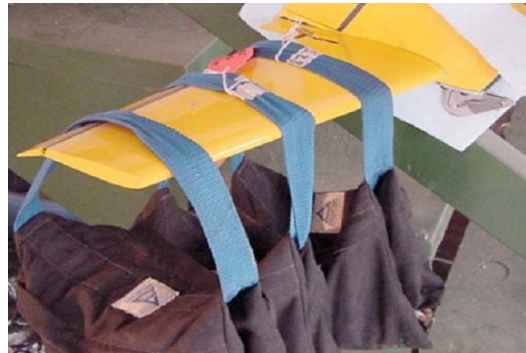
Figure 2. 20kg Static Winglet Load Test

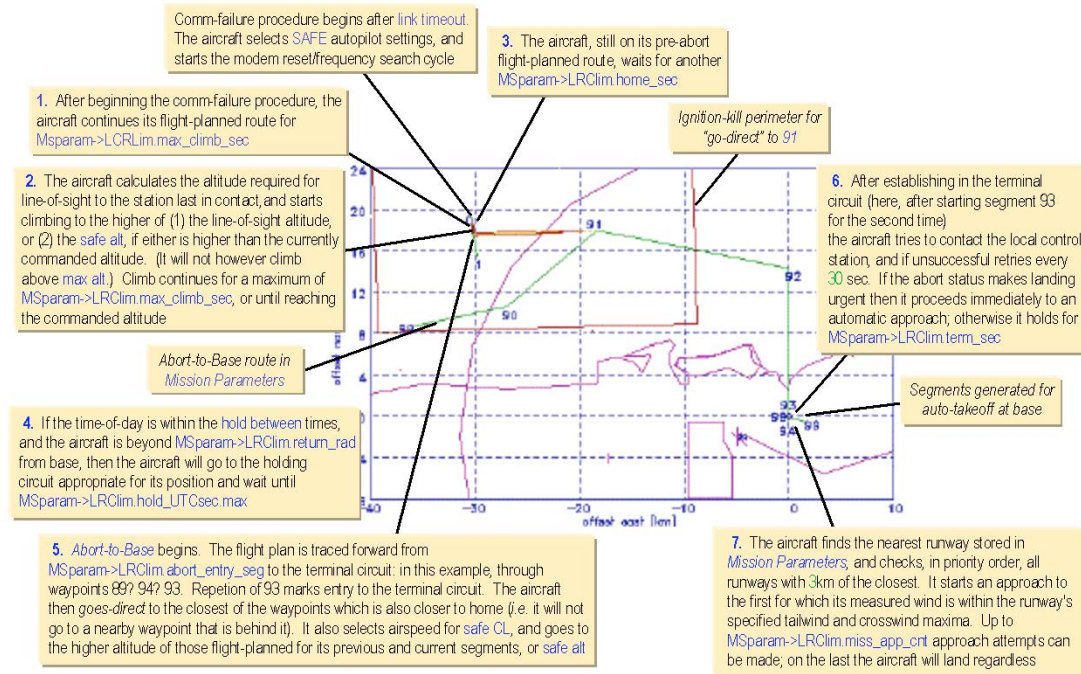
Figure 1. Lost-Communication Sequence

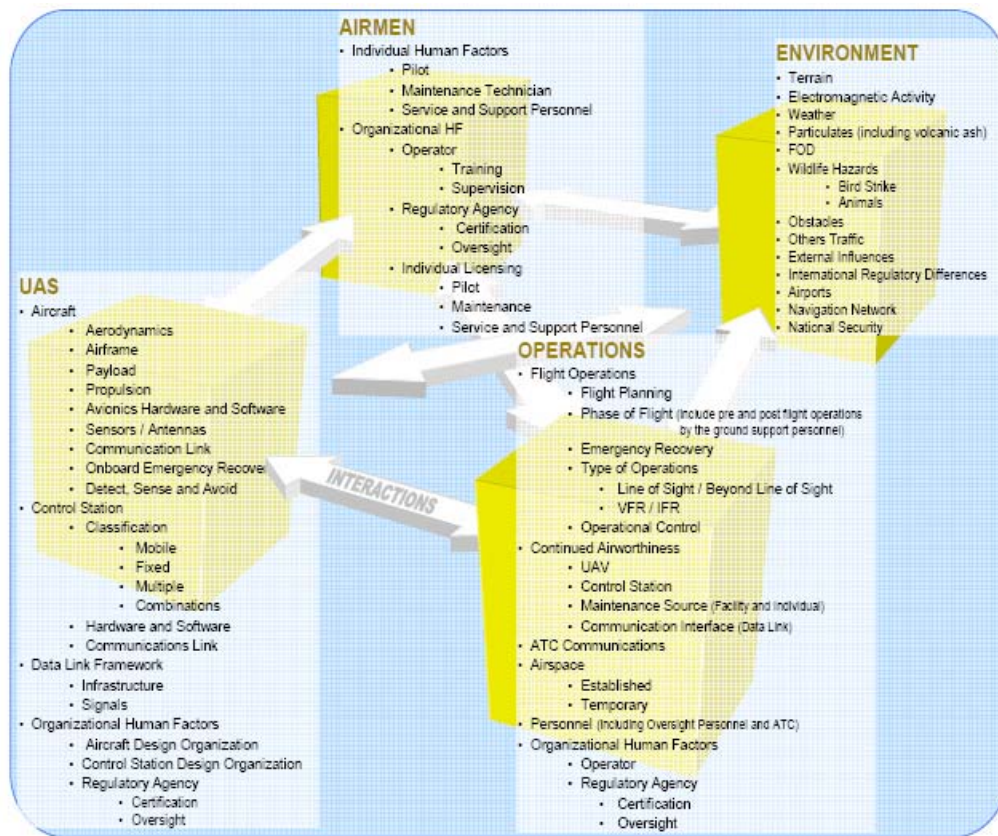
Figure 1. UAS Hazard Classification and Analysis System

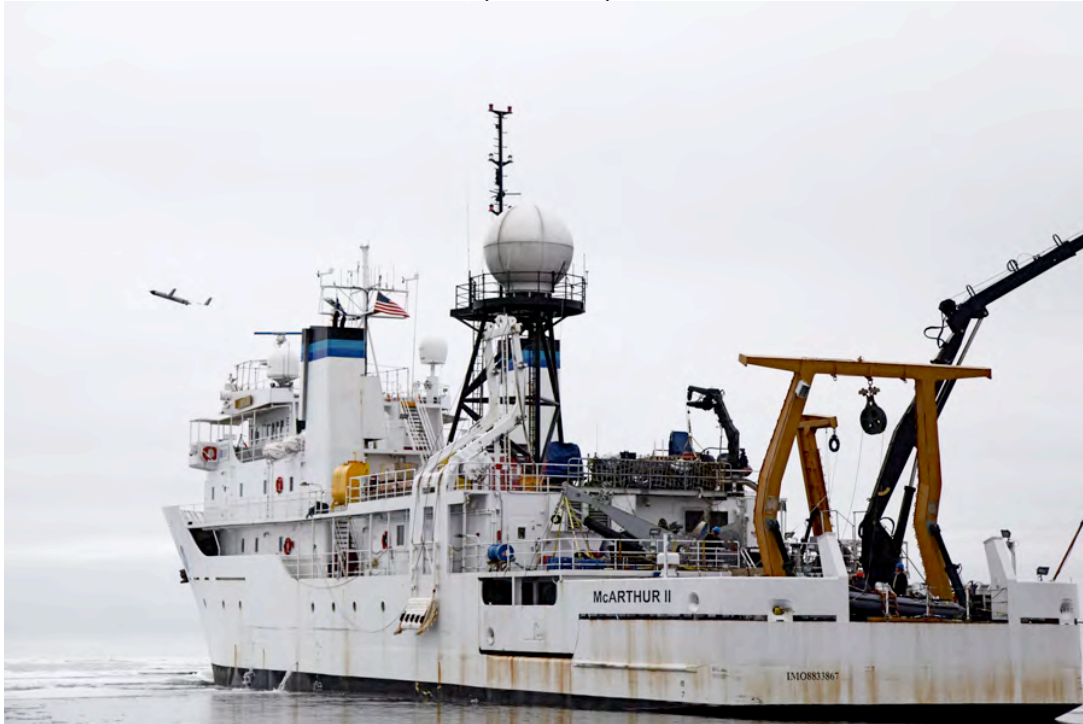
May 28, 2009 ScanEagle Launch in Bering Sea

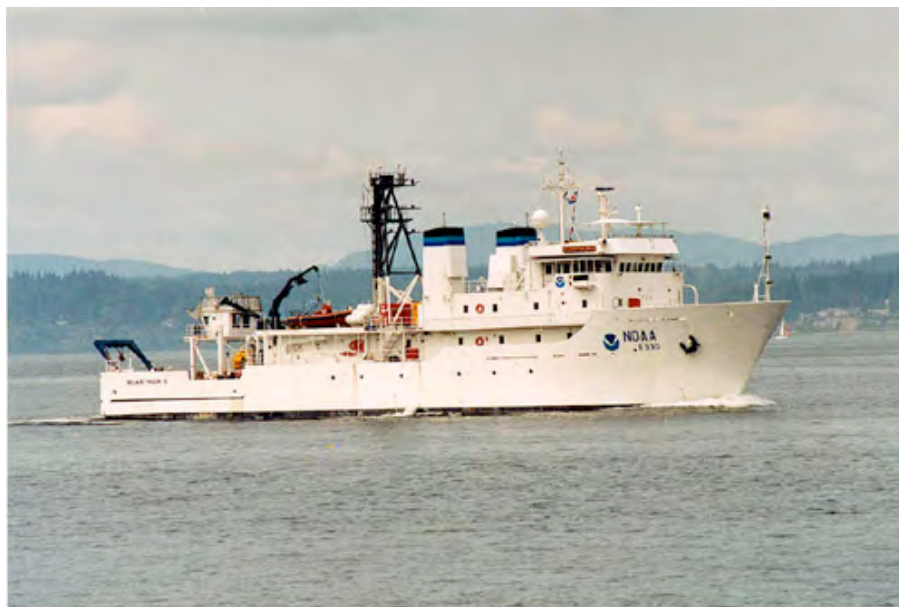
Figure 1 - The McArthur II Underway.

The *McArthur II* (figure 1 and table 1) was acquired from the U.S. Navy in 2002 and was converted by NOAA from a T-AGOS surveillance vessel to a multiple-disciplinary platform capable of a broad range of missions. As was its predecessor, the *McArthur*, the *McArthur II* is named after William Pope McArthur. The vessel is operated by NOAA's Office of Marine and Aviation Operations. (NMAO), and is home ported at NOAA's Marine Operations Center, Pacific (MOP), in Seattle, Washington.

Length: 224 ft.
Breadth: 43 ft.
Draft: 15 ft.
Displacement: 2301 tons
Cruising Speed: 10.5 knots
Range: 8000 nm
Endurance: 30 days
Commissioned Officers: 4
Licensed Engineers: 3
Crew: 17
Scientists: 14/15 (max, 14 when we go International due to addition of PHS Officer)
Hull Number: R-330

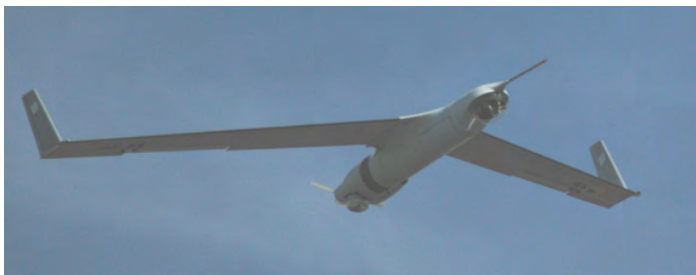
Figure 2 - Insight UAS carrying an electro-optical (visible light) analog (video) camera.

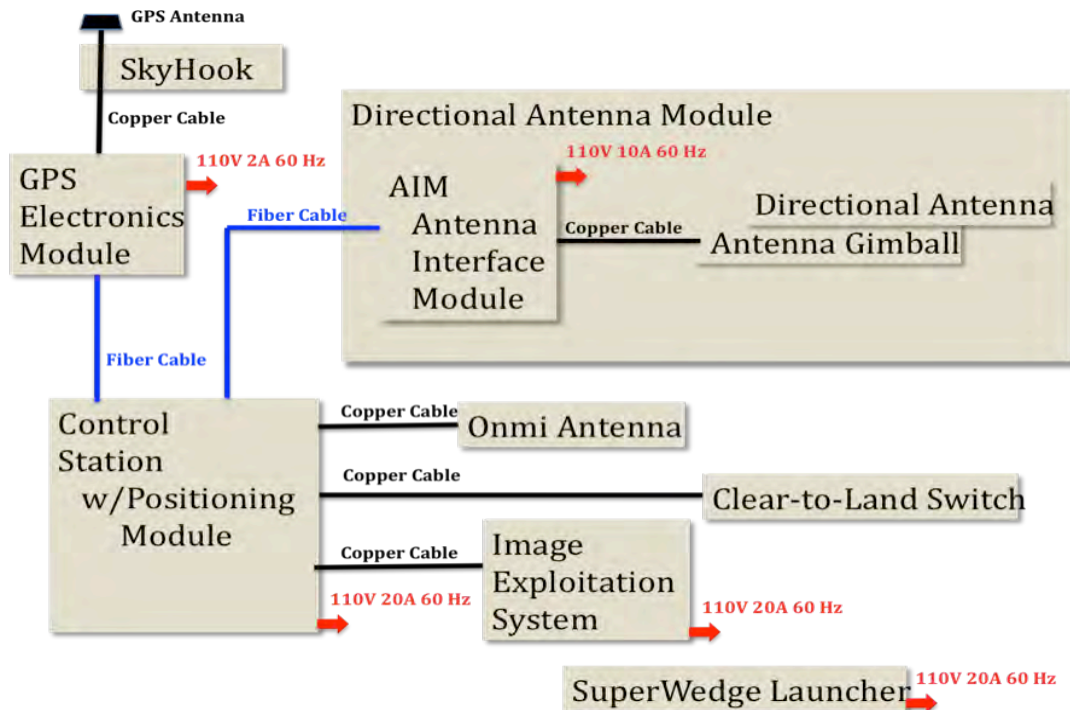
Figure 3 – Insight Block Interconnection Diagram.

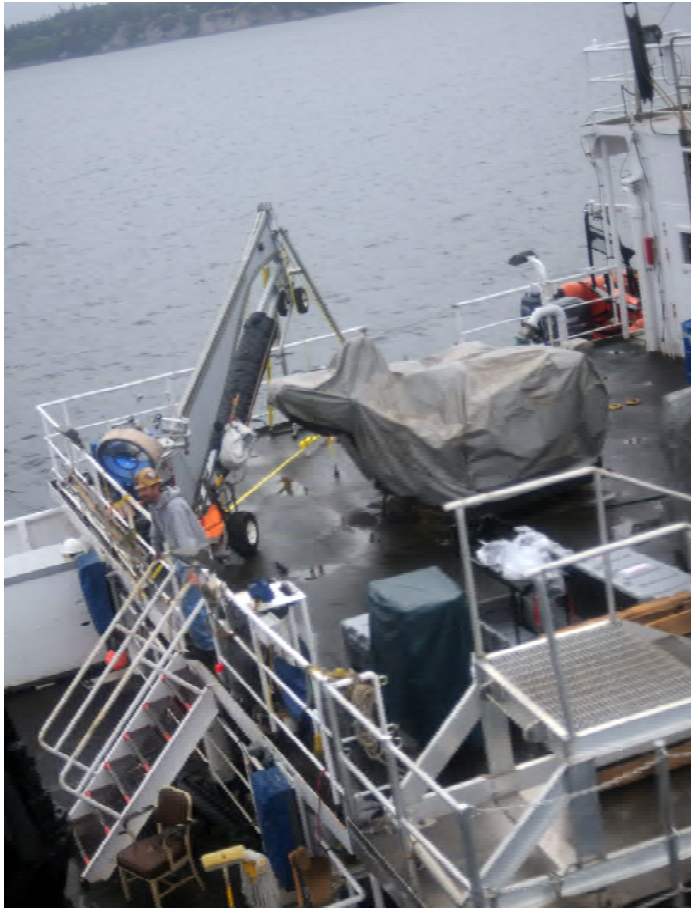
Figure 6 – SuperWedge deployed onboard the NOAA Ship Oscar Dyson.

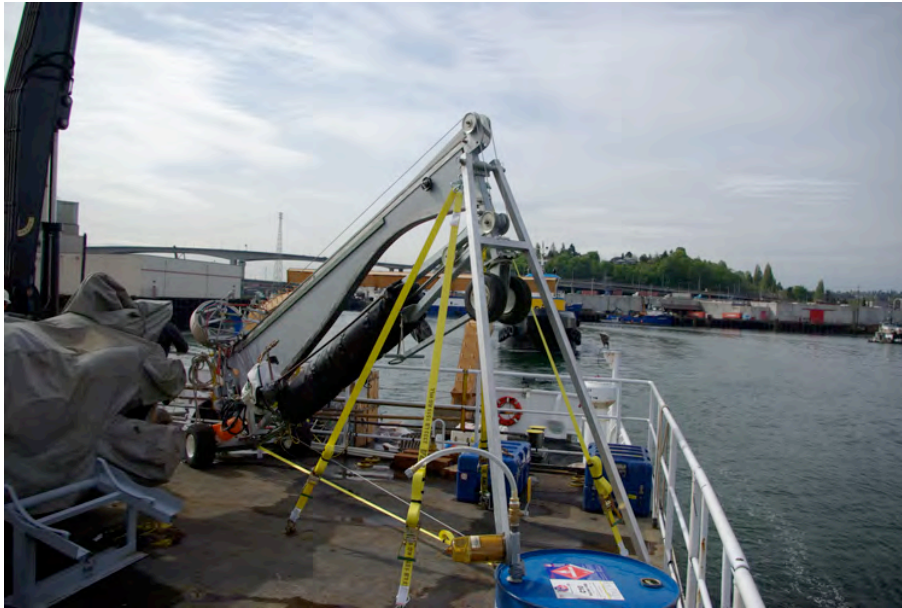
Figure 7 – Launcher Installed and Secured On The Winch Deck.

Aboard the McArthur II The SuperWedge launcher will be deployed on the port side of the winch deck. The launcher will be aimed forward and quartering from this port side location. For launches the port side fast boat will be lowered to the winch deck level to ensure that there are no obstructions during launch. Launches cannot occur if there is a tail wind. This requires the ship to navigate to accommodate this wind envelope. Figure 8 shows the NAVAIR approved launch wind speed / angle envelope for initial ship integration experimentation. The launcher is secured with multiple tie-downs. Existing tie points on the winch deck are suitable for this purpose. The ship's crane can load the launcher, after it is erected on the dock into this location. Once installed the launcher will remain in this location until the deployment is complete.

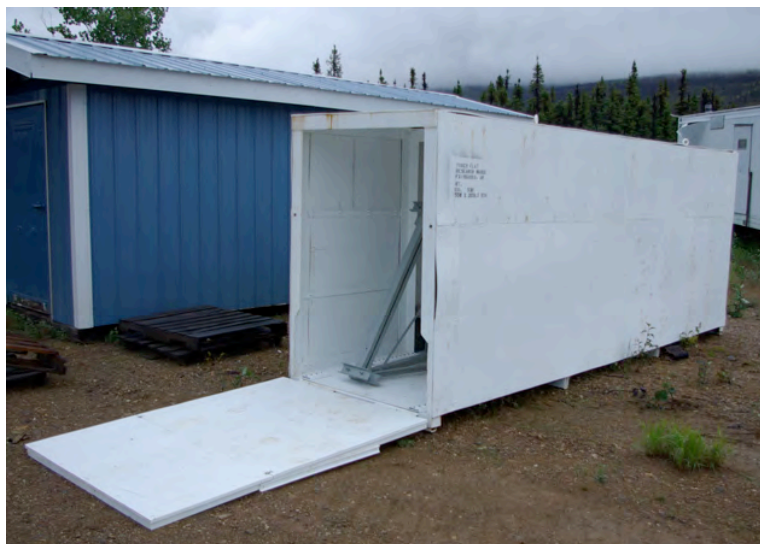
Figure 9 – Launcher’s Shipping Enclosure

The footprint and weight for the SuperWedge launcher is show in Table 2. The launcher is mounted on wheels. The additional adjacent footprint required for aircraft checkout is a minimum of 10 x 10 feet and is accommodated on the center aft section of the winch deck near the launcher. This location provides for tie down points for the aircraft container in case of rough seas or high wind. Figure 9 shows the shipping crate for the launcher and will be left dockside or forwarded to the debarking destination during deployment.

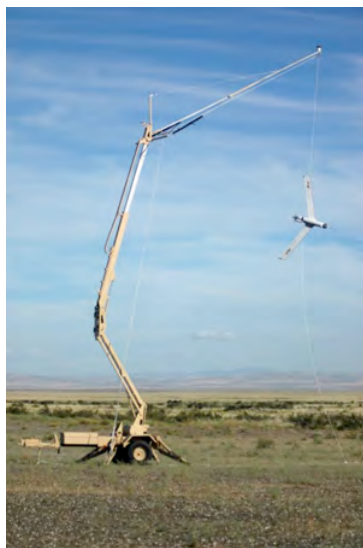
Just Captured Insight UAS

The standard SkyHook recovery system consists of a cable-trussed pole located at its bottom 36 feet in the air that extends 25 feet horizontally off the lifting mechanism. From the end of this pole a ¼" rope hangs through a series of pulleys. On the tip atop this recovery boom is a GPS antenna. For recovery the aircraft automatically flies into this vertical rope where it is captured with a custom hook mounted on the aircraft's wing tip. With this design, there have been roughly 10,000 successful recoveries, with over 1,500 aboard ships as of January 2009. In a standard arrangement a 36-foot Genie man-lift is used to elevate the SkyHook recovery boom. Figure 10 shows this standard configuration with a "just captured" aircraft. The custom solution deployed aboard the McArthur II supports the upper pulley of the recovery rope from the hook on the ship's crane. Figure 11 shows this rigging option. On land the bottom of the rope is attached to the ground. On a ship the rope is anchored to a lower boom, as seen in figure 11. In the Genie lift arrangement there is 17 to 20 pounds of tension in the rope to provide enough tension to force the aircraft to rotate (yaw) and hook when it hits. In the customized installation where the ship's crane is rigid, unlike the Genie lift option, this tension is reduced to 12 pounds to provide a softer recovery yet still forcing the aircraft to yaw for capture. Rubber bungee cords are installed on both ends of the rope and adjusted to maintain this tension.

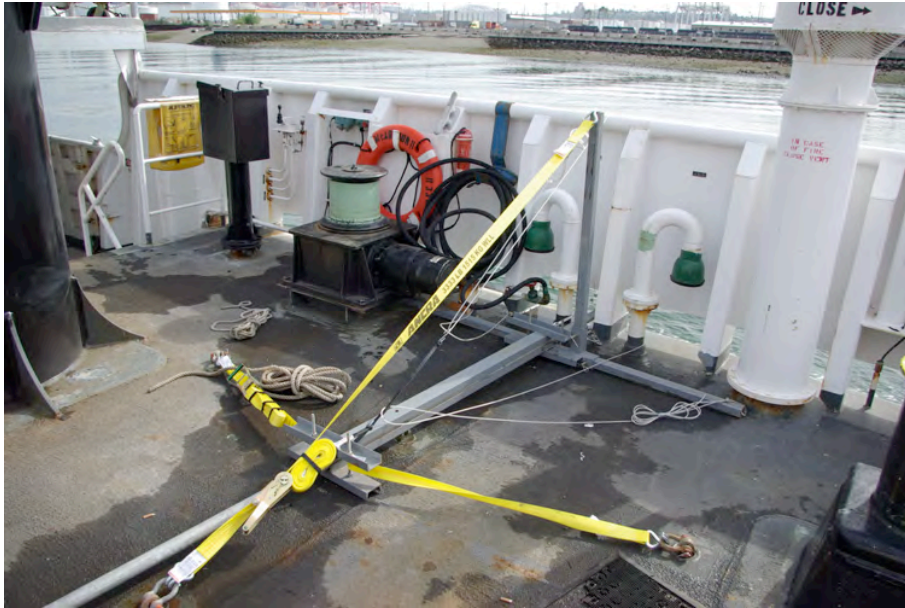
Figure 13 – Lower Boom Assembly

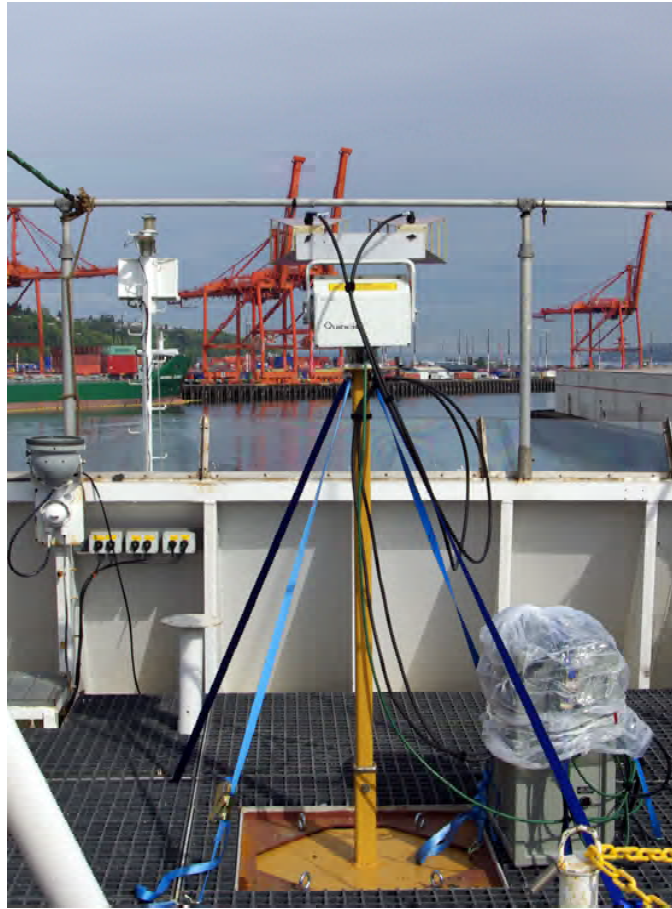
Figure 16 – Directional Tracking System

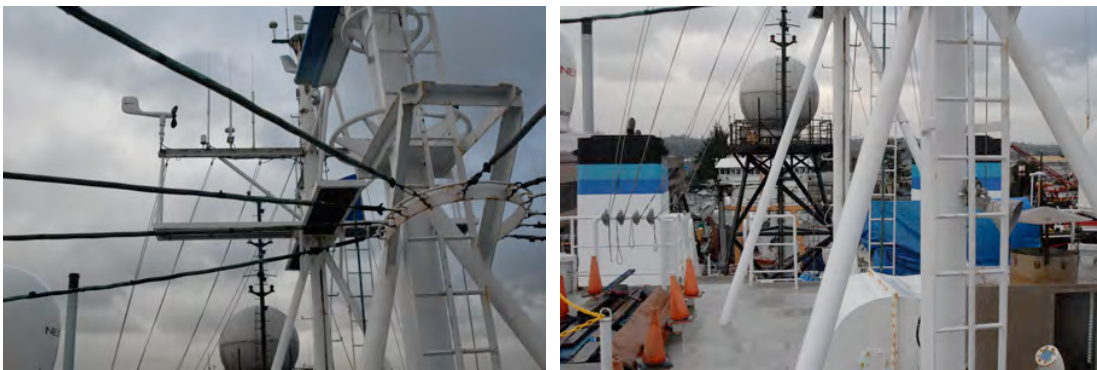
Figure 17 – The Directional Antenna's Field of View

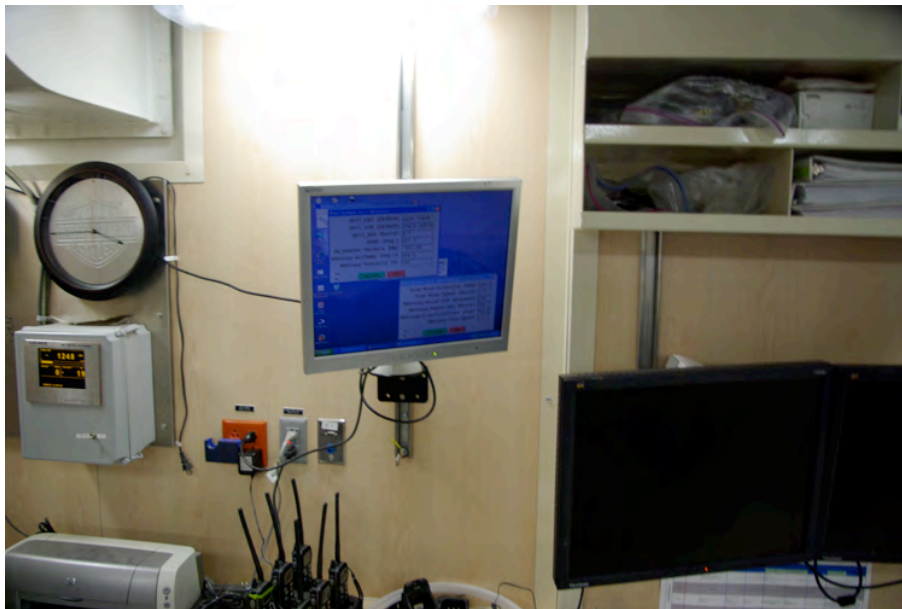
Figure 18 – The meteorological display provided aboard the McArthur II

- True wind speed (knots)
- True wind direction (degrees)
- Relative wind speed (knots)
- Relative wind direction (degrees)

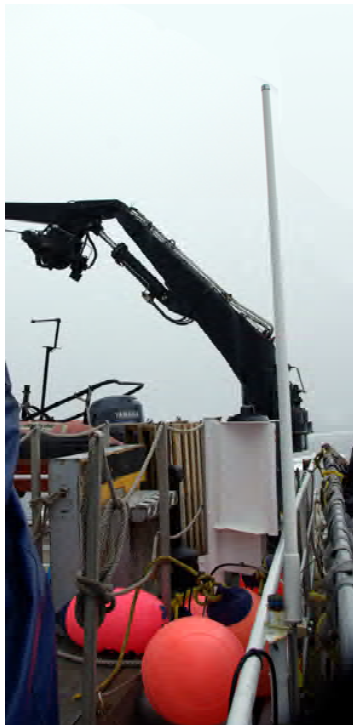
Figure 19 – Omni Directional Antenna Mounted on Ship's Railing.

- Omni directional whip antenna
- Antenna mounting hardware
- Coaxial RF cable (between the Control Station and the whip antenna)

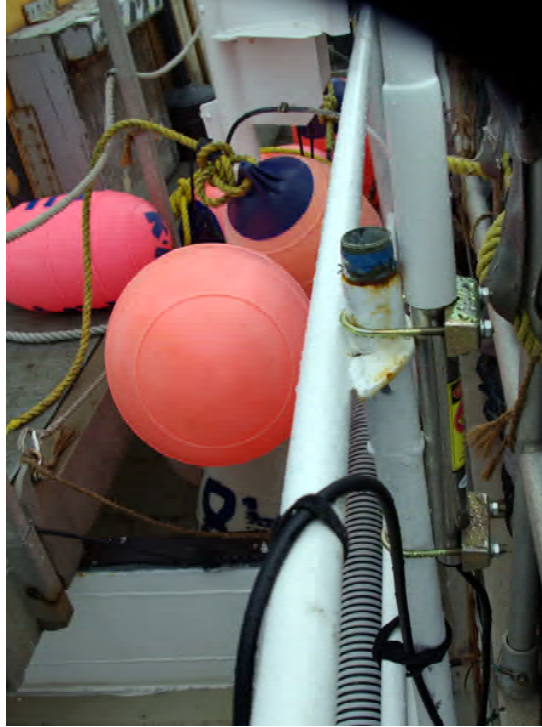
Figure 20 – Brackets for Mounting the Omni Directional Antenna

The omni directional antenna is approximately 72" long, weighs 4 lbs and is mounted with two U-bolts to a vertical structure onboard the ship, figure 20. From the omni directional antenna, a co-axial cable will run not more than 75 feet to the control station in the dry lab.

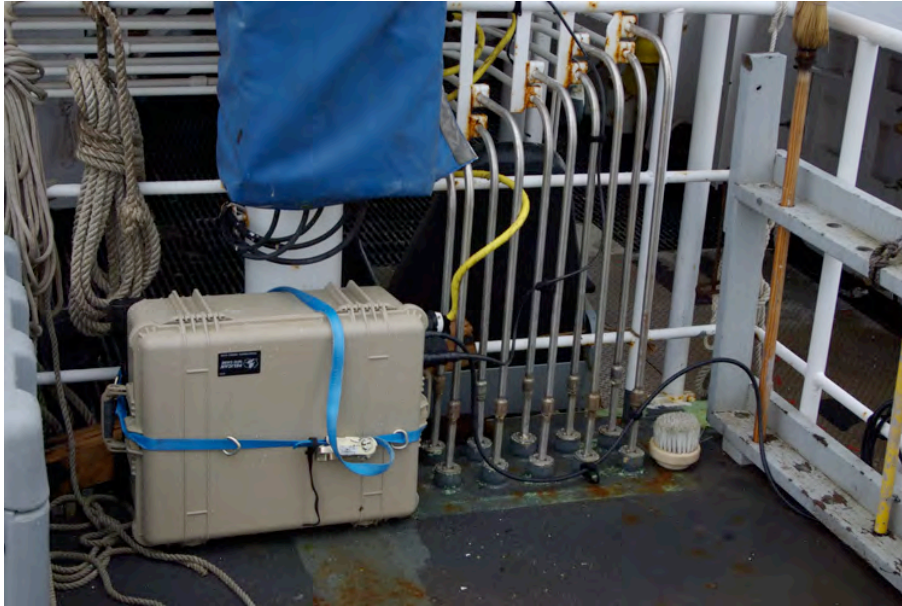
Figure 21 – The GEM Module.

The GPS electronics module provides a real-time kinematic data necessary for automated recovery. The module consists of a UPS, a GPS receiver, and a GPS antenna that is mounted near the top of the SkyHook. Figure 21 shows the GEM mounted on the deck of the McArthur II in a weatherproof Pelican case. The GPS antenna, shown in figure 22 is mounted on a weighted plate that swings above the recovery ball.

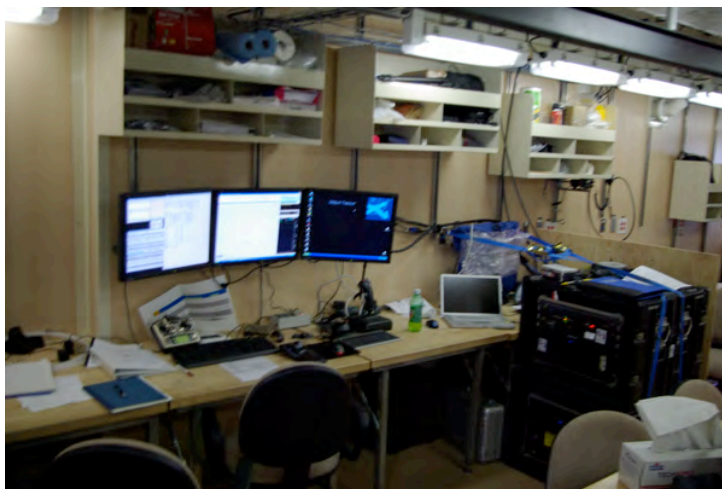
Figure 23 – Control Station and Operator Console.

The Control Station (CS) provides for control and monitoring of the aircraft as well as control of the payload and observation of the video downlink. Connections are made from the CS to the image exploitation system for exploitation of the video imagery. The CS equipment consists of two 7U rack-mount transit cases containing a UPS, control computers, video equipment and associated electronics and wiring. Figure 23 shows the control station, including the operator console installed in the dry lab aboard the McArthur II.

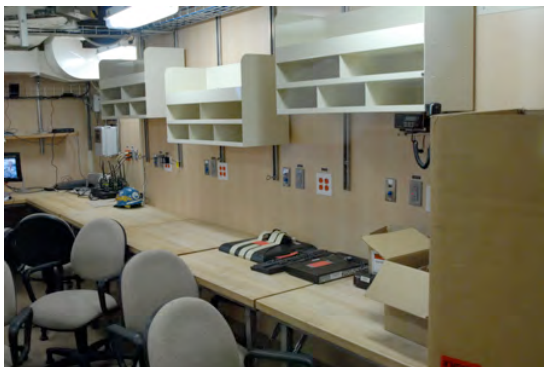
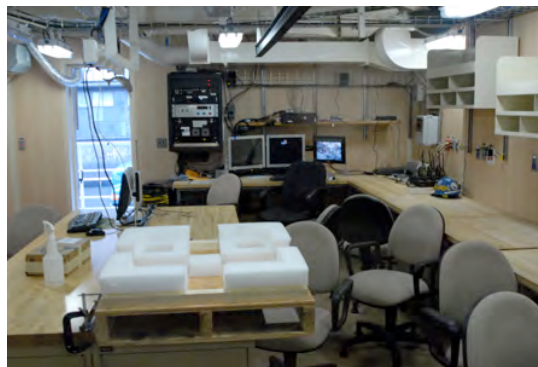
Figure 24 – Dry Lab Location For Control Station and Maintenance.

On the McArthur II the Control Station (CS) is located within dry lab. Figure 24 shows the dry lab space that the CS will be installed. There is adequate room within the dry lab to also perform aircraft maintenance as required.

Desk space for the control station

Space suitable for maintenance

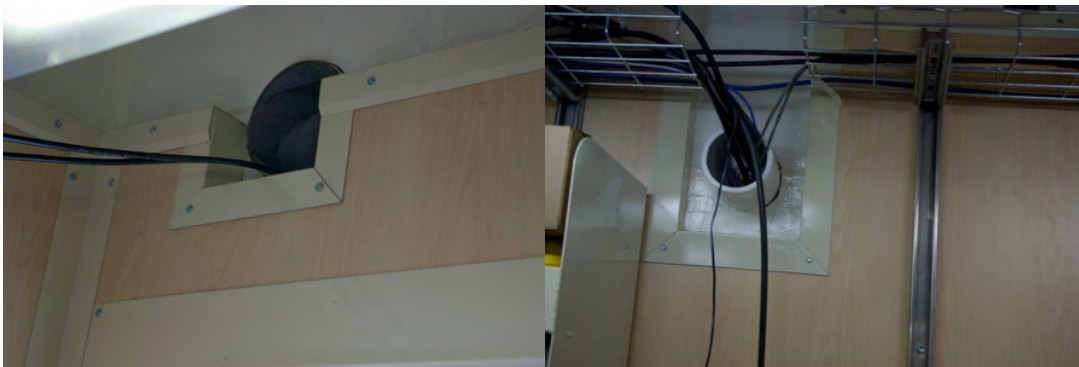
This cabling will exit the laboratory space where the CS is housed through an access portal on the port side of the ship, figure 25.

Figure 25 – Port and Aft Cabling Access Portals Inside Laboratory Space.

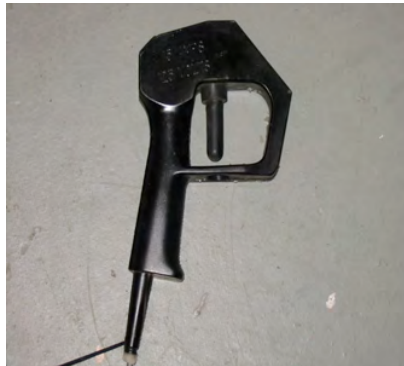
The Clear-To-Land switch is used during recovery operations. The recovery observer holds the switch in the activated position to indicate to the UAS that it is cleared to land. Releasing the switch at any time instructs the aircraft to wave-off from the approach. The Clear-To-Land switch connects to the control station via a 50 ft. cable. Figure 26 shows the switch.

Figure 26 – the Clear-To-Land Switch.

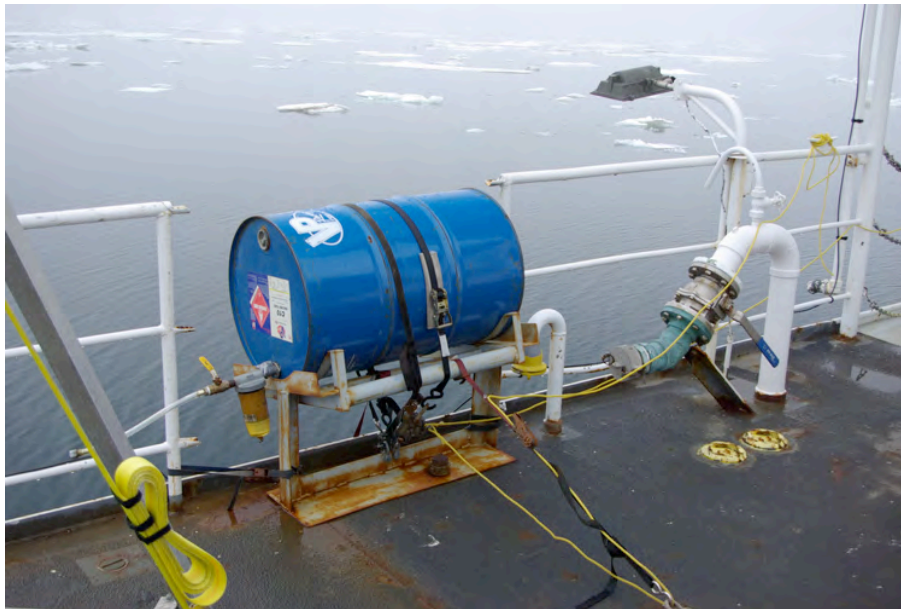
The University of Alaska will provide the aircraft fuel in a 55-gallon. For planning purposes for extended deployments five gallons could be used for every three days of flight operations planned. The Mogas will be at least 92 octane and ideally be a racing fuel C-10 because it is less susceptible to carburetor icing. The University will provide the fuel. A storage solution to jettison the fuel drum overboard in the event of a fire is shown in figure 27. This storage system is on the winch deck port side. Fuel will be transferred from the 55-gallon drum in a 5-gallon can and from that can dispensed into the aircraft through a 3-gallon bottle.

Figure 27 – 55-Gallon Fuel Storage Drum Rack on McArthur II.

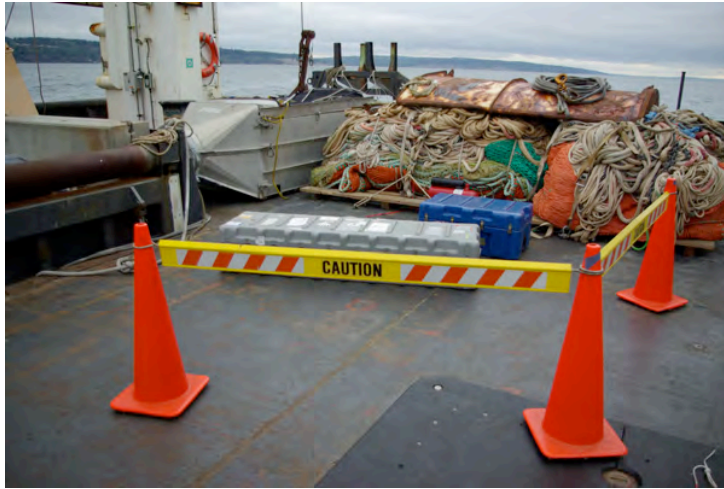
Figure 28 – Typical Cordoned Area For Fuel Operations.

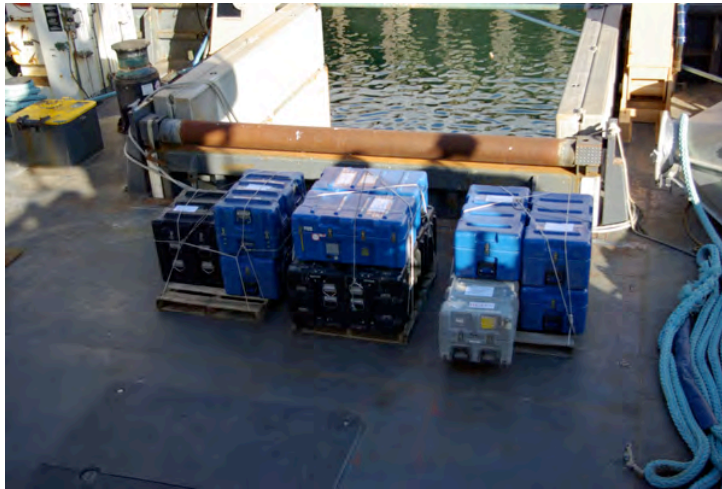
The aircraft will be stored in either the wet laboratory or outside on the winch deck. Each aircraft is contained and maintained in a storage container approximately 16 in tall by 20 in wide by 72 in long. Packing materials and spare parts will be stored in the foreword lower hold. Figure 29 shows the entire shipment for pickup including the control station with the exception of the launcher after a deployment aboard the NOAA Ship Oscar Dyson.

Figure 29 – Entire UAS Cargo (minus the launcher).

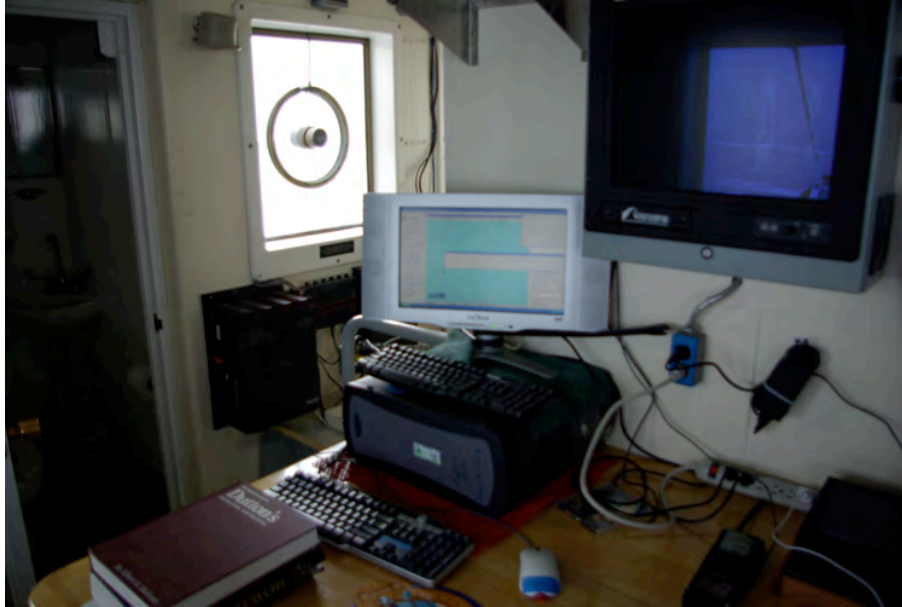
A network capable computer will be setup on the bridge and will run the network ground station software. This along with a video display of the imagery from the aircraft will be available for interested crew on the bridge to better understand where the UAS is during flight. Figure 30 shows this setup on the McArthur II.

Figure 30 – Network Ground Station Installed On Ships Bridge.
