**Ship-Based Unmanned Aircraft System (UAS) Surveys of
the Bering Sea Pack Ice from the NOAA Ship *McArthur II*
(NOAA Cruise: MC2-09-02)**

13 May – 11 June 2009

NOAA – U.S. Department of Commerce
National Marine Fisheries Service
Alaska Fisheries Science Center (AFSC)
National Marine Mammal Laboratory (NMML)

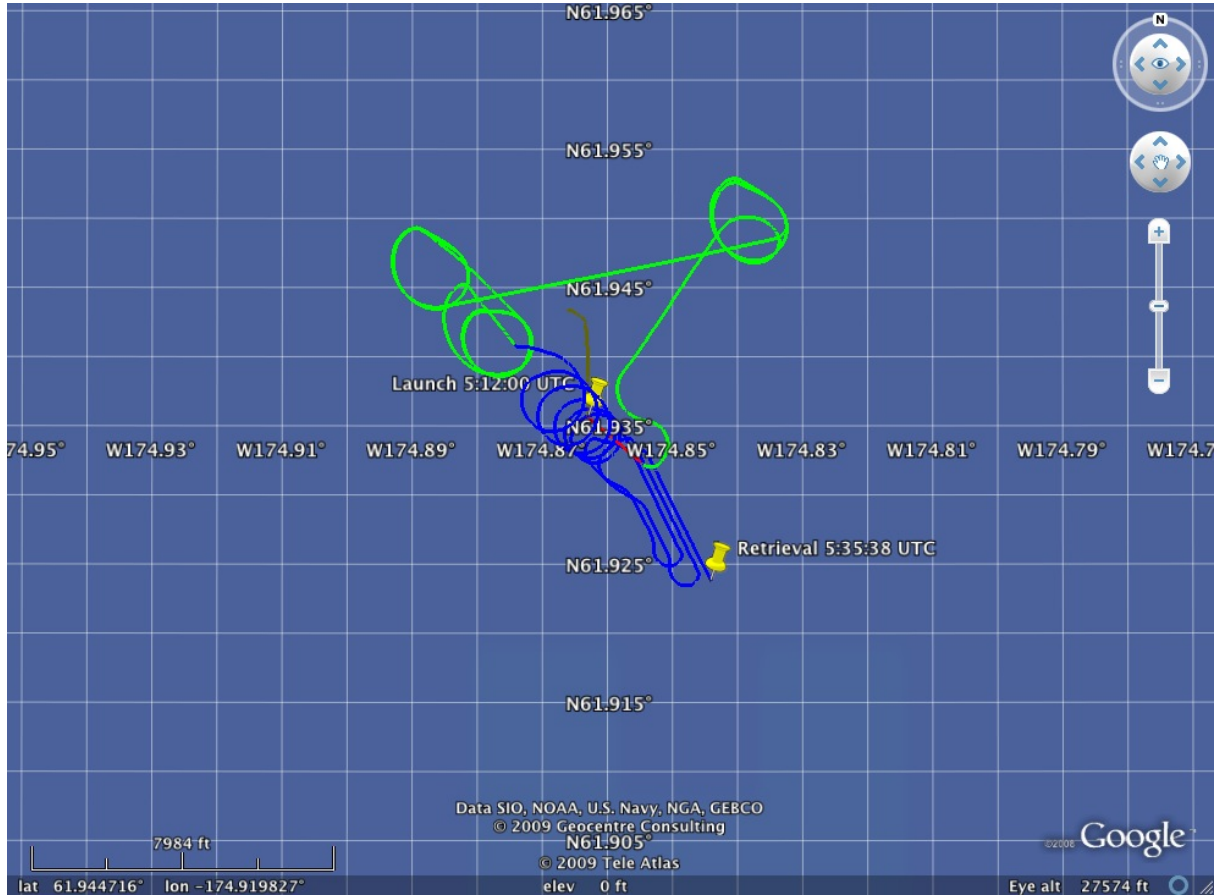
Map showing tracklines of both vessel and UAS for each flight

Approximately 30 seconds after launch the aircraft's payload was unlocked for a first look. There was visible moisture that appeared to be ice on the front of the EO dome. As a result the aircraft was flown to a higher altitude, 1,500 ft, well clear of the fog and a significantly warmer condition (5C) and recovery procedures were started. While at altitude the fuselage was inspected and appeared to be wet but free of ice and the ice on the dome diminished significantly. Upon descent for recovery, however the dome built a significant layer of ice. The aircraft returned for capture and due to ship roll and poor timing the first recovery was waved off by the outside observer. The aircraft performed an inside capture on the second attempt at 21:45 Alaska time. The ice that had accumulated on descent had liquefied prior to post flight inspection.

The fog deck was determined to be between approximately 500 feet and less than 1000 feet. We did accomplish a goal of the flight to calibrate our understanding of this Bering Sea fog and it's visibility, altitude, and hazard to flight.

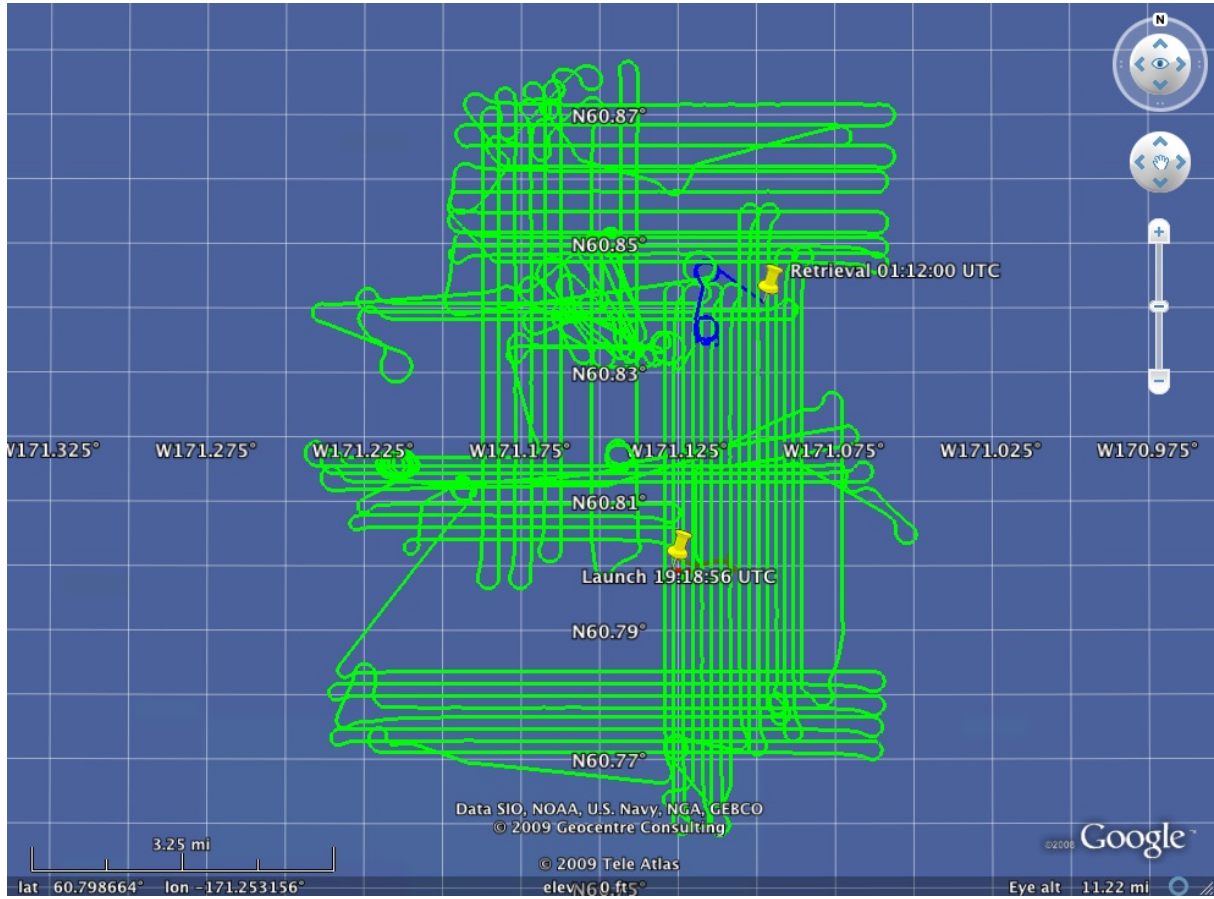
Map showing tracklines of both vessel and UAS for each flight

For a brief time after launch we flew the aircraft at 2,000 ft altitude but for the remaining time and for operational work the aircraft imaged the ice floes at altitudes between 350 and 500 ft.
