**NOAA *Okeanos Explorer* Program**

**MAPPING DATA REPORT**

**CRUISE EX0909 Leg 1**

Mapping Field Trials

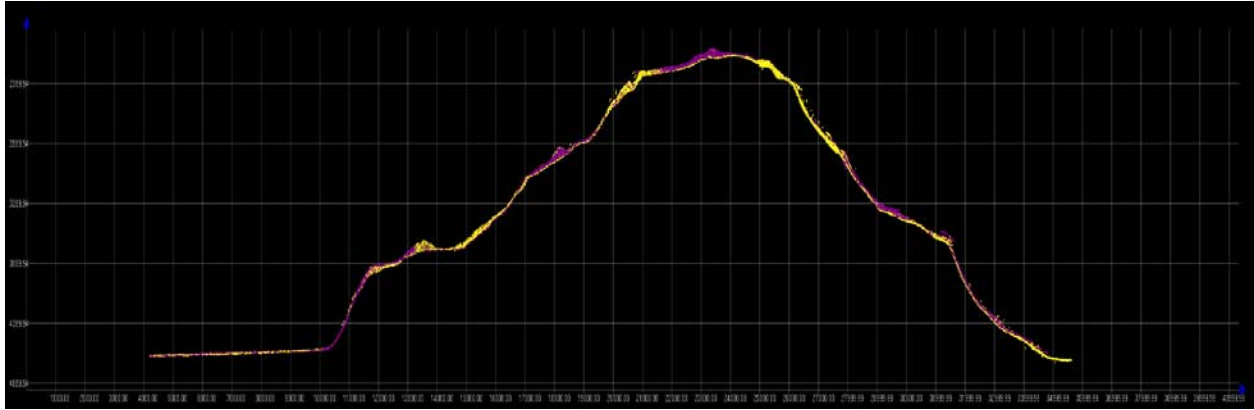
**Figure 2. Screen grab of subset editor in CARIS HIPS showing agreement of cross lines (yellow) with main scheme lines (Purple). Image credit: NOAA.**

The cross lines yielded a favorable comparison between main scheme lines and cross lines.
