## **NOAA *Okeanos Explorer* Program**

# **MAPPING DATA REPORT**

### **CRUISE EX1001**

2010 Ship Shakedown

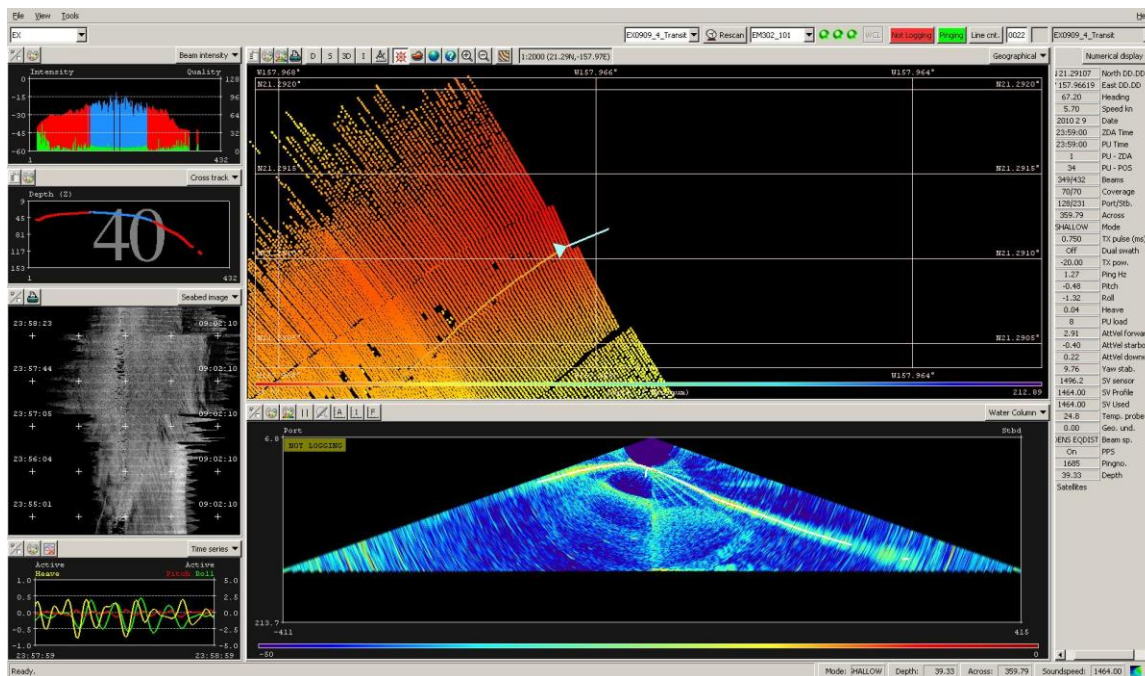
**Figure 5. EM302 multibeam data in 40 meters water, showing lack of sector overlap. Image generated in SIS. Image credit NOAA.**

During the initial hour or so when we turned on the multibeam, we were in very shallow water (~40 meters), and the EM302 sectors showed two previously unseen artifacts. The sectors did not overlap, and the pings did not line up between sectors (see screengrab below). These artifacts did not continue in deeper water.

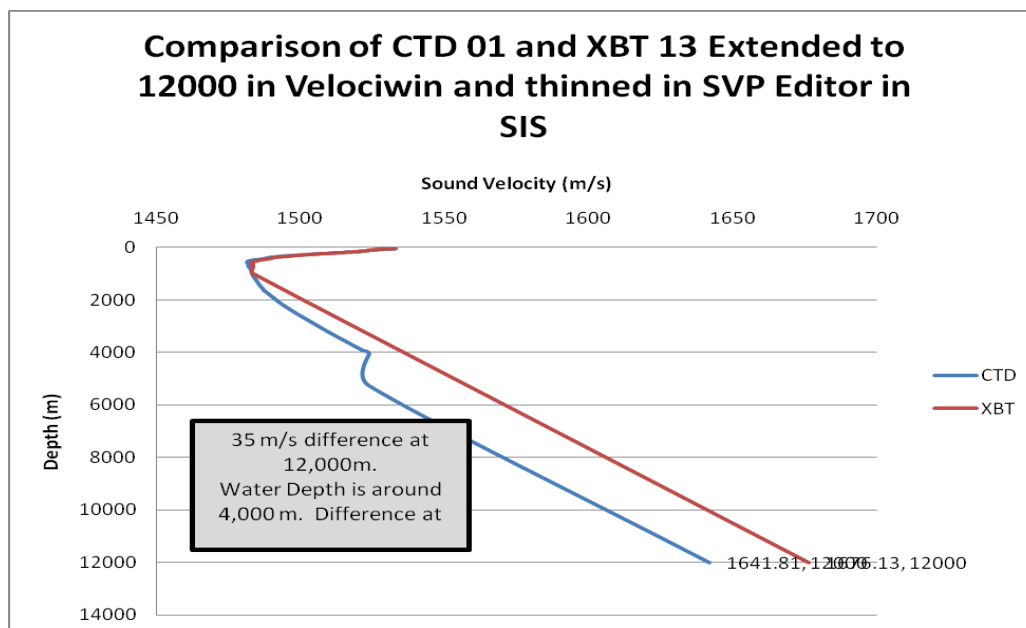
**Figure 8. Comparison of CTD and XBT extended in Velociwin and thinned in SVP Editor in SIS.**

A problem with our XBT processing was detected during the comparison process. A sound velocity error was detected in a deep water patch test line that had the CTD applied for the first half of it, then an XBT for the second half. It was determined that the sound velocity error was due to the method by which we were extending sound velocity profiles to 12,000 meters, as required by SIS. Typically we extend profile data using Velociwin. It was found that this was introducing sound speed errors of up to 35 m/s. We changed procedure to extend profiles in SIS rather than Velociwin. See Appendix I for complete analysis report by SST Colleen Peters. The Velociwin coders have been contacted regarding this problem and a solution is expected.

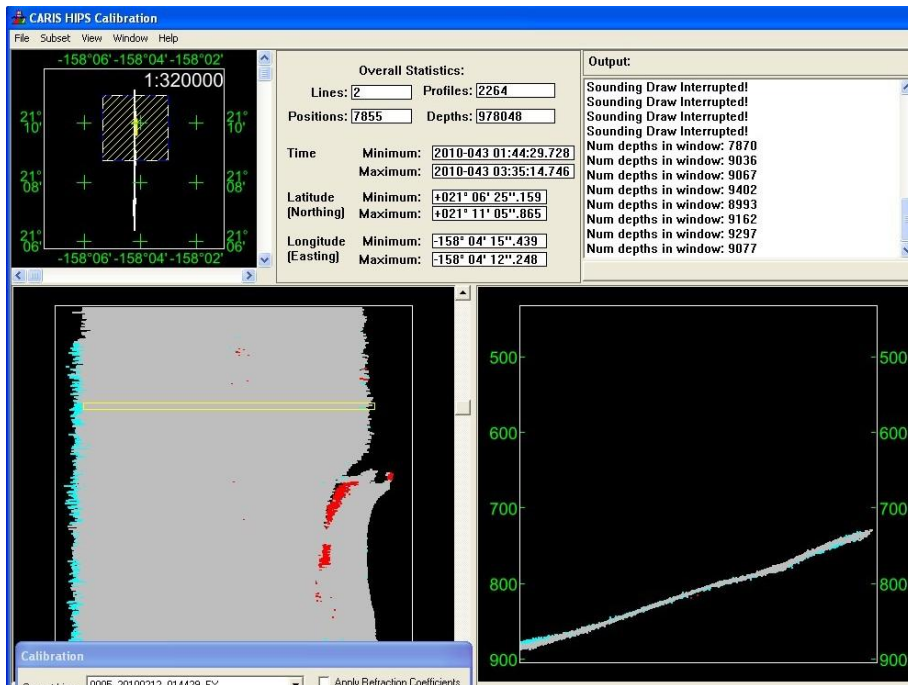
Figure 13. Roll calibration of lines 0005 and 0006 shown in CARIS HIPS and SIPS 6.1. Zero roll offset.

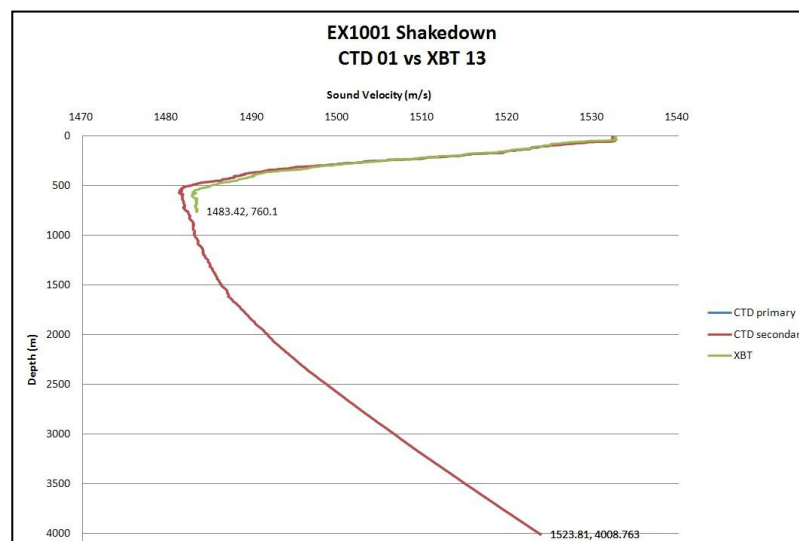
This is the typical comparison of Sound Velocity from the XBT and both sets of T&C sensors on the CTD.

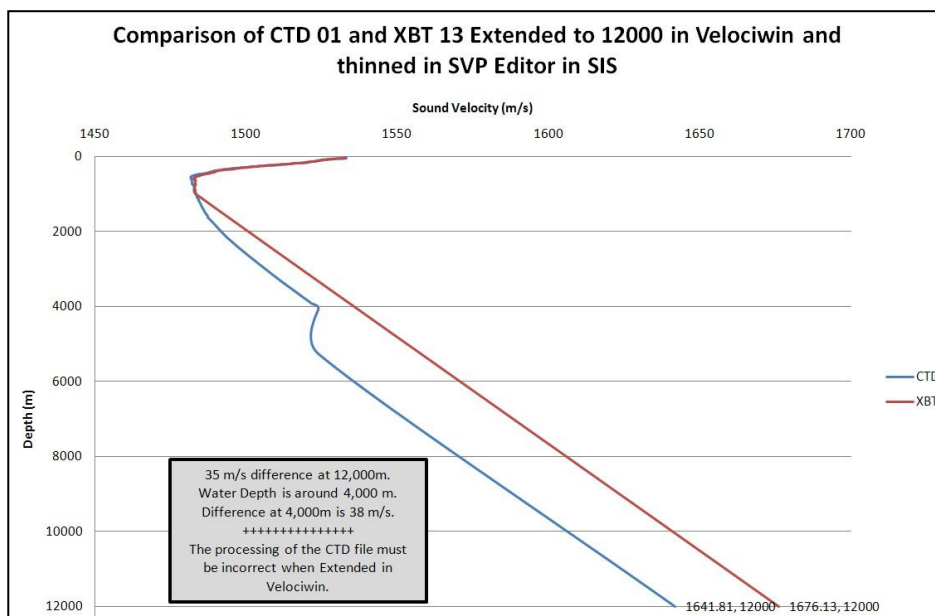
Velociwin takes the last point in the cast, 760 m for the Deep Blue XBT (and 4,000 m for this particular CTD) and extends the file. There is a discrepancy in the processing method for the CTD. A new CTD was used, and Velociwin may require additional tweaking of the .con file to reflect the new instrument configuration.

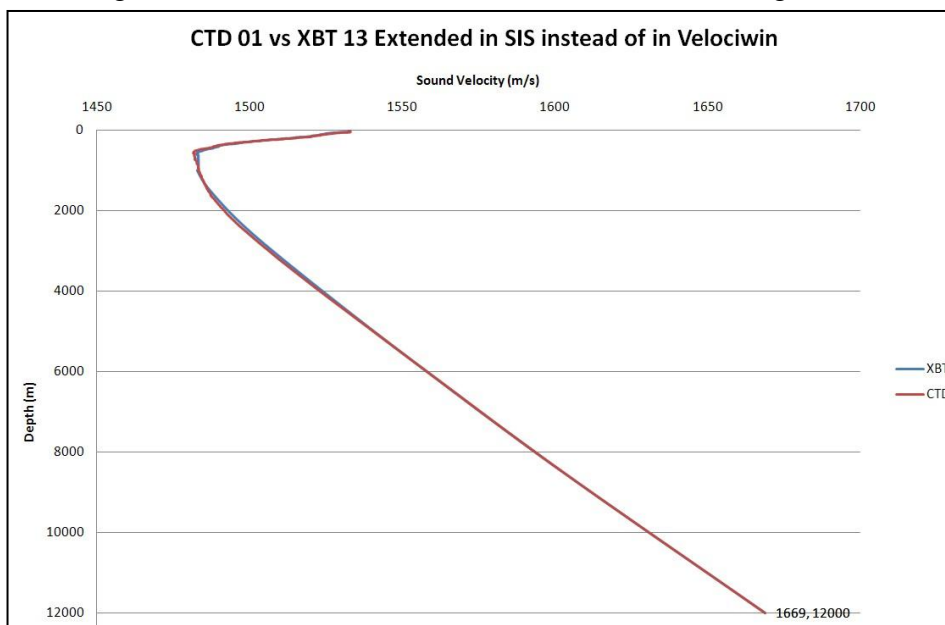
When the file is processed in Velociwin for the formatting and *not* extended, the file can be extended in SIS and thinned as normal.

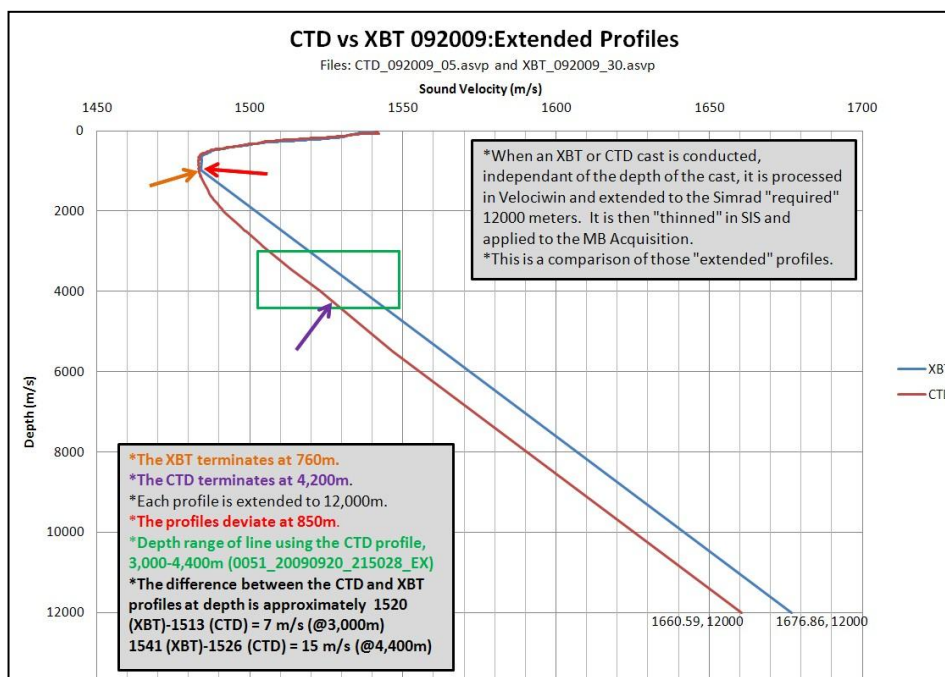
This comparison shows that there is a discrepancy between the extending procedures in Velociwin.

Regardless of any issues with 2010 instrument configuration, the same problem is observed from a cast conducted in the 2009 field season. Velociwin extends the file at the last depth, and in the case of the XBT does not follow a predicted/historical curve as observed in the data from the CTD cast.

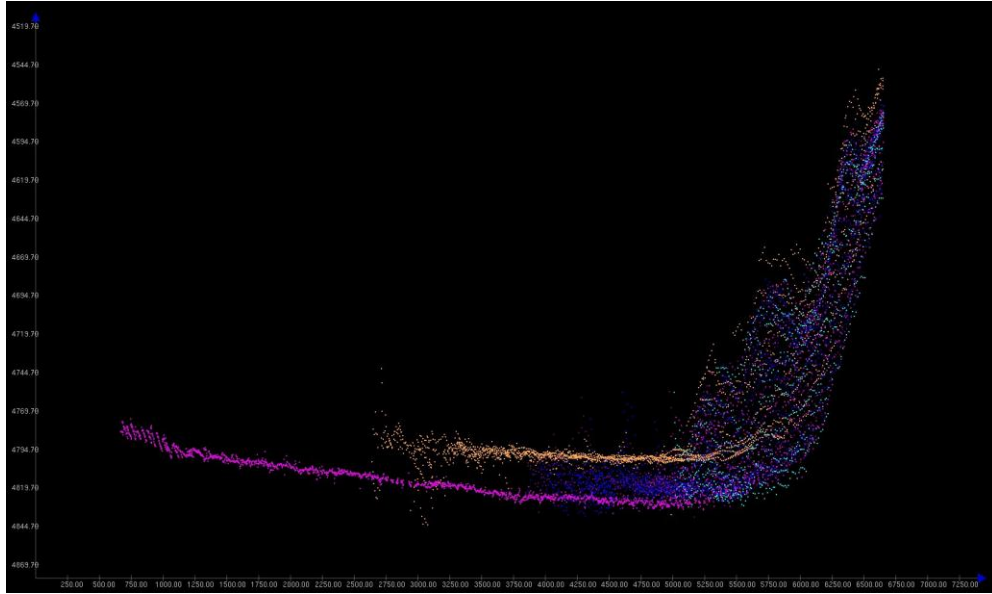
Cross-section of deep water patch test line with CTD .asvp file extended in Velociwin applied. Sound velocity processing error seen.

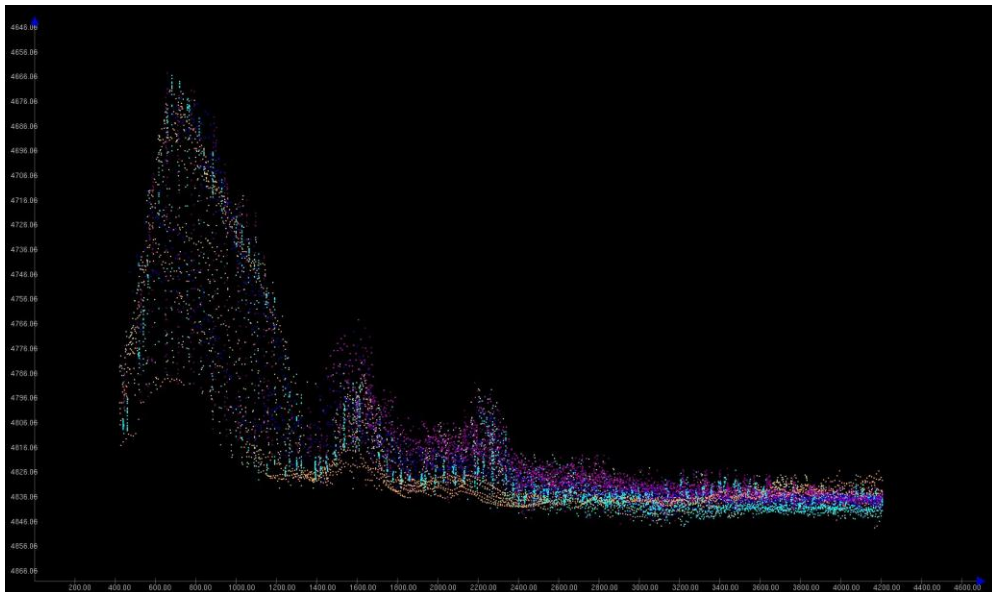
Cross section of deep water patch test line with XBT .asvp file extended in Velociwin applied. No sound velocity processing error present.

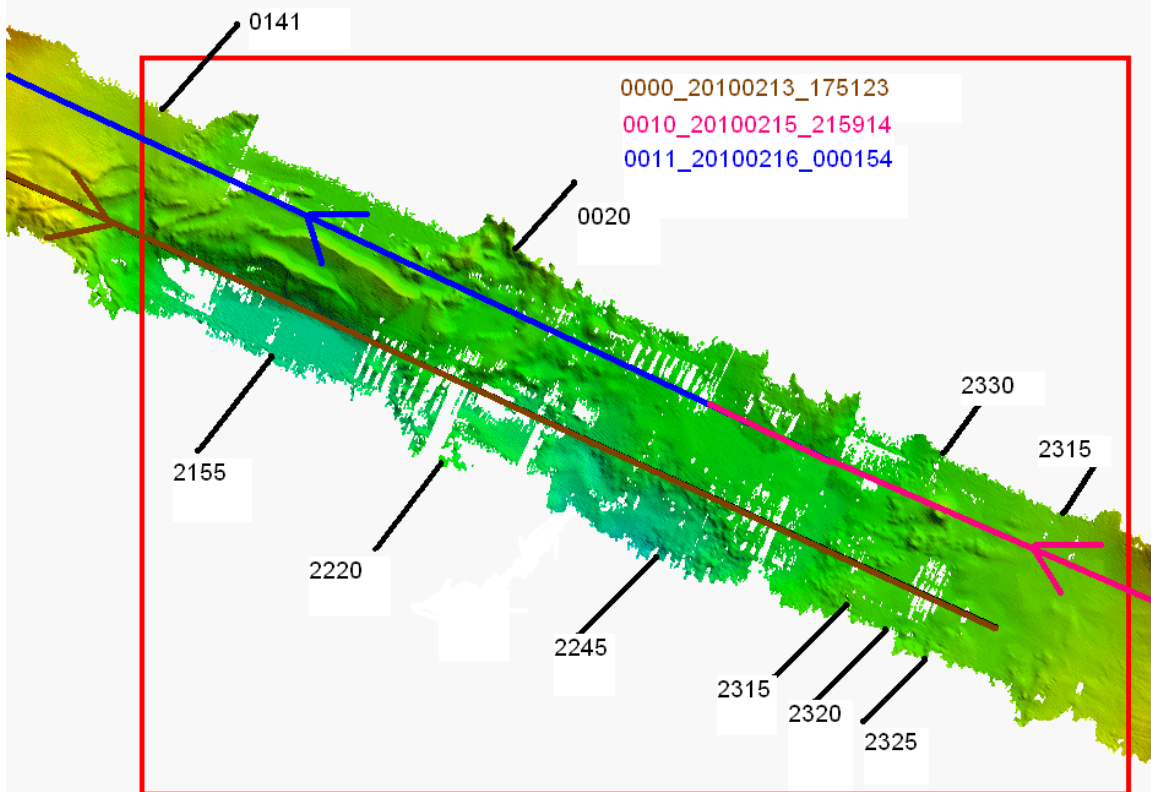
Figure 24. Details of deep water round trip transit data (AREA 1). EM302 multibeam filenames in color associated with color of trackline. 50 m cell size. Event markers (time in GMT) correspond to entries in logbook. Image generated in CARIS. Image credit NOAA.

- 2155 – started to lose bottom. Depth was at 3100 m. Changed SIS max depth from 3000 m to 4000 m. Problem fixed.
- 2220 – Sonar started to lose bottom again ~not because depth gate.... Tried turning Dual swath to off and once sonar found bottom again, still missing data.
- 21245 – tried turning Dual Swath back on to test if sonar can keep bottom in 3000 m of water in AUTO/VERY DEEP mode. Sonar able to track bottom now but has consistent drop outs throughout swath – at nadir and outer beams. Problem seems to deteriorate. Took dual swath back in off to test.
- 2315 – slowed to 9 kts – sonar losing bottom at nadir. Data looks good now
- 2320 – dual swath dynamic on to test quality at 9 kts
- 2325 – slowed to 8 kts to test dual swath (dynamic) at 8 kts. Data looks good now at 8kts in Dual swath in 4-6 ft seas

From testing during eastward transit, it was determined that in depths deeper than ~2700 m, the data quality degraded at 10 kts in dual swath dynamic mode. Bringing the speed down to 8 to 9 knots slightly improved data quality. (~2325 hrs)

After dual swath was disabled, data quality remained degraded in deeper water. (~2245 hrs)
