**FINAL
PRIMARY RESTORATION PLAN AND
ENVIRONMENTAL ASSESSMENT
FOR THE 2006 T/V MARGARA GROUNDING
GUAYANILLA, PUERTO RICO**

The Puerto Rico Department of Natural and Environmental Resources
and
the National Oceanic and Atmospheric Administration

April 2015

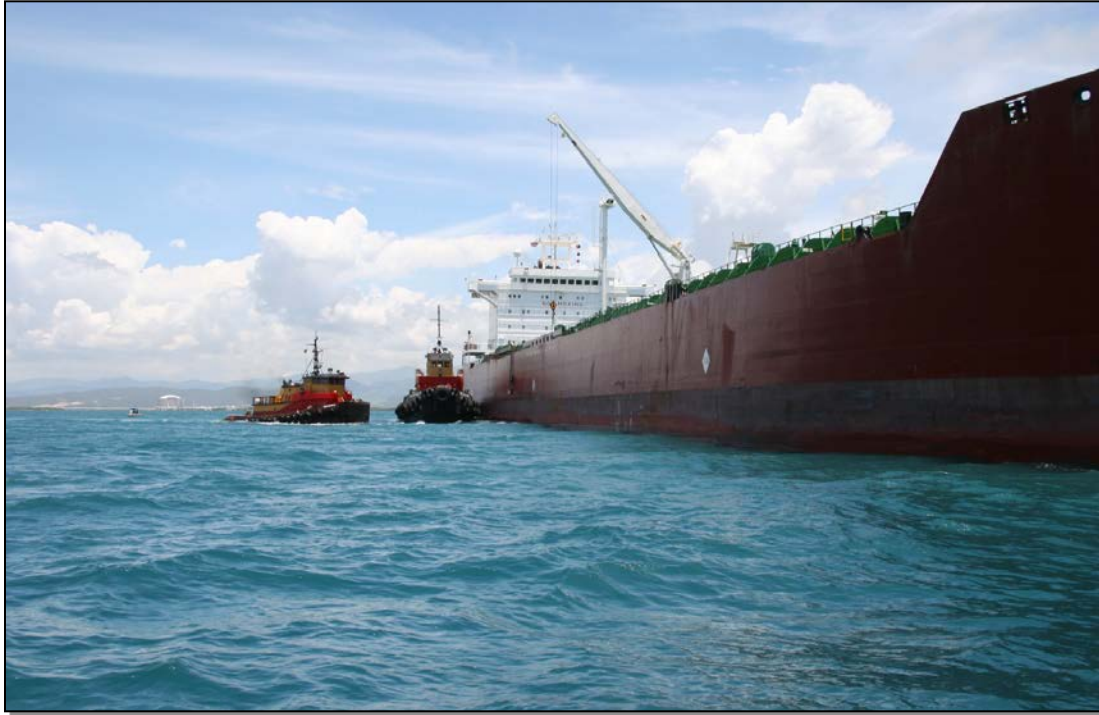
T/V MARGARA aground with tugs alongside on April 27, 2006. Photo courtesy of Puerto Rico Department of Natural and Environmental Resources

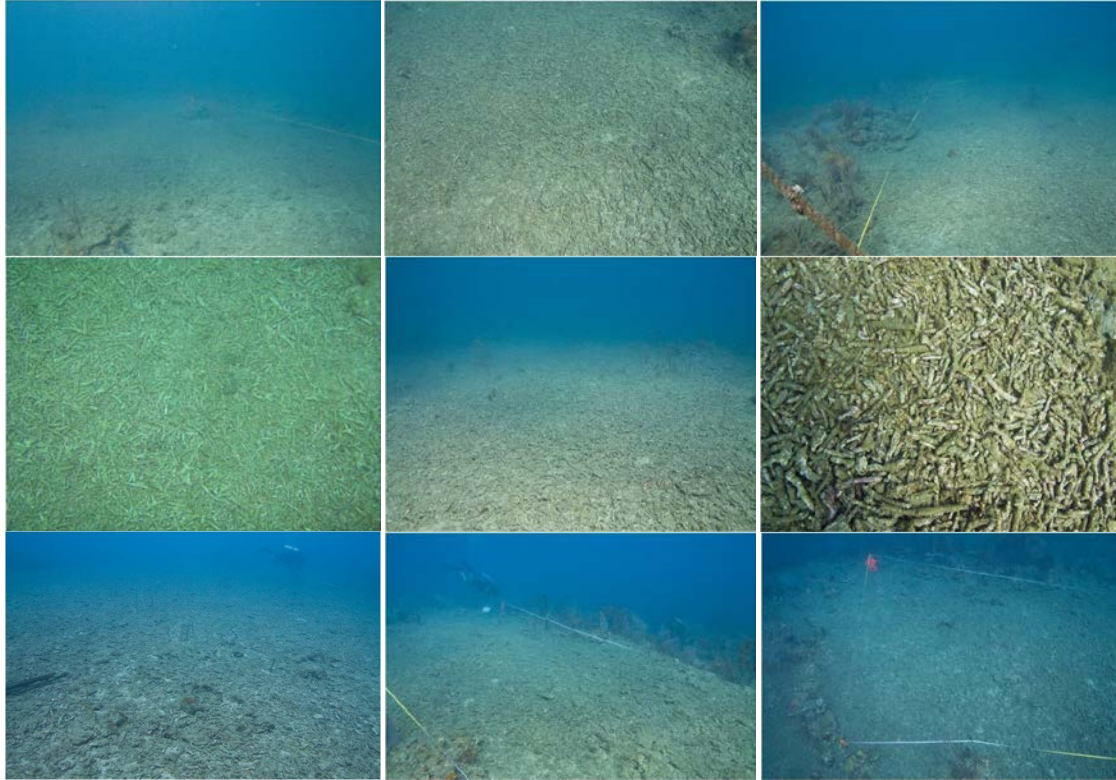
Figure 9: Photos of rubble and some of the areas needing primary restoration at the T/V MARGARA site. Photos by NOAA Restoration Center, December 2008.

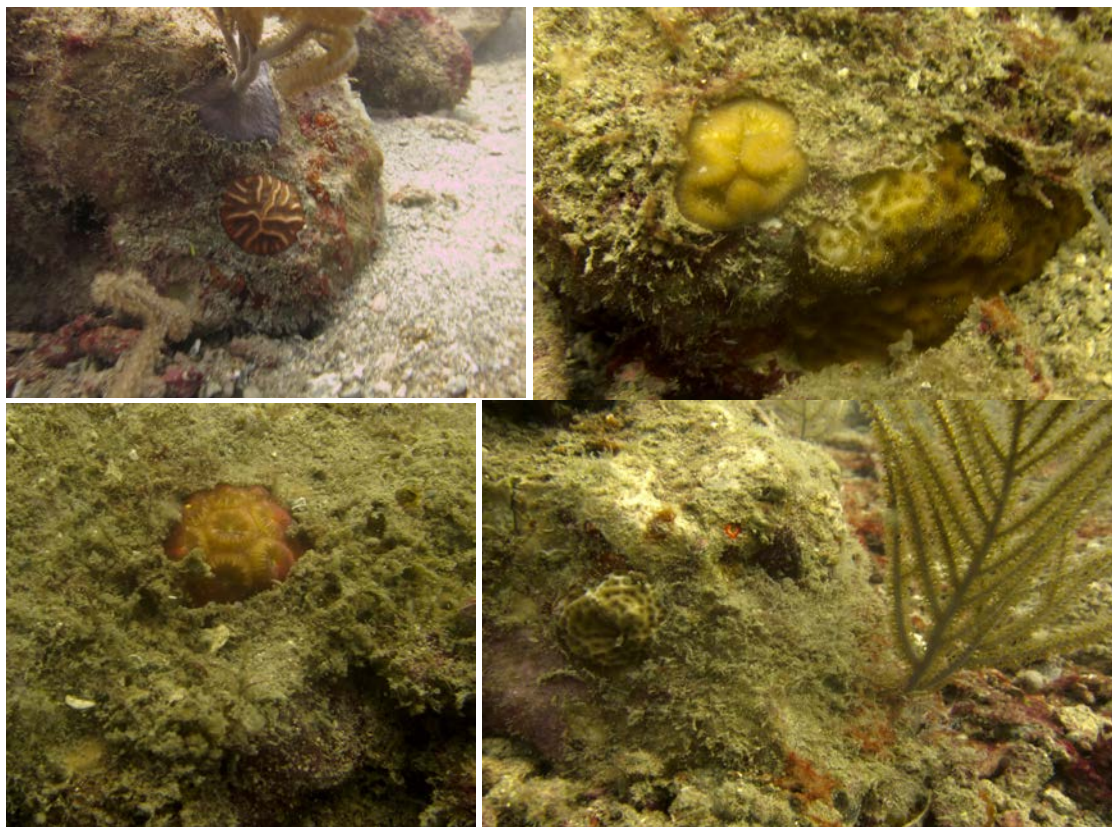
Figure 14: Photos of scleractinian and octocoral recruits on limestone deployed at T/V MARGARA site in 2010. Photos by NOAA’s Restoration Center, 2013.

The quarried limestone rocks that are identified for use are the same material as the coral reefs and were themselves coral reefs at one time. Therefore, the material has similar properties to what was present at the site before the grounding occurred and is a more comparable reef material than foreign materials like ceramic, cement only, cement modules or other materials.

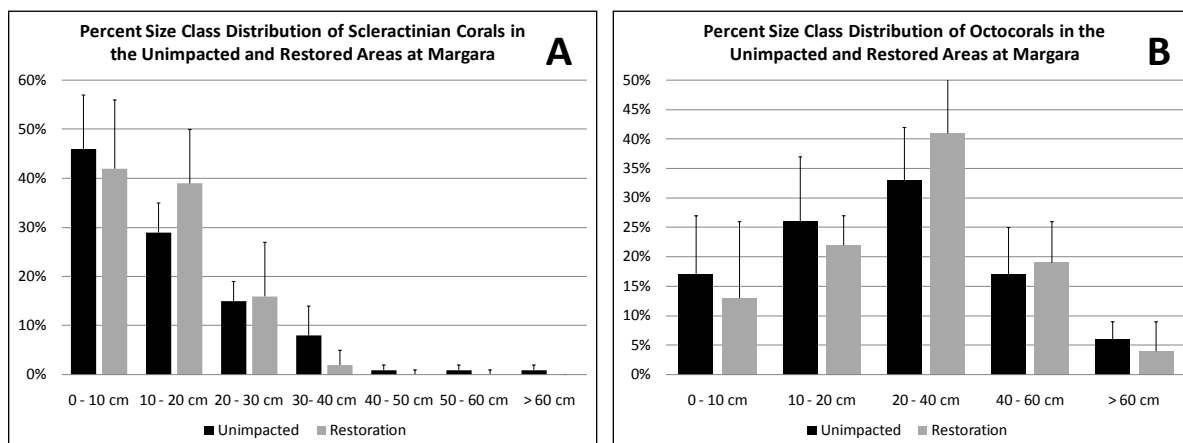
Figure 3: Percent size class distributions of scleractinians (Graph A) and octocorals (Graph B) in the un-impacted reef adjacent to the T/V MARGARA site (black bars) and in restored areas after emergency restoration (gray bars).

Figure 3 below provides a comparison between the size classes of corals found in the un-impacted reef area adjacent to the T/V MARGARA site and the size classes of the corals that were reattached during the emergency restoration. A higher percentage of scleractinians in the 10 – 20 cm size class range were reattached during the emergency restoration than were found in the adjacent reef, and a lower percentage of corals greater than 30 cm were reattached compared to the size distribution of scleractinians found in the reference area. For octocorals, a higher percentage of corals in the 20-40 cm size class were reattached. Size class distributions were similar (within 5% of each other) for the other size classes for both reference and restored areas.
