HACKENSACK RIVER COUNTY PARK STUDY

SITE ANALYSIS FOR THE: PROPOSED HACKENSACK RIVER COUNTY PARK

DESIGN PROPERTIES OF LONG ISLAND, LTD.
Landscape Architects, Site Planners

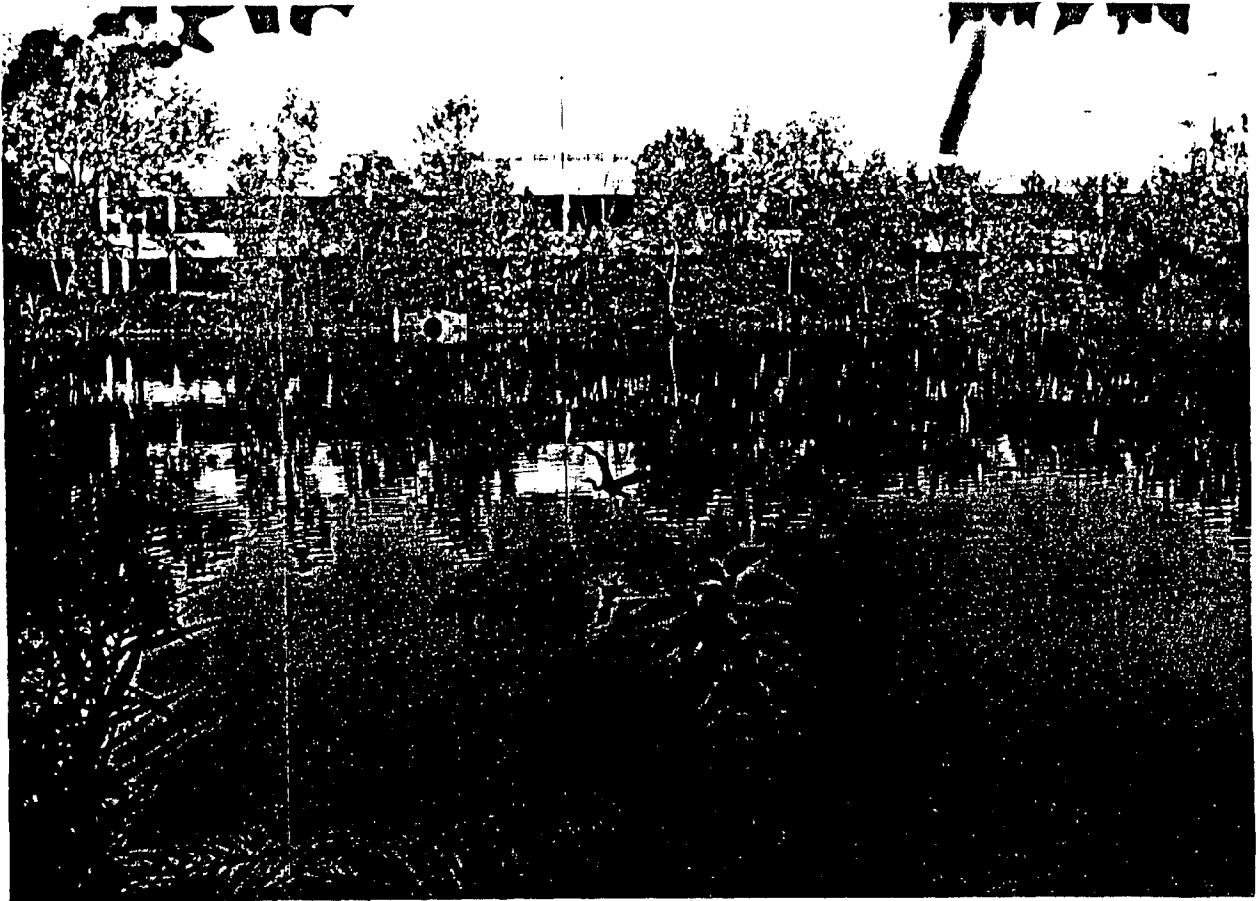
PHOTO 3

VIEW FROM ACROSS RIVER TO PROPOSED PROMENADE AREA.

EXISTING VEGETATION WOULD REMAIN WITH SELECTIVE VIEWS CUT ONLY

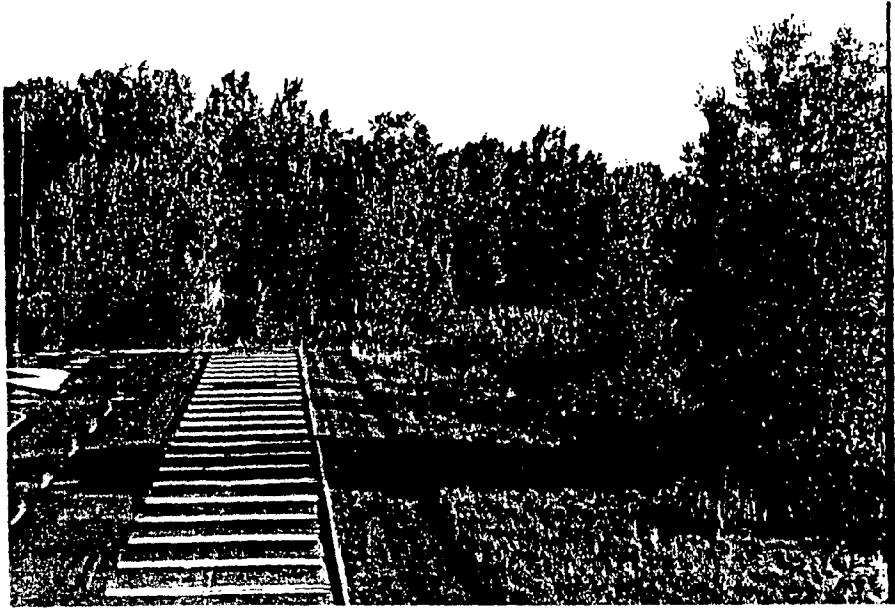
PHOTO 5

VIEW OF EXISTING VEHICULAR ACCESS

It is necessary to create a visual key or direction that denotes where users to the area would park since not everyone will use the pedestrian access from the mall. The area we are recommending is noted on the plan. (See photo 5) This particular area is presently completely outdoors and not under the parking garage. It stands out on its own because it is outside. It is a good area to bring people in because from here there could be a path up to the end of the promenade. Here there would be the option of going in three directions. One route could be to the trail system, another could be to the west to the canoe launch area, or one could enter the promenade area and travel south. This area should be denoted with signage and plant materials that buffer and soften the edge where the building and parking meets the natural grass areas. It is an appropriate area to bring vehicular users in because it will have its own sense of entry; which helps the user find their way and have a sense of direction.

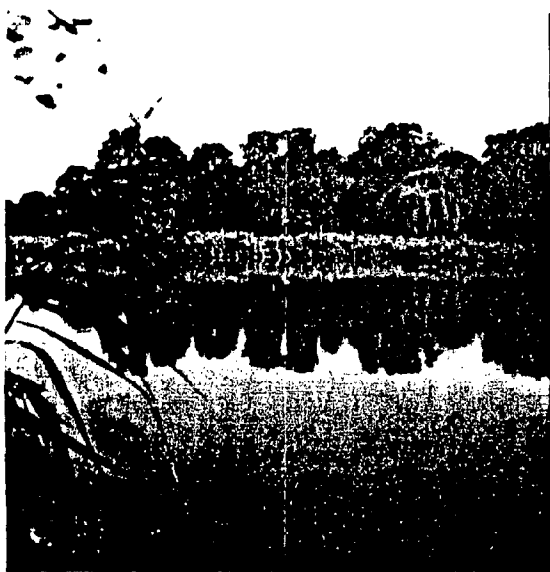
PHOTO 11

4g. A few steps to the west of "the beach" is the river view area. This is an appropriate spot for a viewing platform as this point juts out into the river and does afford views across and down the river. (See Photo 11) This is also a shade area with mature Populus deltoides, Eastern Poplar, Robinia pseudoacacia, Black Locust, and Rhus sp. creating nice overhead cover. As groundcover, Lonicers prostrata, Creeping Honeysuckle is evident. This area is important as there are not many areas to be directly related to the waterfront along the existing pathsystem and this view could allow for presentation of the waterfowl that are present along the river corridor.
