## Building Climate Resilience of Urban Waters, Ecosystems, and Communities

**Final Report** for State Coastal Conservancy submitted by Ocean Discovery Institute in partnership with California Sea Grant and San Diego Canyonlands

**Project no. #** 15-060

**Publication no.** CASG-18-024

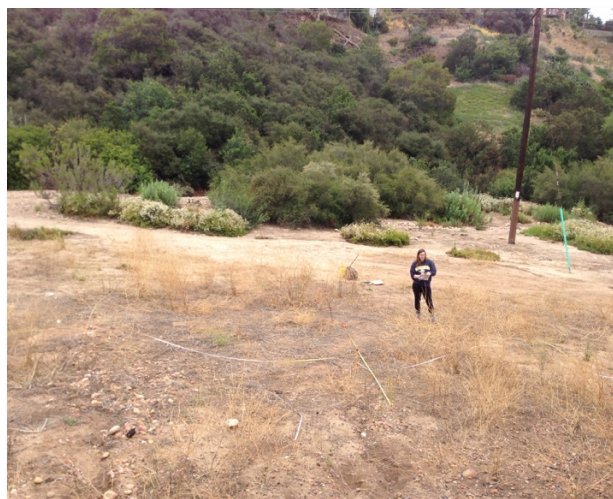
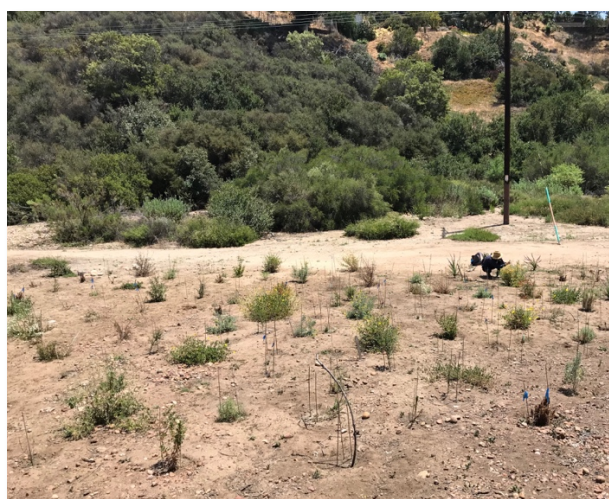
Manzanita Canyon restoration plot MU12 before planting in May 2016 (left), and 6 months after planting in May 2018 (right).

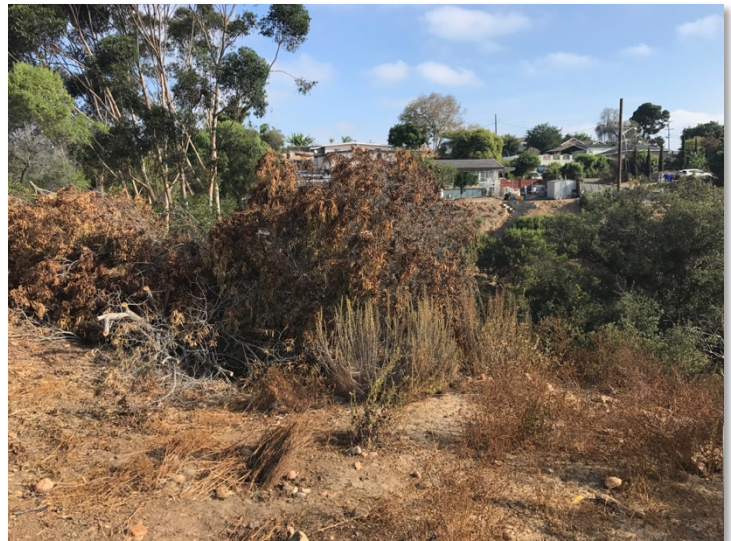
Figure. 1. Renegade trail closure using pruned limbs from nearby maintenance activities placed at the head of a trail leading down a steep slope.

*Trail closures.* Renegade trails were identified and mapped in the first year of the project. Trail closures occurred opportunistically in both years of the project as large plant material (e.g., cut up fallen tree, brush) became available in close proximity to a renegade trail (Figure 1). Occasionally, cactus or the native woody plantings, if the trail was in a restoration plot, were also planted in trails to discourage use. Brush, woody natives and/or cactus were placed in and across renegade trails in one to several locations, depending upon length of the trail, to block access. Total length of closed trails was calculated using Google Earth with trail GIS layer overlays.

*Renegade trail closures.* Over the two-year project, approximately 645.3 linear meters of renegade trails were closed using brush (e.g., cut tree limbs, shrubs) and/or native woody restoration plantings. At the same time, use of established access points was encouraged through installation of stairways and railings, signage, and plantings. These trail closures, coupled with improvements to established access trails, seemed to deter opportunistic use of renegade trails (e.g., pedestrians seeking a short cut between the ridge and floor of the canyon). The closures did not, however, completely eliminate use of renegade trails providing access into encampment areas.

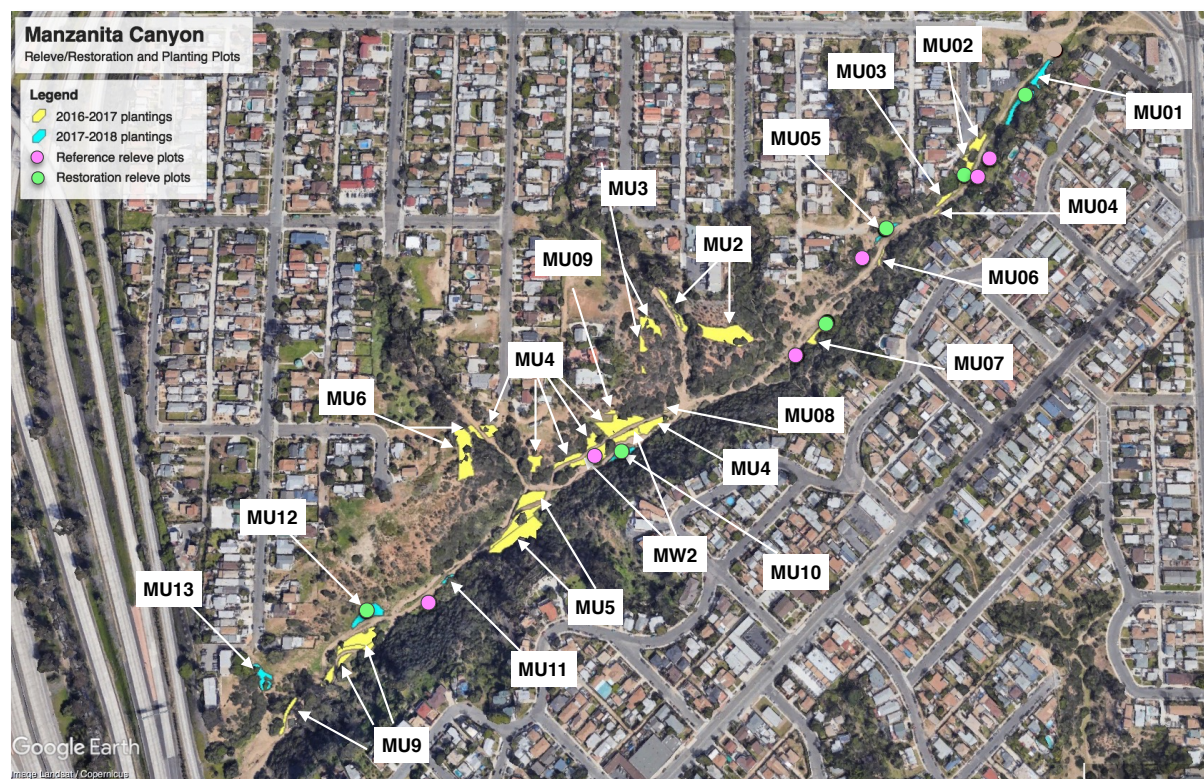
Figure 2. The restoration plots (polygons), and paired restoration-reference plot Relevé survey locations in the 1-km long Manzanita Canyon, San Diego, California. Plots were surveyed between October 2016 – May 2018. Note that MU4 was treated as two plots, one on the canyon floor (coastal sage scrub) and the other along a slope of mixed coastal sage scrub & southern oak chaparral.

**Native plantings.** Before the start of this project in early 2016, 22 restoration polygons (hereafter “plots”) were established throughout Manzanita Canyon (Figure 2) and a planting palette for each plot was defined based on a combination of criteria, including existing established species, species that are generally common in San Diego canyon ecosystems but that had undergone decline in this canyon, and City regulations (e.g., adherence to Brush Management Zones near residences so that utilities could be maintained). Six nearby reference plots were also established that were similar in topography to the six restoration plots to which they were paired (Figure 2).

A total of 1537 native perennial plants were planted during late 2016-early 2017 (716 plants over 16 plots) and late 2017-early 2018 (820 plants over 6 plots) (Figure 2). Each planting was marked with two bamboo garden stakes (Figure 3) and, for the first 2-3 months, surrounded by a plastic cylinder (Figure 4) to prevent herbivory. The restoration plots varied in area, species planted, and numbers of plantings (Appendix 1).

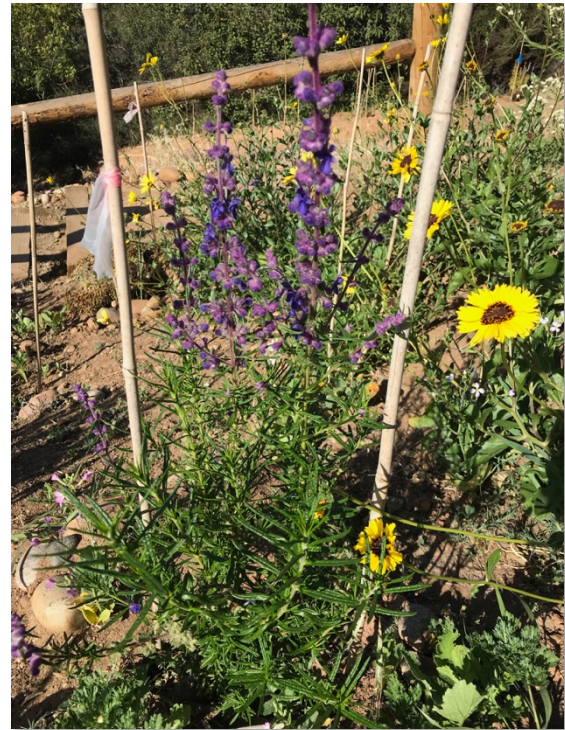
Figure. 3. A planted *Trichostema lanotum* marked with two bamboo garden stakes in plot MU13, May 2018.

*Planting Growth and Survival.* At least 10% of each planting species in each plot were tagged for monthly measurements of growth. Throughout October 2016- February 2017 (year-1 plantings) and October 2017-May 2018 (year-2 plantings), basal stem diameter of each tagged plant was measured using a caliper placed at the soil surface level. The volume of the tagged plants was measured by measuring height the tallest point of the plant, length at the widest diameter of the plant, and width of the diameter perpendicular to length.

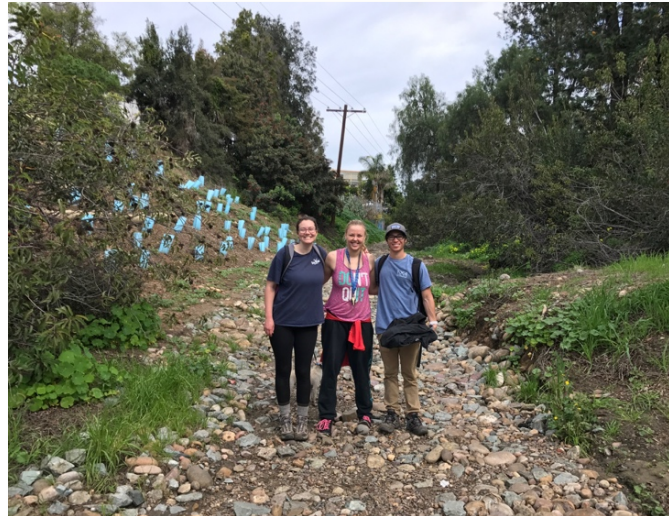
Figure 4. Project team members, Nina Venuti, Blanka Lederer & Charles Adams next to recently planted plot MU02 revealing blue cylinders placed over new plantings to deter herbivory; Feb 2017.

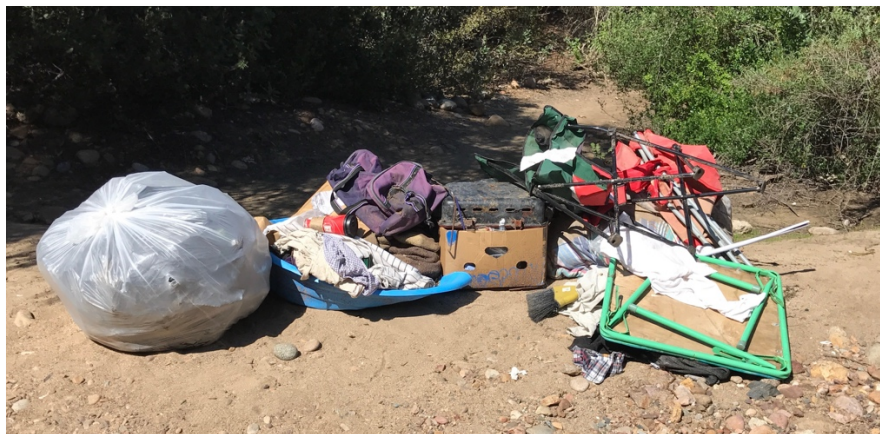
Figure 7. A typical example of large trash items found throughout Manzanita Canyon; pictured here are folding chairs and table, gas stove, suitcase, kids pool, broom, clothes, and a bag with trash and blankets found on 09 March 2017 at the base of Jamie’s Way access trail.

*Canyon-wide trash.* Over the two-year long project, roughly 12.95 metric tons of trash and debris (137.5 m<sup>3</sup>) were removed from the canyon by the project team and community volunteers. Included were bags of mesotrash and an assortment of large items, mostly commonly furniture (e.g., couches, chairs, mattresses, headboards, desks), household items (e.g., fans, lamps, carpets, suitcases, mirrors, microwave ovens, toilets, a tub, a water heater), and shopping carts and strollers (e.g., Figure 7).

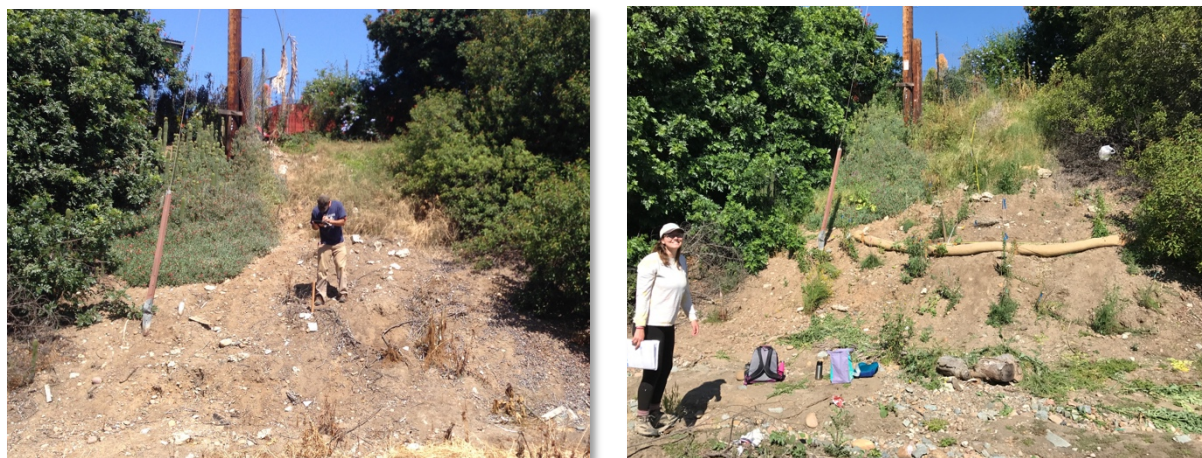
Figure 12. Manzanita Canyon restoration plot MU02 in May 2016, before planting, and in April 2017, 3 months after planting.
