Wise practices for coping with
BEACH EROSION

Anguilla

FORCES TO BE RECKONED WITH

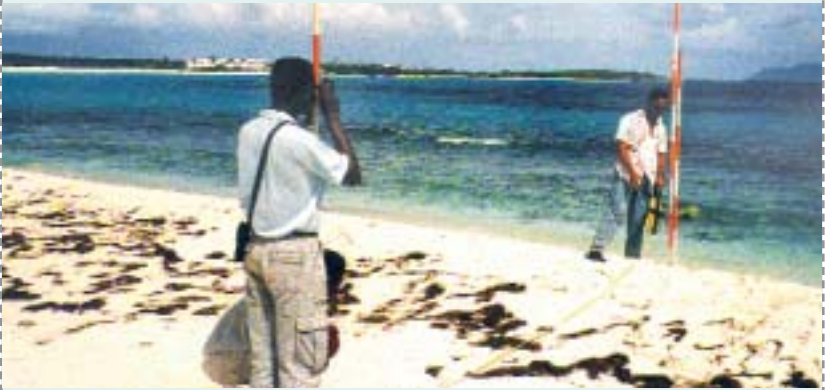
In order to manage these changes, Anguilla's beaches have been monitored since 1992 by the Department of Fisheries and Marine Resources, who measure the beach slope and width every 3 months at numerous sites around the island, as well as at the offshore cays.

Beach monitoring
in progress at
Shoal Bay West,
1992

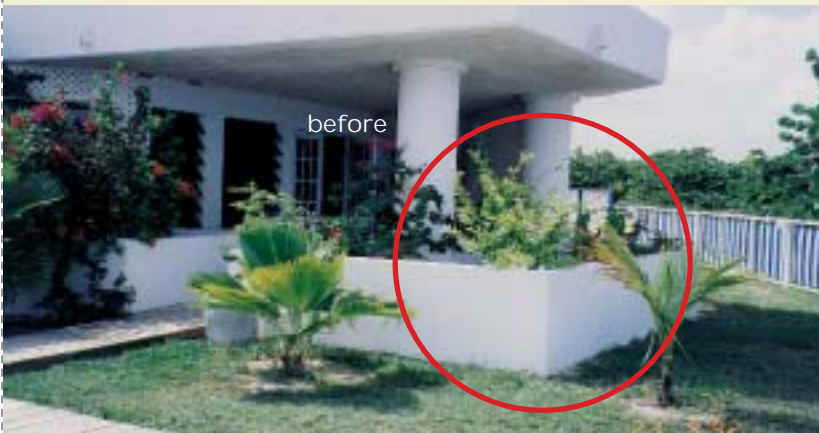
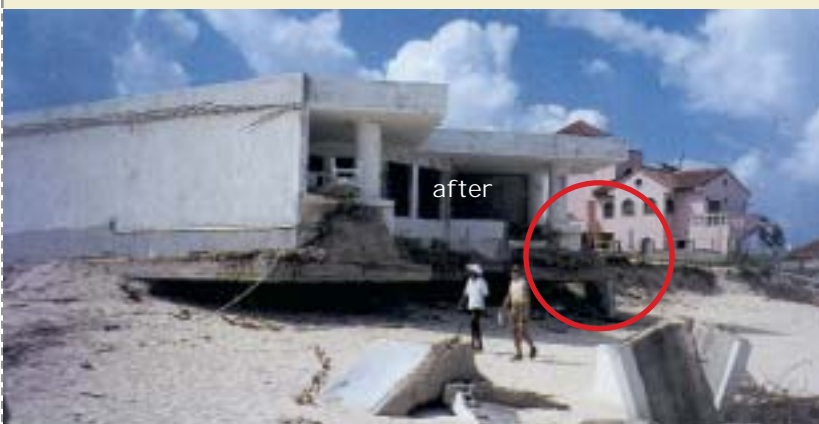
Beachfront properties were transformed overnight after Hurricane Luis struck in 1995. Mead's Bay Central: reference point before and after Hurricane Luis

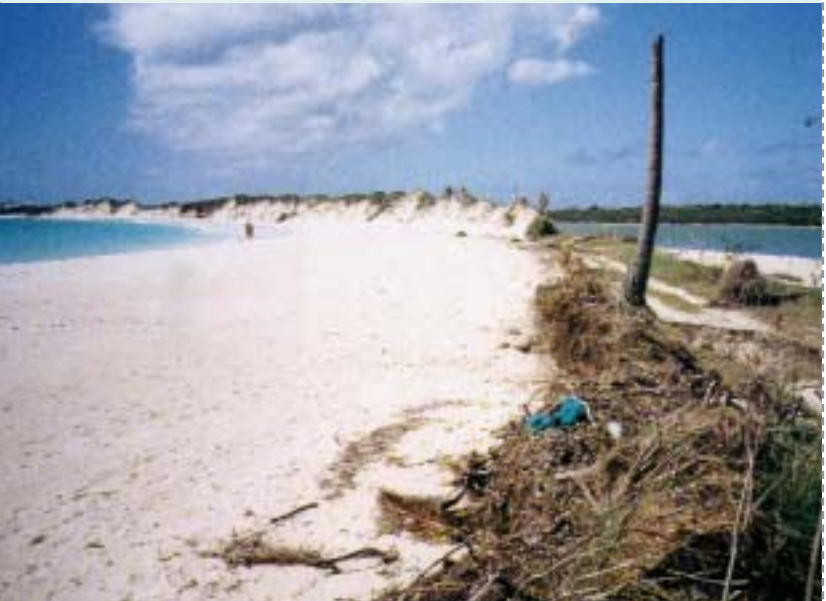
Sandy Ground. During Hurricane Lenny (Nov. 1999) the sea and the pond were temporarily joined

Cove Bay, 2 months after Hurricane Lenny struck (Nov. 1999). There used to be a wide belt of sand dunes separating the salt pond (right side of photo) from the sea. Now only eroded remnants exist

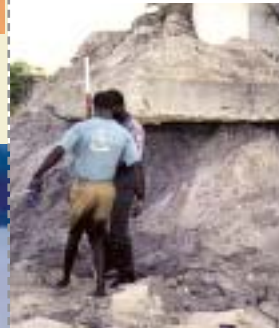
(below) Measuring sand loss after Hurricane Luis, 1995

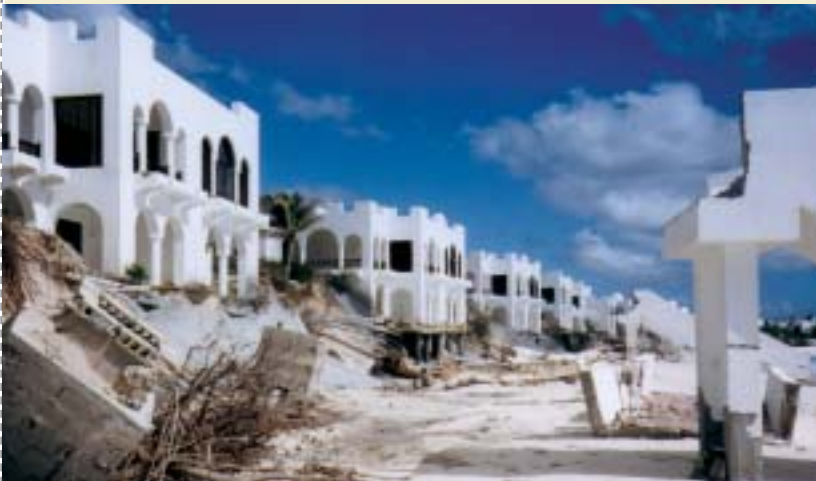
(left) Maunday's Bay after Hurricane Lenny in 1999. Hotel villas were undermined and stairways leading over the once extensive dunes were left as isolated monuments

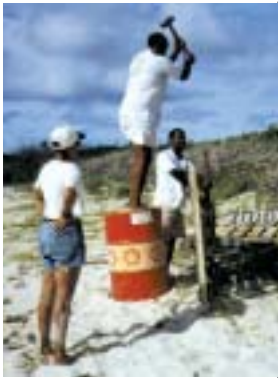
Building sand fences at Savannah Bay, 1997

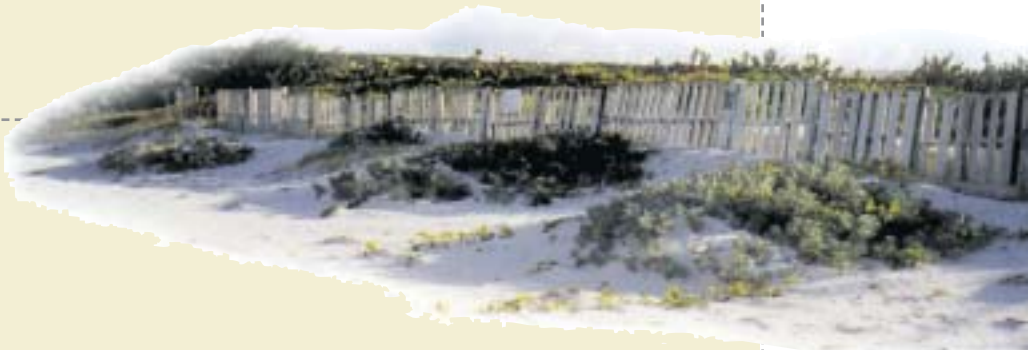
*Sand fences
and sea lavender,
Shoal Bay, 1998*

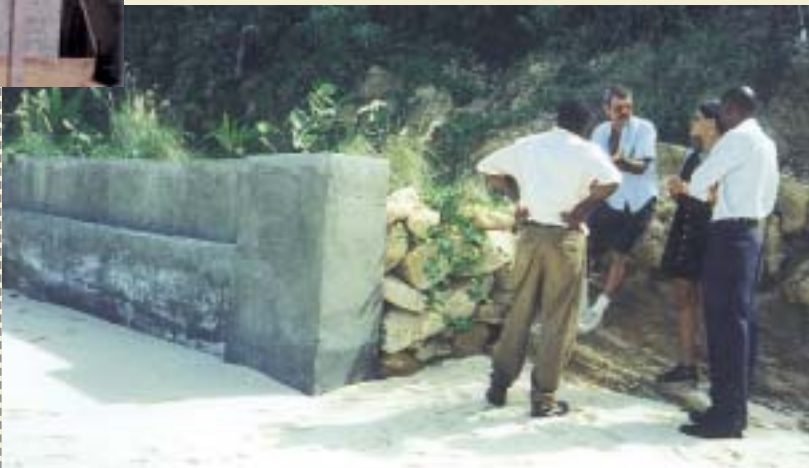
*A retaining wall under
construction at Mead's Bay
after Hurricane Luis, 1995*

*Planners and
a developer
discuss a recently
constructed seawall
at Mead's Bay,
Anguilla, 1998*

- Resorting to 'hard' engineering structures such as seawalls, revetments and bulkheads, only when there is a need to protect beachfront property from wave action. Such structures, even with careful design, result in the loss or narrowing of the beach over time.
- Considering all other beach enhancement measures such as offshore breakwaters, groynes and beach nourishment (placing sand from the offshore zone or from an inland source on the beach) at a particular site. All such measures require careful design and environmental impact assessments, so always first consult the Department of Physical Planning.
