Wise practices for coping with

BEACH EROSION

Montserrat

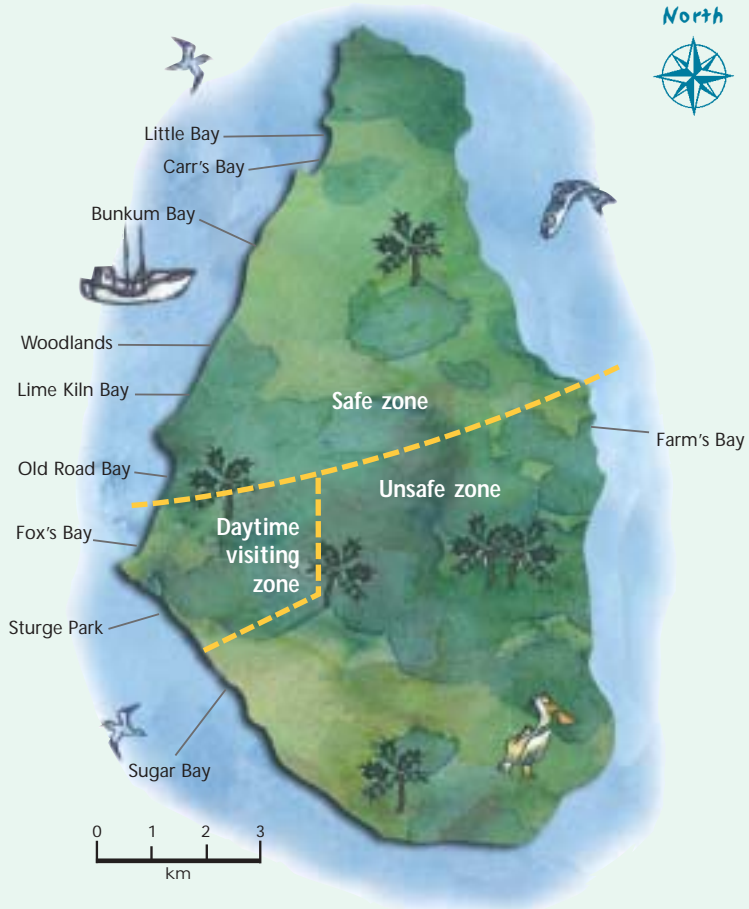
Location of
monitored
beaches
in Montserrat

In order to manage these changes, Montserrat's beaches have been monitored since 1990 by the Ministry of Agriculture, Land, Housing and the Environment, and more recently by the Fisheries Division. They measure the beach slope and width every three months at several sites around the islands. During the volcanic emergency, 1995-1998, monitoring was interrupted, but recommenced in 1999.

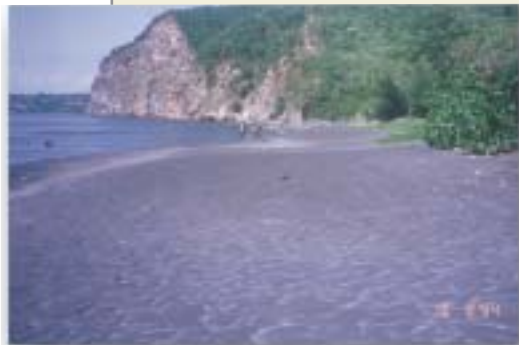
Fox's Bay, 1994,
before Hurricane Luis

When Hurricane Luis struck in 1995, much of the beach was lost at Fox's Bay on the west coast and at other beaches. In the months and years after the hurricane, the beaches recovered to some extent, but were further impacted by Hurricane Georges in 1998, and Hurricane Lenny in 1999.

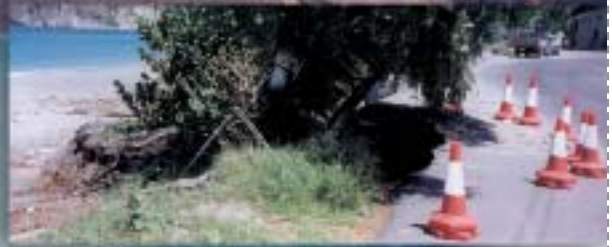
Road damage at Carr's Bay after Hurricane Georges, 1998

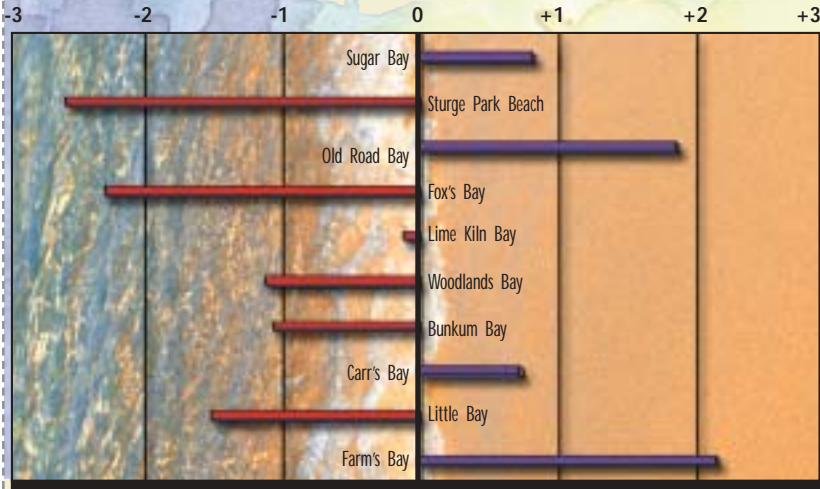
The table shows generalized rates of change at the measured beaches in Montserrat between 1990 and 1996. During this period most of the beaches showed erosion, a result, at least in part, of the impact of several severe hurricanes. However, most beaches in Montserrat show erosion along one part of the beach and accretion (or build-up) at adjacent sections, thus these figures must be treated as average trends.

Beach change rates in Montserrat (metres per year)

A negative rate of change (—) indicates erosion and retreat of the shoreline, a positive rate of change (—) indicates accretion or advancement of the shoreline towards the sea.
