To Tree, or Not to Tree...

The use of discarded Christmas trees for dune stabilization

By Greg Berman, Coastal Processes Specialist

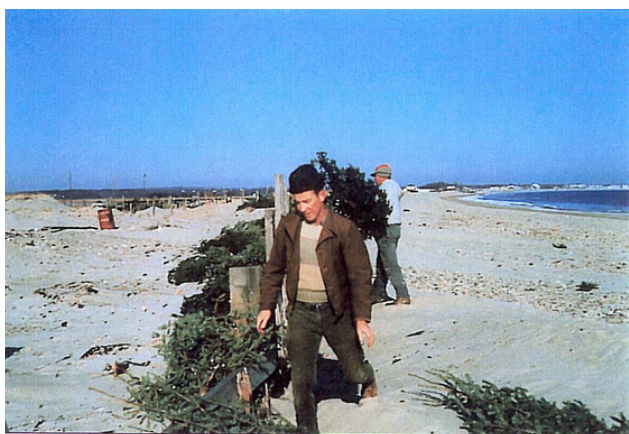
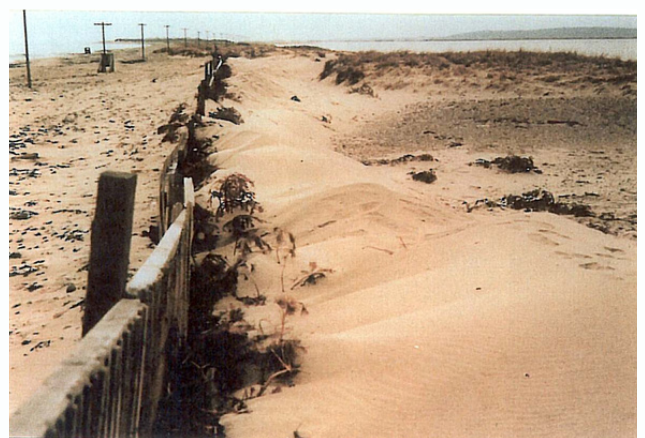
In the late 1960s and early 1970s discarded Christmas trees were used on Duxbury Beach (MA). By the late 1970s the use of Christmas trees was discontinued as they were considered ineffective for longterm stabilization (Rosen et. Al., 2009, Kraemer, 2000, images from Kraemer, 2000).

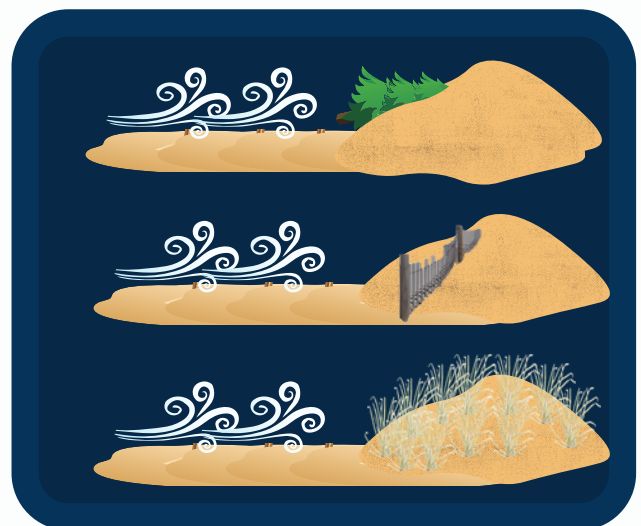
Over the long term, vegetation, such as beach grass, is most effective at retaining sand in a dune. Before grasses can be established other techniques, such as sand fences, are used to hold and accumulate sand. Sand fences are designed to imitate the natural accumulation that beach grass provides to the dune. There are many different types of fencing used for erosion control. Slat fencing, installed with small posts, has 50 percent porosity which slows down the wind, causing sand to accumulate near the fence.

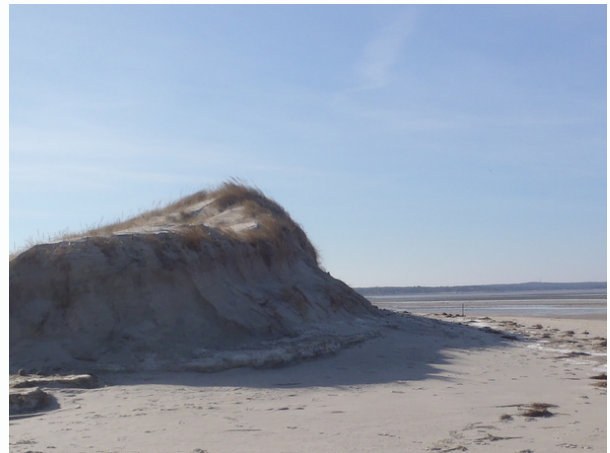
Wave-eroded scarp

Storms create higher water levels upon which waves can erode the seaward toe of the dune. Further away from the beach, and higher up in the dune system, erosion can occur that has little to do with wave action. Wind can scour out circular sections of dune, often called “blowouts.” Blowout evolution on Cape Cod tends to occur at a bare patch in an otherwise vegetated dune and develop into a saucer-shaped blowout, with further erosion transitioning the feature to a bowl blowout (HESP, 2016).

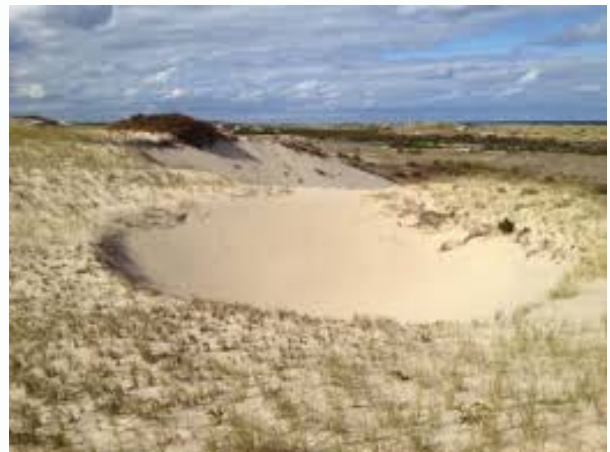
Wind-eroded blowout (HESP, 2016).

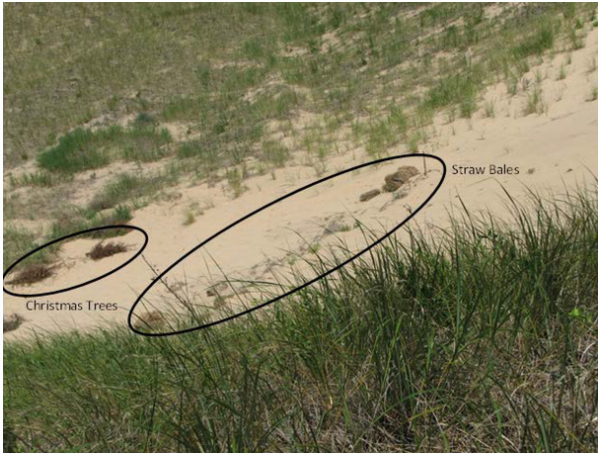
Discarded Christmas trees and straw bales reduce the downslope slide of sand in a wind-scour blowout feature at Castle Park Reserve, MI (from Bleeker et al., 2013).

In these steep blowout areas Christmas trees, more so than sand fences, have the potential to reduce further erosion.

Windblown sand accumulates at Christmas trees and sand fencing at similar rates (Bleeker et al., 2013); however, on a steep slope, sand tends to slide through fencing. A stable embedded object, such as a straw bale or Christmas tree, can stop the slide of sand, stabilize the dune surface, and thereby reduce slope failure.

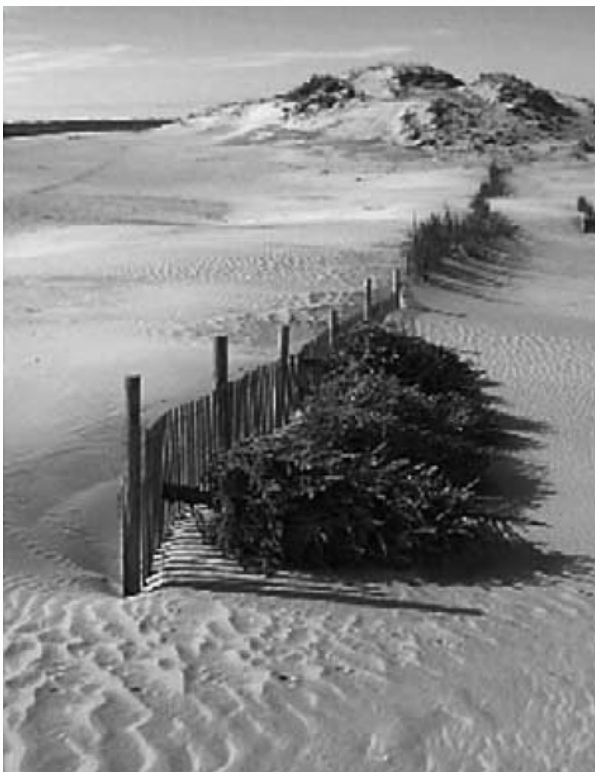
Discarded Christmas trees in a spur configuration enhance sand fence (image: Mitasova et al., 2005).

Additionally, Christmas trees can be arranged in a spur configuration to reduce wind speed from a variety of directions. Studies have shown that adding spurs or an additional row of sand fencing can slightly increase the volume of trapped sand, however the construction cost does not make this economical (Savage, 1963; Knutson, 1980; Miller, et al, 2001). By using a free material, such as discarded Christmas trees, enhancing the standard row of straight (parallel to the dune) sand fence may become economically feasible.

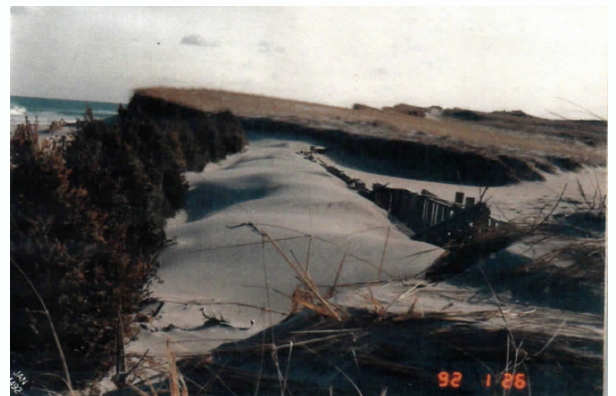
Sand fences enhanced by discarded Christmas trees to mimic a double row of sand fence. Image from 1992 courtesy of Massachusetts Beach Buggy Association.

It has been established that, for a time, Christmas trees can trap sand in a similar way to sand fence. Adding Christmas trees landward of a sand fence is, in effect, creating an array similar to a double row of fence.

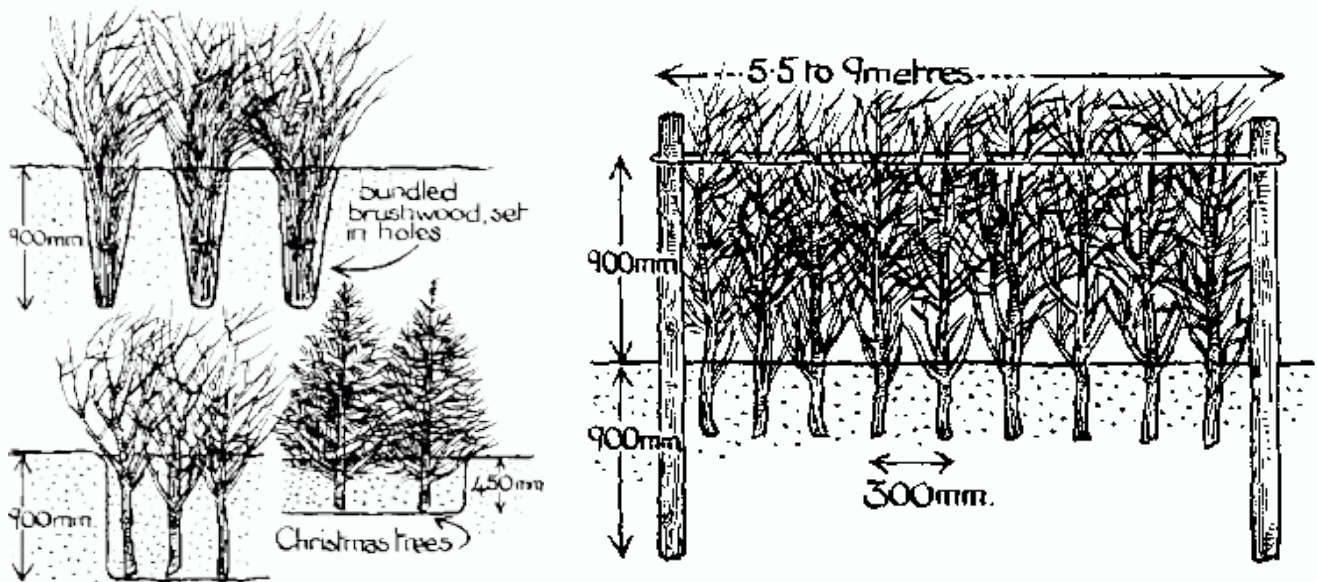
Image adapted from TCV, 1979, updated 1986. [Sand Dunes Handbook](#).

Another well-studied method is Brushwood fences, which are typically made by securing branches (often pine branches, think Christmas trees) in a row between poles and fastening the section to posts.

A simpler, and often shorter-lived method is to partially bury the pine branches in a trench. Both methods have been used extensively (Stratton and Hollowell, 1940) and if properly designed they are very efficient sand trappers. Savage (1963) found them to trap slightly more sand than the slat type but cost almost twice as much due to the high labor requirements. In the 1970s it was determined that sand fence catches sand more consistently than brush fence and still required less labor to install than brush fence (Woodhouse, 1978). In the 50 to 60 years since these studies the price of labor has gone up at a significantly higher rate than the cost of materials, therefore it is still unlikely that the use of brush fencing could be economically justified, unless the labor is made up almost entirely of volunteers. In the U.S., brush fences have largely been replaced by rolls of prefabricated fence that can be quickly and cheaply secured to posts.

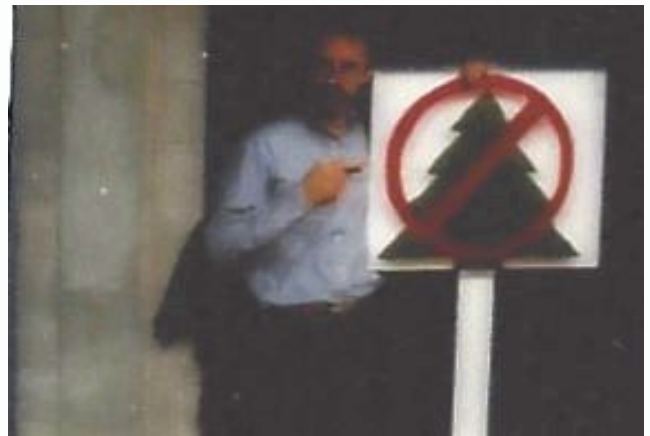
Fort Fisher, North Carolina - No more trees sign.
Photo credit Spencer Rogers.

In southeastern **North Carolina** 8,000 trees and in northeastern Florida more than 40,000 trees were placed on dunes in the 1980s. The 10-year program at Fort Fisher State Park in North Carolina sought to repair the damage from off-road vehicles. Once the repair was accomplished, the program was discontinued as it was starting to “favor a few species at the undesirable expense of others.” At **Florida** sites, concerns over threatened and endangered species necessitated extensive monitoring efforts to ensure the processes caused no detriments to the species (Barnett et al., 1989).

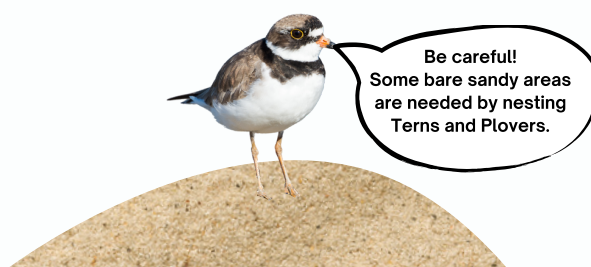
PROS (FROM LITERATURE)	CONS (FROM ABOVE GUIDANCE DOCUMENTS)
A WAY TO GET RID OF DISCARDED CHRISTMAS TREES	BECOME A SOLID WASTE NUISANCE ALONG THE COAST
CAN RAPIDLY ACCUMULATE SAND FOR COASTAL DUNES, THEREBY INCREASING RESILIENCE TO STORMS	IMPEDE THE ESTABLISHMENT AND GROWTH OF LIVE PLANTS (EFFECTIVE PROTECTION REQUIRES LIVE PLANTS)
CHEAPER THAN INSTALLING SAND FENCE (IF USING VOLUNTEER LABOR)	LEAVE LARGE, DESTABILIZING HOLES IN THE DUNE WHEN THEY ARE RIPPED OUT BY WAVES
POTENTIALLY LESS METAL INVOLVED THAN SAND FENCING	REPRESENT ACTUAL PHYSICAL BARRIERS TO PLOVERS
FOSTERS COMMUNITY INVOLVEMENT IN COASTAL REASOURCE AREA RESTORATION	DEGRADE NESTING HABITAT FOR PROTECTED SHOREBIRD SPECIES BY PHYSICALLY OCCUPYING OTHERWISE SUITABLE NESTING HABITAT AND IMPEDING CHICK MOVEMENT

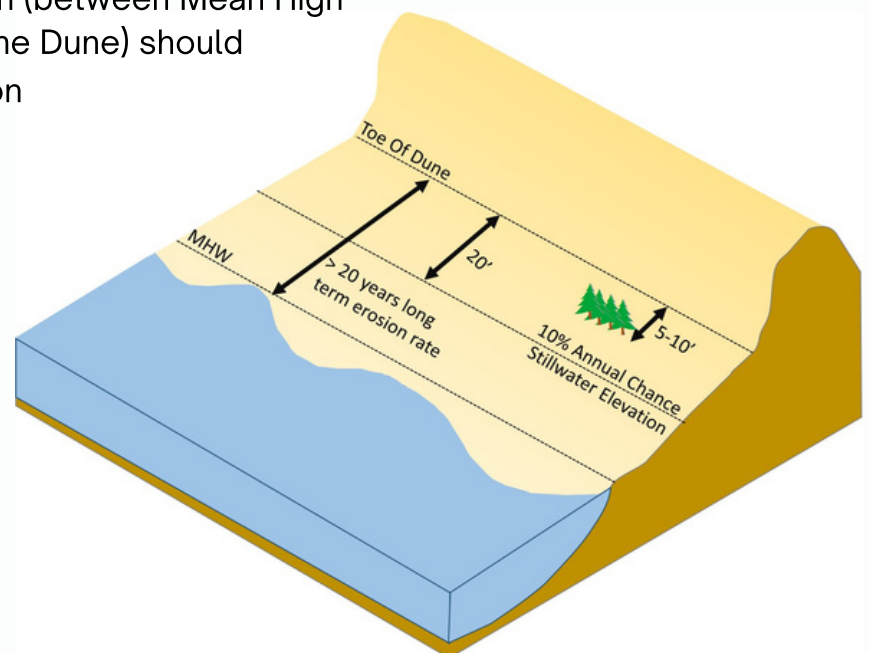
If Christmas trees are proposed on the seaward toe of the dune/beach interface, then adequate distance from the water (both vertically and horizontally) is very important. There should be enough distance (>20' horizontally) between the 10% Annual Chance Stillwater Elevation (aka 10 Year Storm) and the toe of the dune to provide a buffer for storm erosion. The beach width (between Mean High Water (MHW) and the Toe of the Dune) should have at least 20 years based on long term erosion rates. This should provide enough potential longevity to allow most of the tree to naturally degrade before becoming exposed.

- Placing trees seaward of an eroding dune scarp will result in washed out trees and debris on the beach. If possible, trees should be placed 10-20 feet landward of the existing vegetation line. Care should be taken that live vegetation (preferred over dead trees) is not adversely affected. A more seaward location may be acceptable if long-term erosion rates are very low or a recent storm has exceeded the 10-year return frequency.

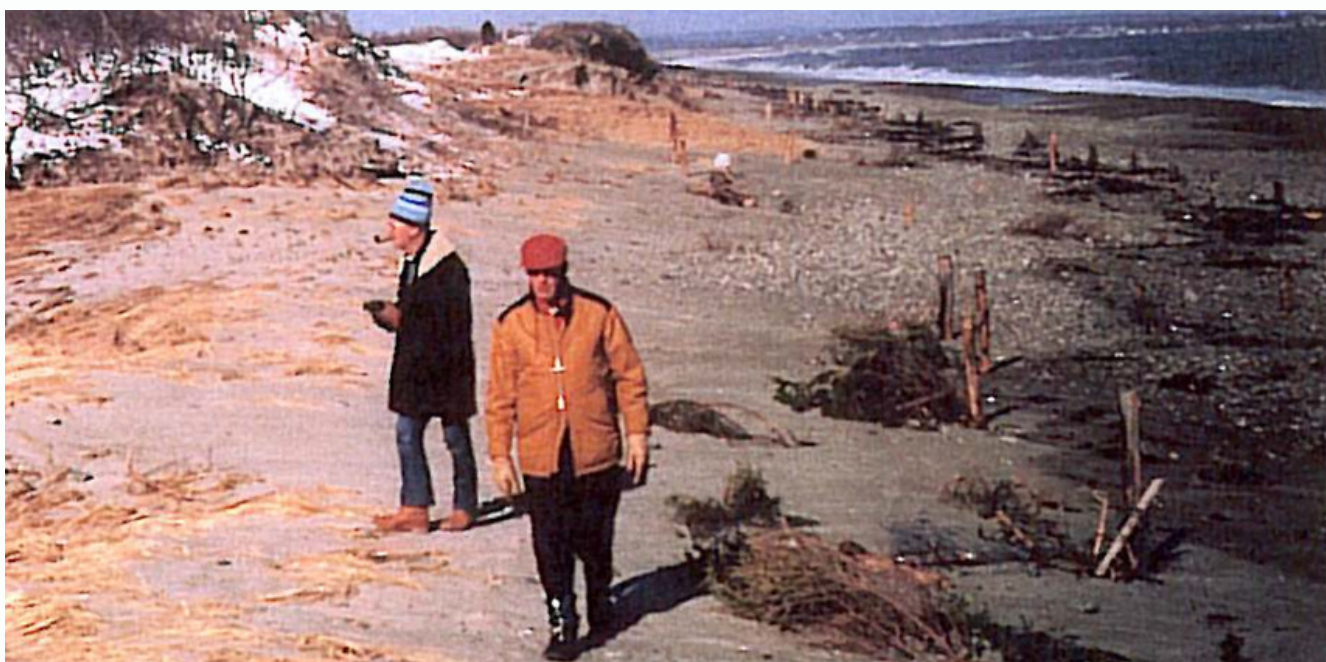
After the intense winter storm in February of 1978 discarded Christmas trees used for dune stabilization on Duxbury Beach (Mass.) were unearthed and became a solid waste nuisance along the coast (image from Kraemer, 2000).
