An Integrated Assessment of Torch Lake Area of Concern

Noel R. Urban, Carol A. MacLennan, Judith A. Perlinger

Michigan Technological University

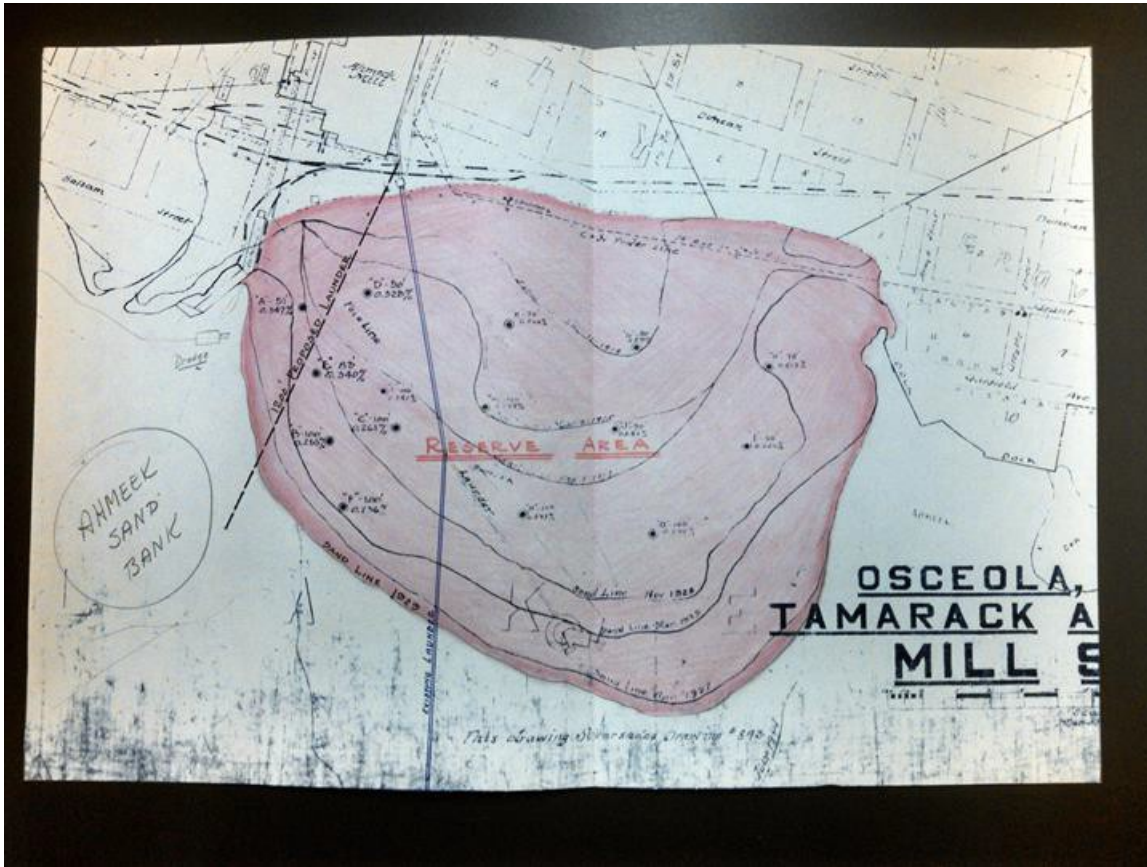
Figure 2-1. Osceola, Tamarack, Ahmeek Sand Bank. Source: Michigan Tech Archives, C&H Collection, Maps and Blueprints.

Stamp sand production was considerable. The mills developed a system of movable launders to transport the sands into the lake. When one area filled up, an adjacent area further from shore became the new deposit area. Mining companies mapped their stamp sand deposits, showing the year of deposits as they expanded in rough concentric-like half circles into the lake. Because the mined rock was either conglomerate or amygdaloid, the character of the sands was somewhat different. This mattered more at a later point when C&H and then Quincy decided to reprocess the sands to recover the considerable copper still remaining. During the early years of reclamation, conglomerate sands were processed first because of their higher copper content and ease in processing. From the late 1910s until the 1950s, sands were reclaimed, processed, and then returned in a new, finer form to Torch Lake (to be discussed in detail under section on reclamation). C&H's stamp sands were from conglomerate rock; Quincy sands were from amygdaloid. Sands deposited around Tamarack City contained both types.

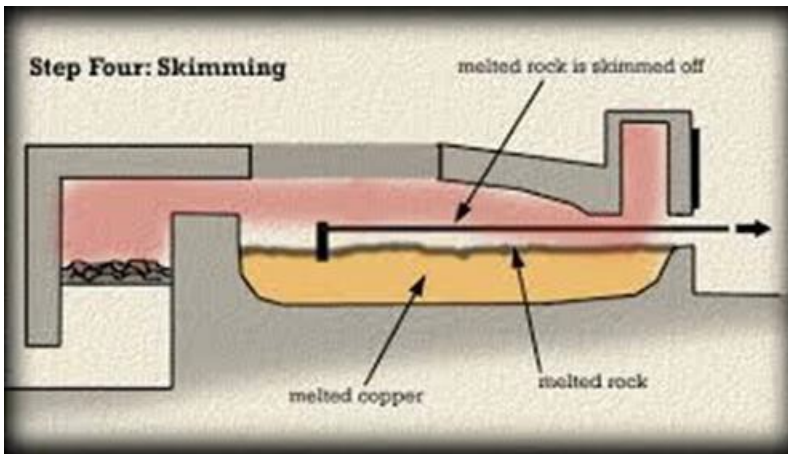
Figure 2-2. Smelter Reverberatory Furnace – Melted Copper and Slag. (Source: Copper Country Explorer. (<http://www.coppercountryexplorer.com/2009/11/smelter-tech-the-reverberatory-furnace/>))

Slag is both part of the production process and a byproduct to be disposed of once refining is complete. The melting furnaces in a smelter produce both molten copper (sinking to the bottom) and a “slag” of impurities that also include some copper that rises to the surface.

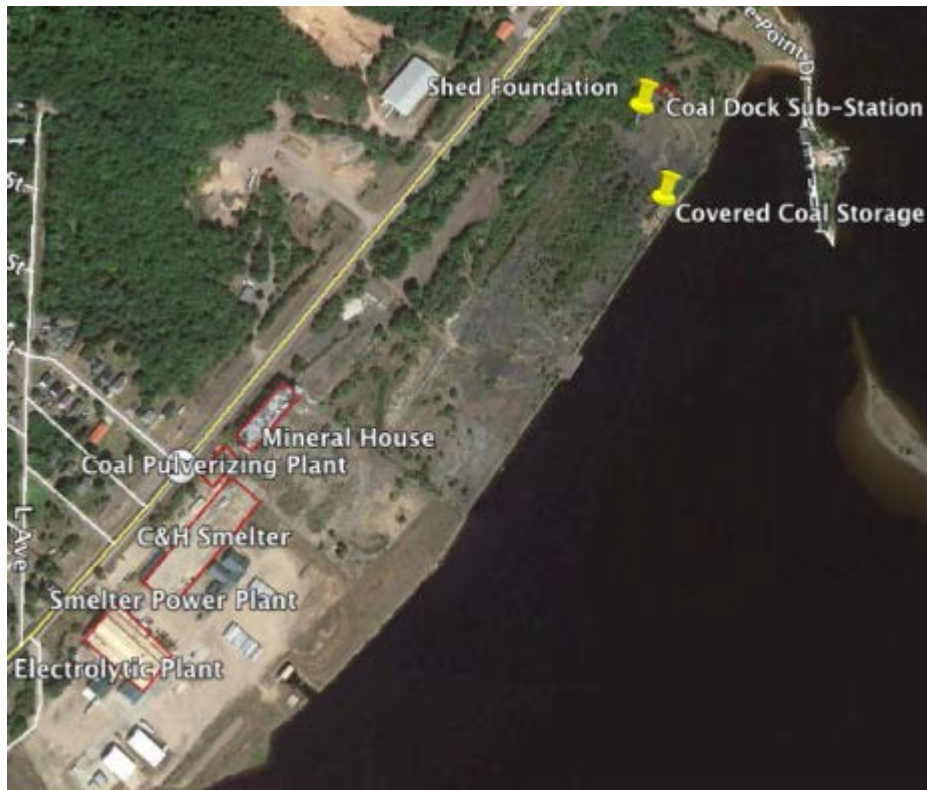
Figure 2-3. C&H Hubbell Smelter Yard Buildings. Google Map with Building Sites (Prepared by Emma Schwaiger, 17 September 2014)

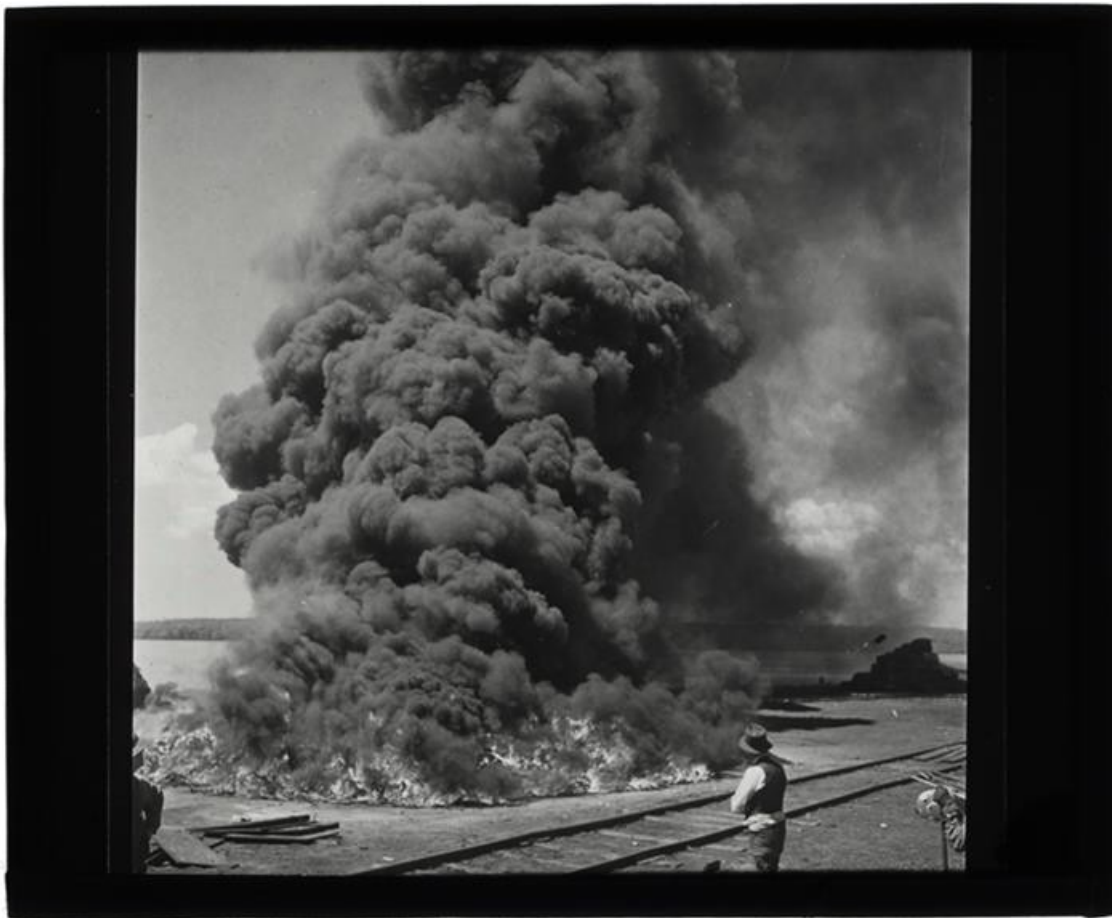
Figure 2-4. Burning of Copper Scrap in C&H Hubbell Smelter Yard (circa 1950s). Courtesy: Keweenaw National Historic Park Archives.

Some copper wire required the burning of insulation, which contained PCBs from the wire before processing. This burning is first documented in the 1940s in *C&H News and Views*. Copper wire was treated as late as 1968, according to C&H reports to the US Bureau of Mines on their

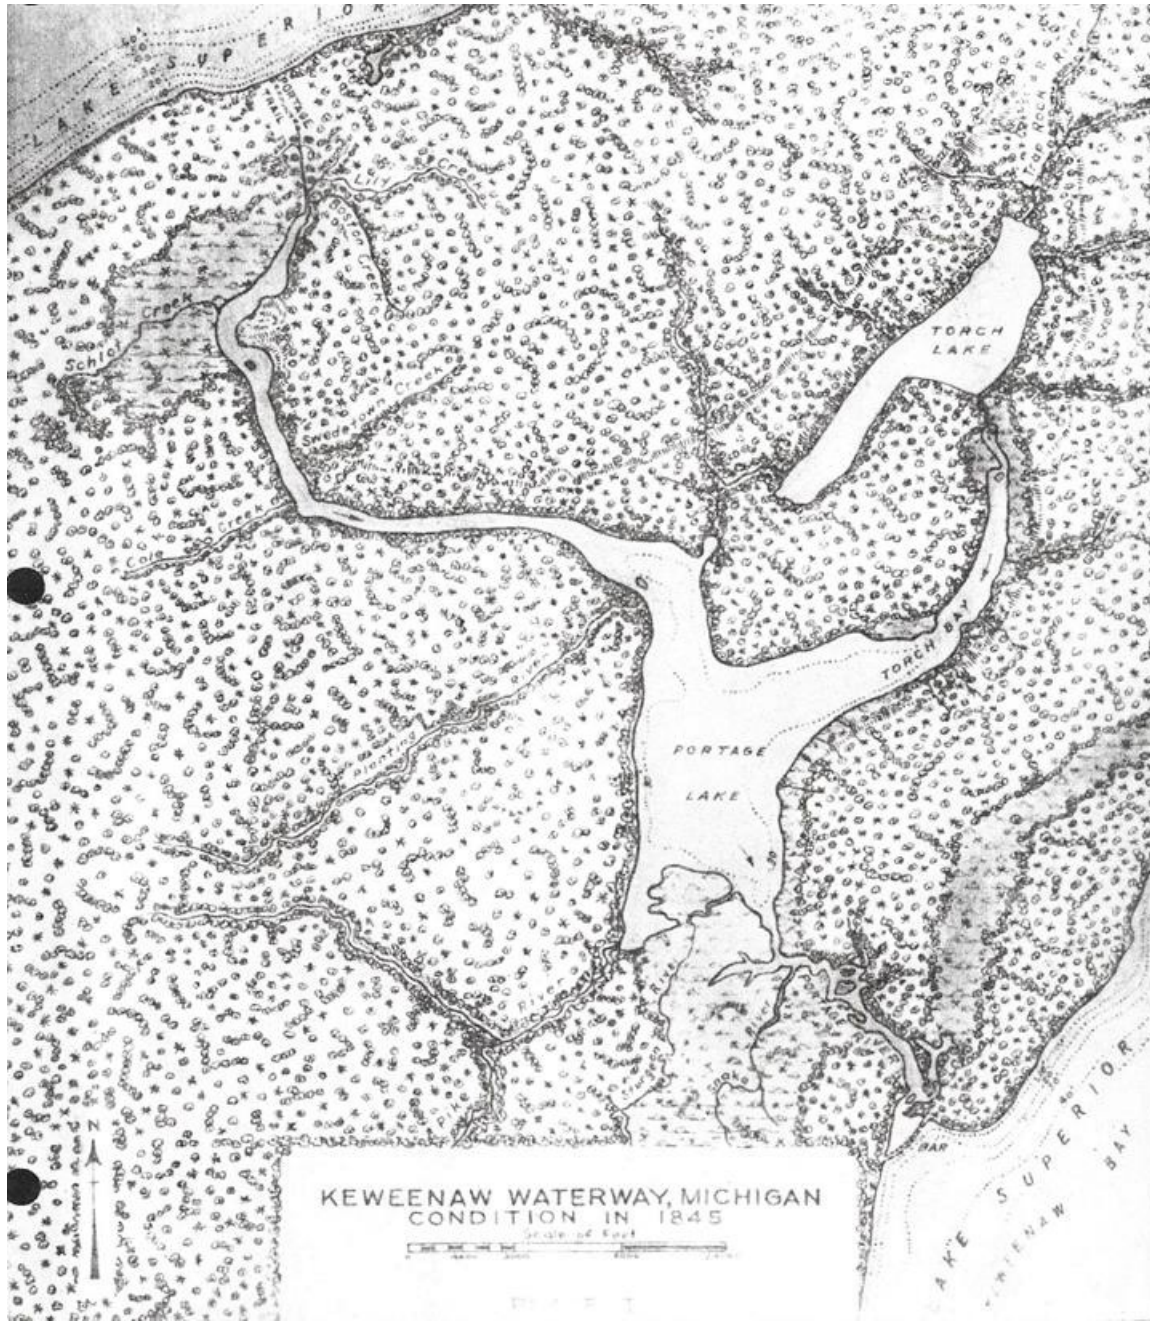
Figure 3-1. Keweenaw Waterway Map: 1845. (US Engineer Office, Duluth MN, "History of Keweenaw Waterway, Michigan," 1940)

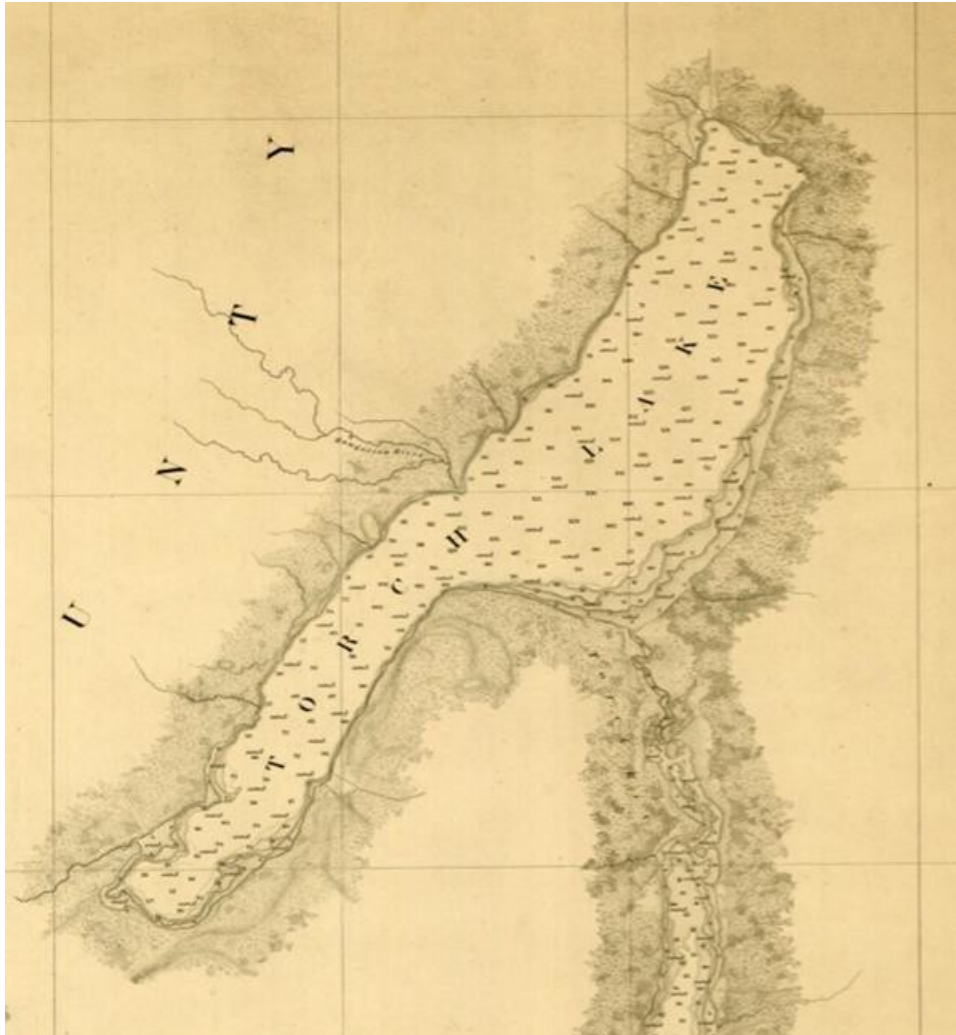
Figure 3-2. Torch Lake Map 1865 ([U.S.Lake-Survey, 1865](#)), 1924 (Figure 3-3), 1948 (Figure 3-4), 1996 (Figure 3-5).

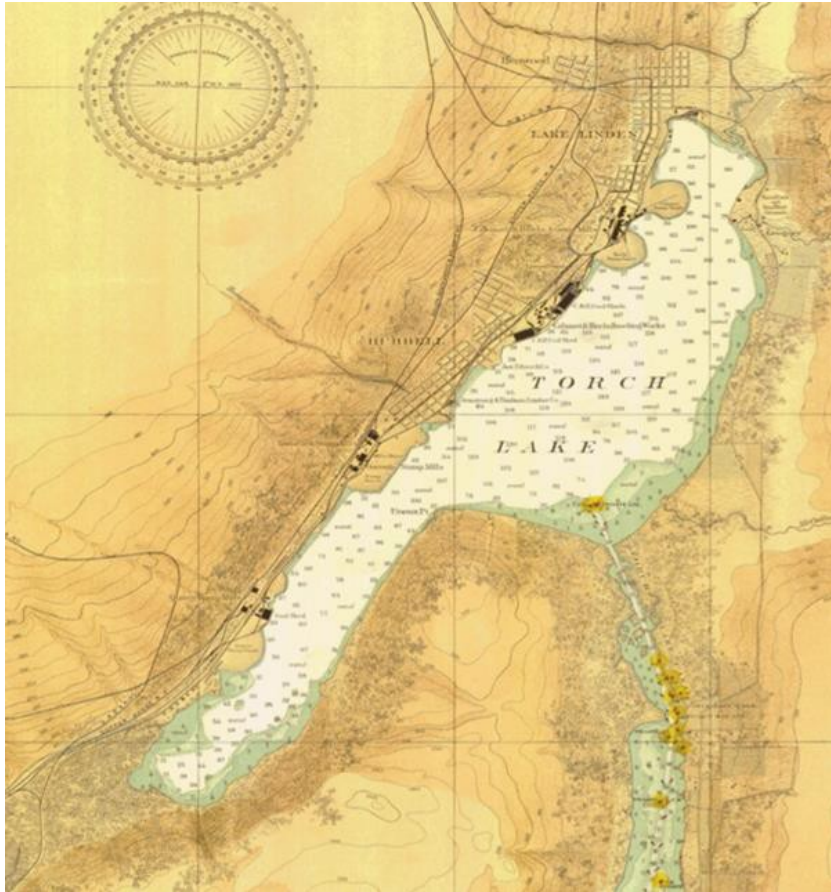
Figure 3-3. Torch Lake Map – 1924 ([U.S.War-Dept-Corps-of-Engineers, 1924](#)).

The earliest signs of environmental change in Torch Lake and its surrounding landscape were the growing volume of stamp sands (tailings) along the western edge of the lakeshore by the late 1800s. Illustrated by the four maps below (Figures 3-2 through 3-5), Torch Lake absorbed approximately one-half of its volume with the coarse sands from the eight mills that lined the waterfront from Lake Linden south to Mason.⁵

⁵ The amount of stamp sand deposited into Torch Lake has been reported to be as small as 20% of the volume of the lake to as high as 50% according to various EPA and AOC documents. The accurate amount is closer to 50%. This was confirmed by a bathymetric survey completed in 1990 which was then compared to the survey in 1865 before stamp sand waste deposits commenced (U.S.EPA, 1992e).

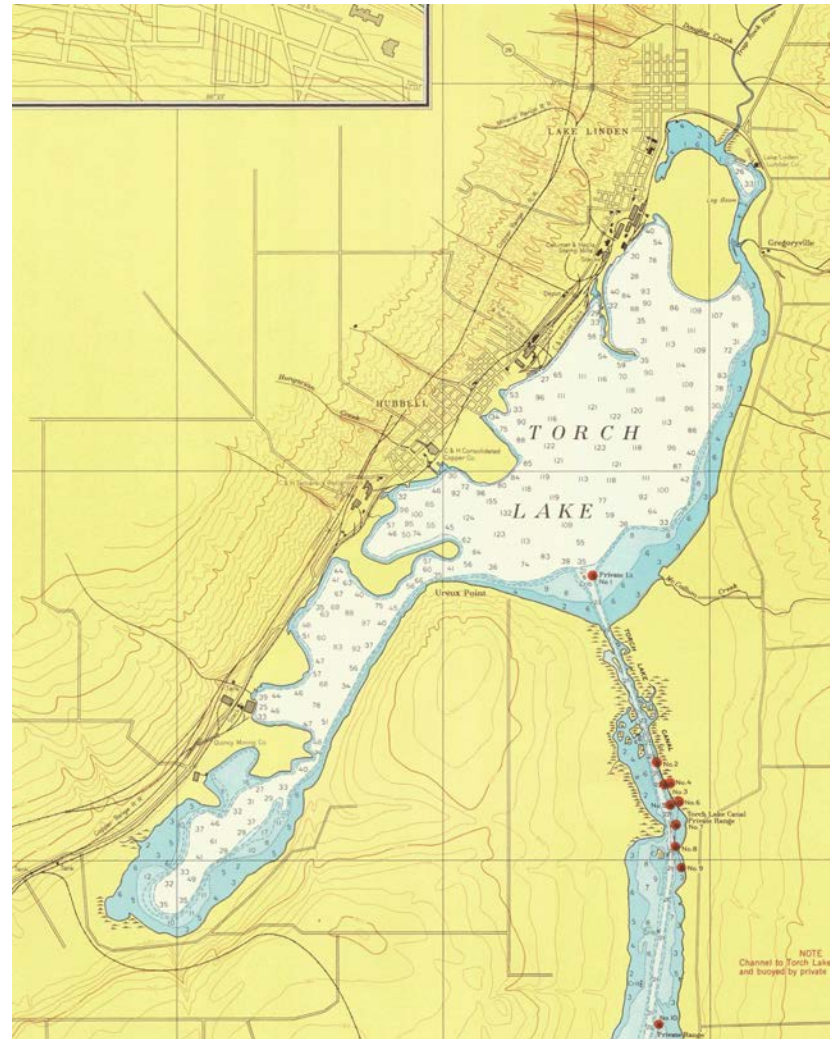
Figure 3-4. Torch Lake Map – 1948 ([USArmy-Corps-of-Engineers, 1948](#)).

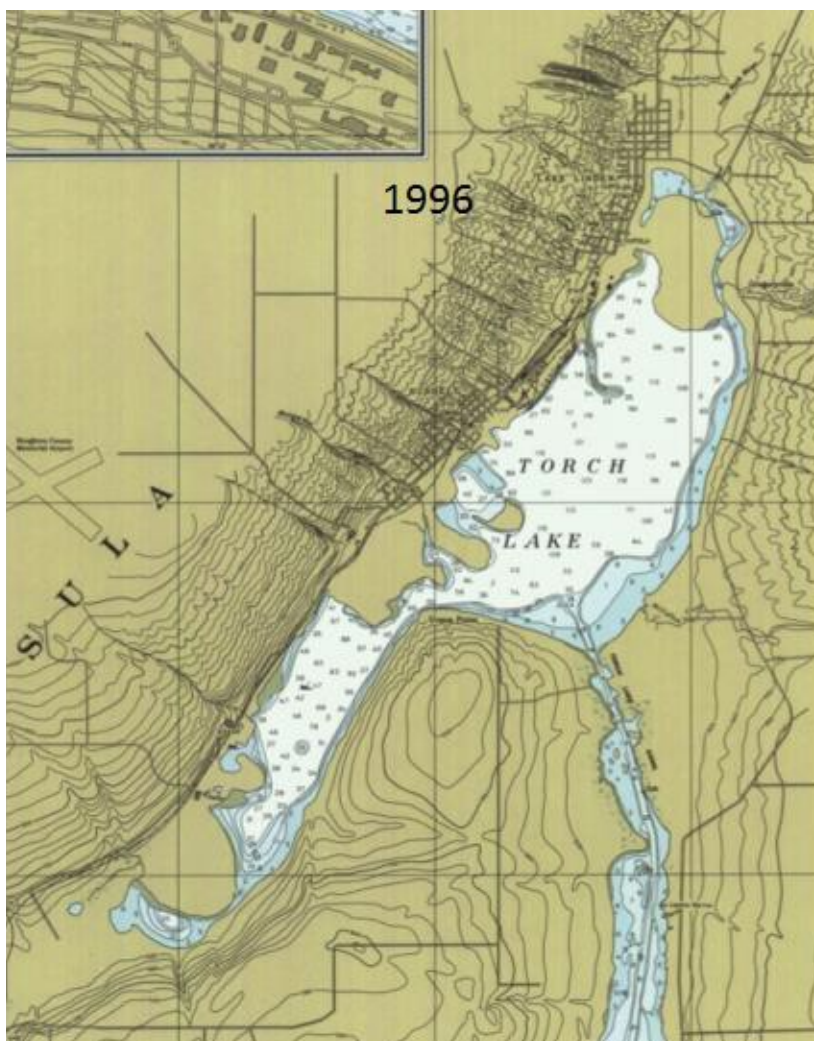
Figure 3-5. Torch Lake Map – 1996 ([NOAA, 1996](#)).

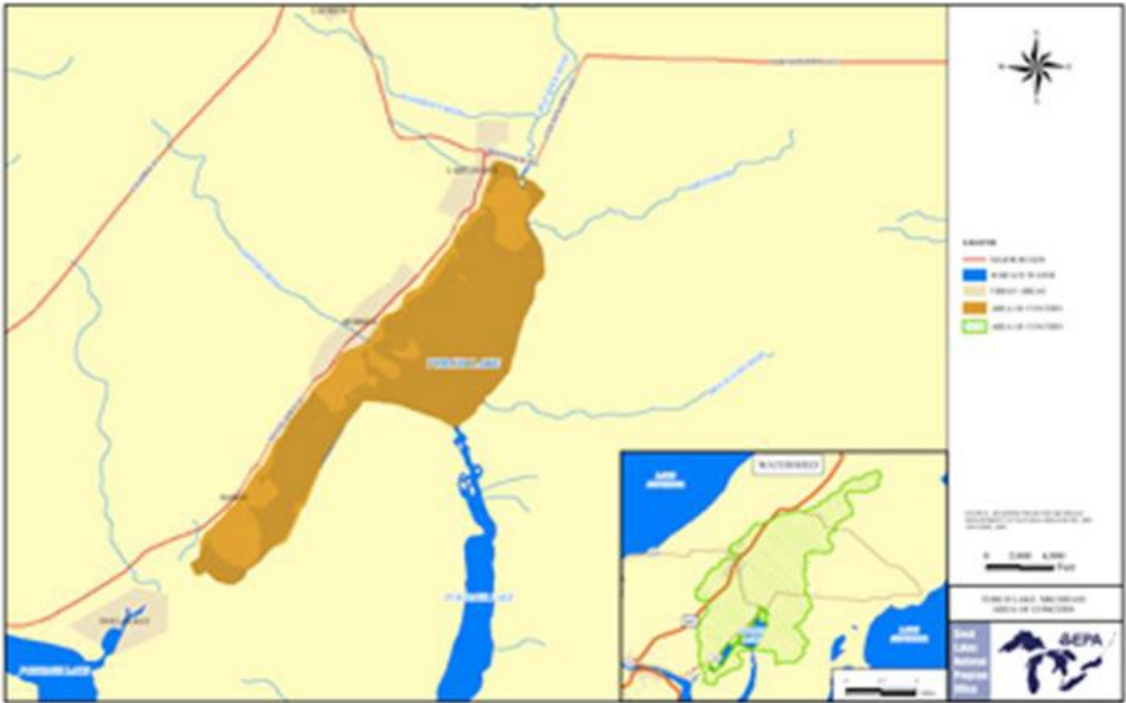
Figure 3-6. Torch Lake Area of Concern. (http://www.epa.gov/glnpo/aoc/torchlake/images/TorchLake_Final_State_Approved.jpg)

The critical variable for listing a contaminated site under the status of an Area of Concern (AOC) is the concept of “beneficial use impairment” or BUI in aquatic environments. Thus, as illustrated in Figure 3-6, the Torch Lake AOC is confined to the lake itself. It does not include the industrial shoreline along the western edge of the lake, which during the mining era (1860s to 1970) generated the contaminants and that were likely causes of the impairments in Torch Lake. An AOC is defined as a geographical area where impairment of beneficial uses has occurred as a result of human activities at the local level ([U.S.EPA, 2018](#)).

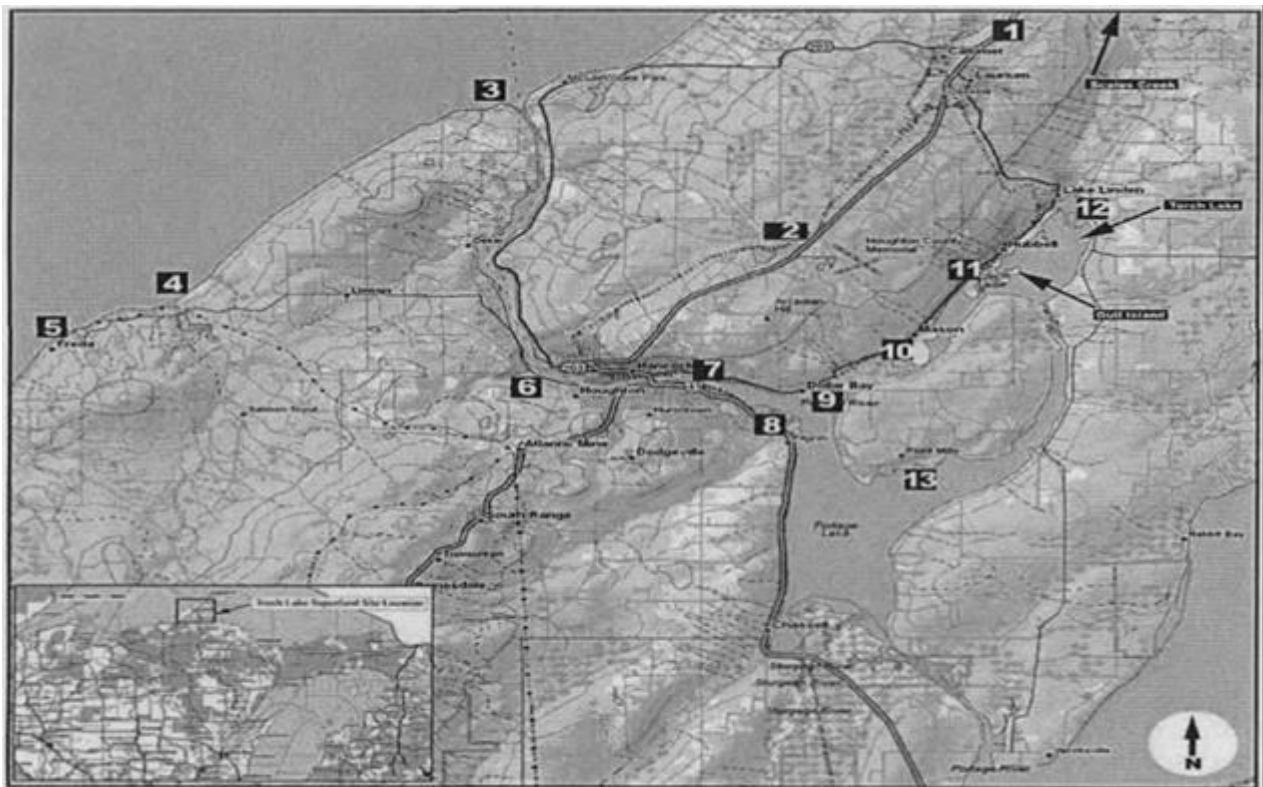
Figure 3-7. EPA Torch Lake Superfund Site. Map showing 13 of 14 Sites on NPL. (From p. 58 of EPA 3rd Five Year Review, 2013. Site No. 14 (Scales Creek) is not shown on this map.)

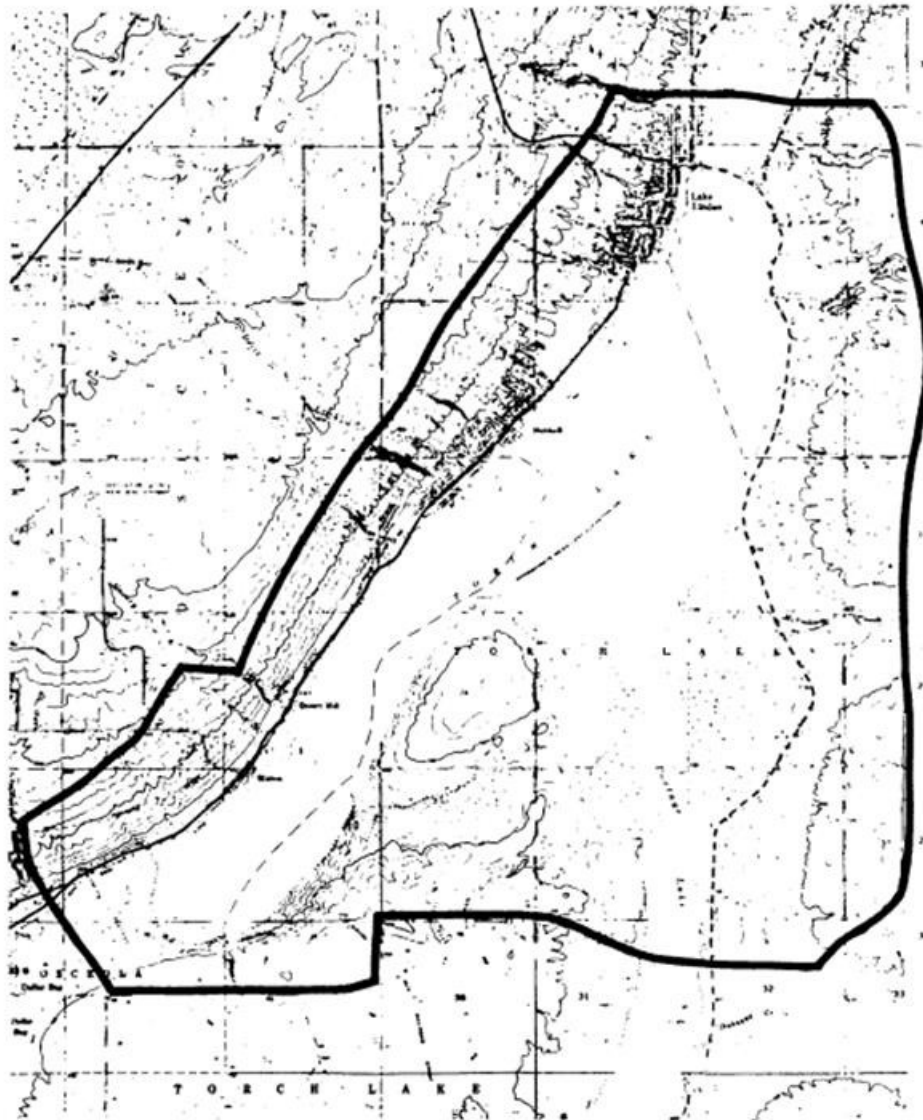
Figure 3-8. Primary Study Area (1989). Source: Donohue & Assoc. Inc. Final RI/FS Work Plan, Vol. 1A (June 1989).

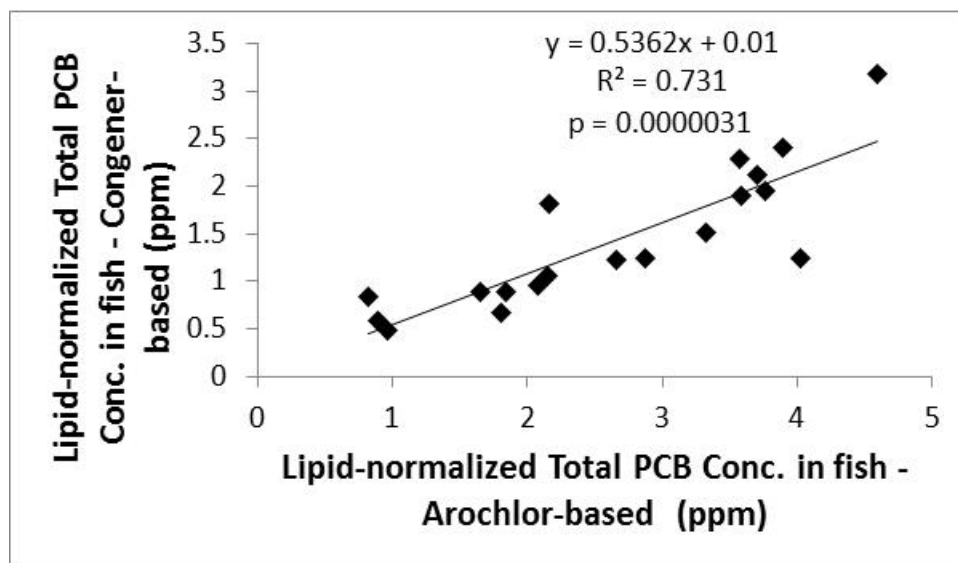
Figure 7-1. Comparison of total PCB concentrations in fish as measured by congener-specific and Arochlor-based methods. Data are for Keweenaw Bay lake trout collected in 1996 and 1999 by the MDEQ Fish Contaminant Monitoring Program. Data are available online at: http://www.michigan.gov/deq/0,4561,7-135-3313_3686_3728-12600--,00.html

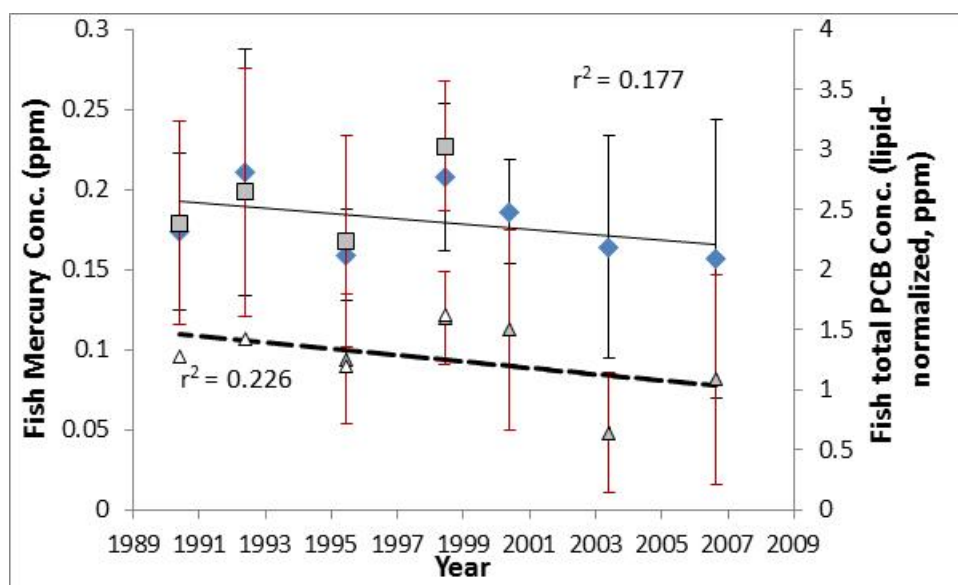
Figure 7-2. Historical trends in PCB and Hg concentrations in whole lake trout from Keweenaw Bay. Data are taken from the MDEQ Fish Contaminant Monitoring Program. Solid diamonds are fish Hg concentrations, and all other symbols represent total PCB concentrations. The squares are total-PCB concentrations calculated from analysis of aroclors, and triangles are based on analysis of individual congeners. Hollow triangles are total-PCB concentrations calculated from aroclor concentrations but adjusted for the difference between congener-based and aroclor-based estimates. The trends are not statistically significant ($p > 0.05$).

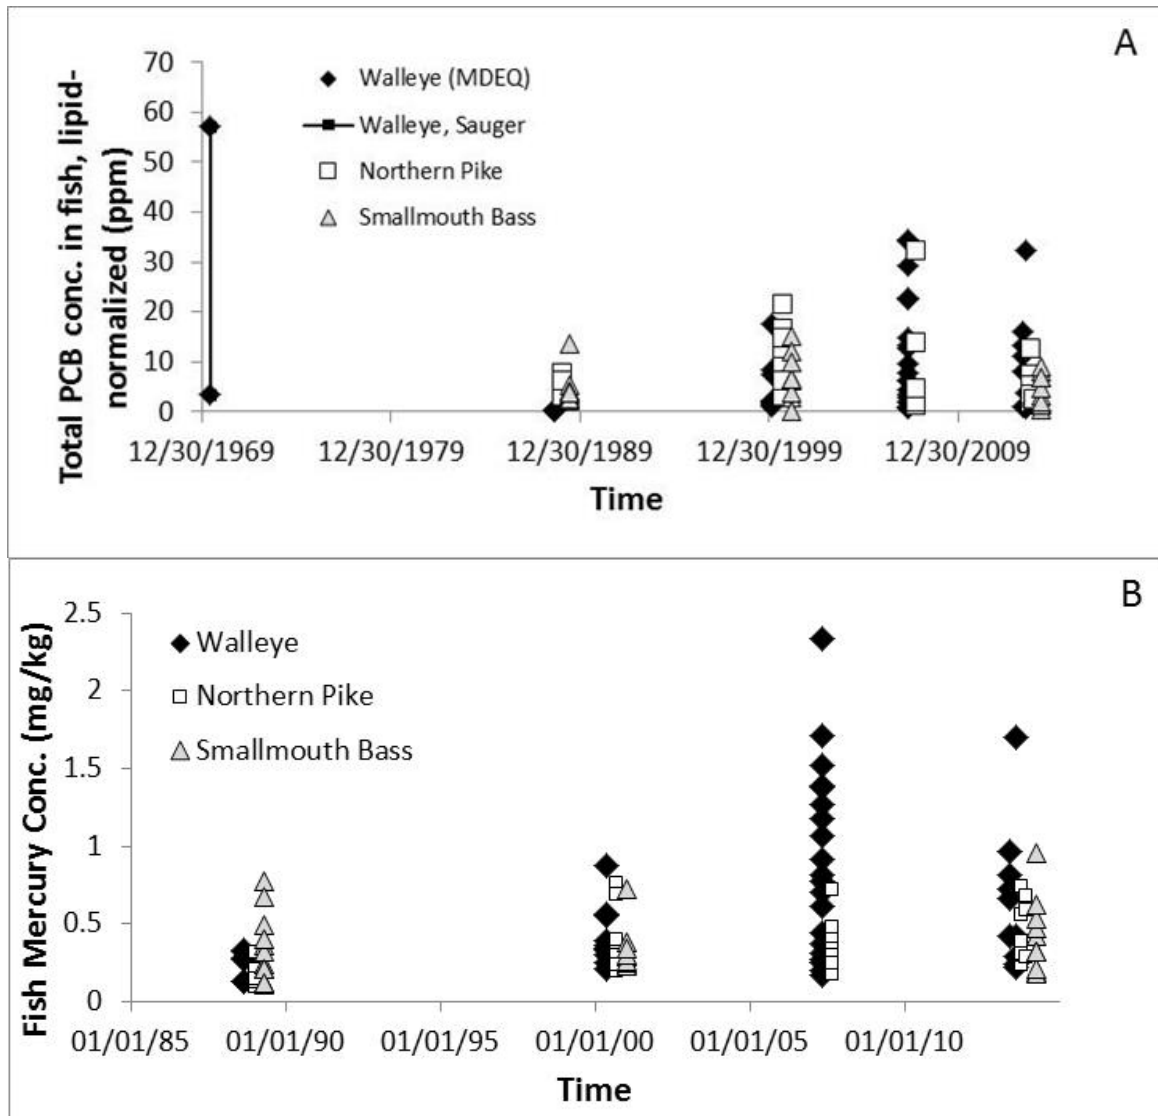
Figure 7-3. Trends in fish concentrations of total PCBs (A) and mercury (B) in Torch Lake. Data are from the MDEQ Fish Contaminant Monitoring Program. PCB concentrations are lipid normalized to eliminate noise from varying lipid content. Pre-2000 PCB concentrations are adjusted for the analytical artifact as shown in Fig. 7-1. Each symbol represents a single fish; size and gender vary among fish. The x-axis (time) scale is different among the two plots.

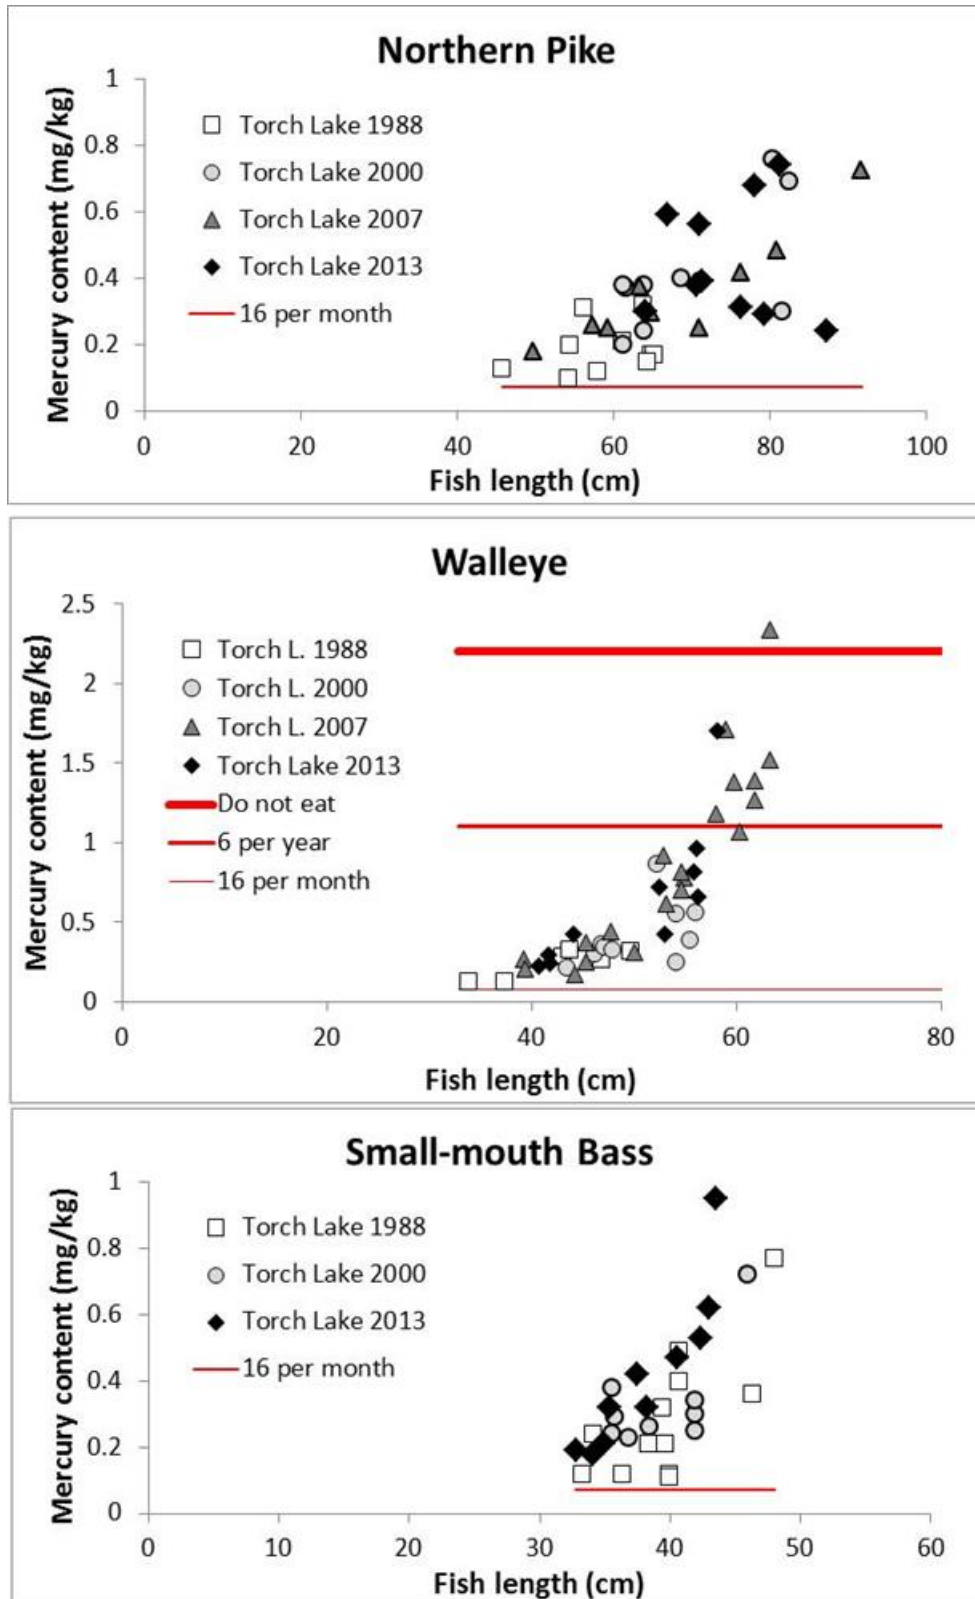
Figure 7-4. Trends with time and fish size in fish mercury content in Torch Lake. Red lines indicate fish consumption trigger levels established by MDCH. All mercury data from the Michigan Fish Contaminant Monitoring Program.

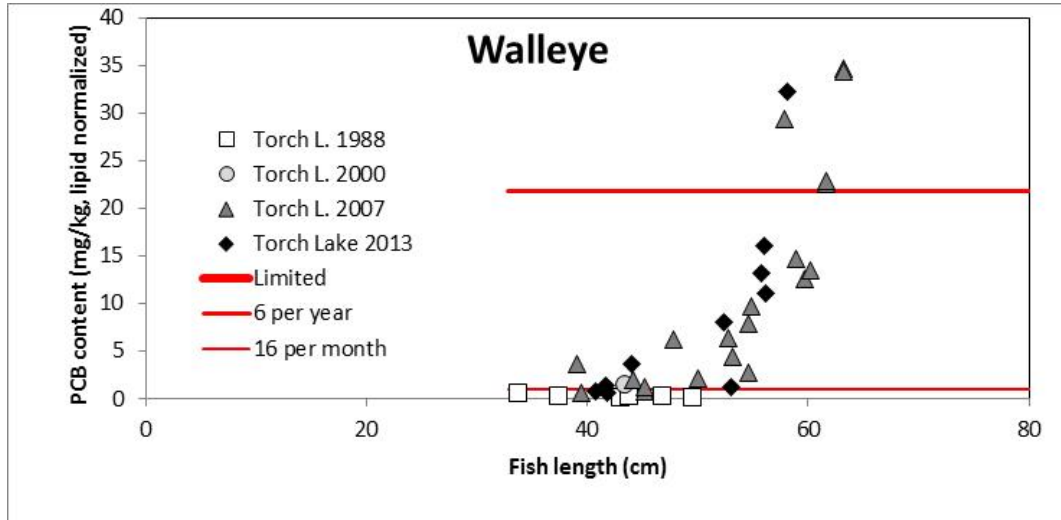
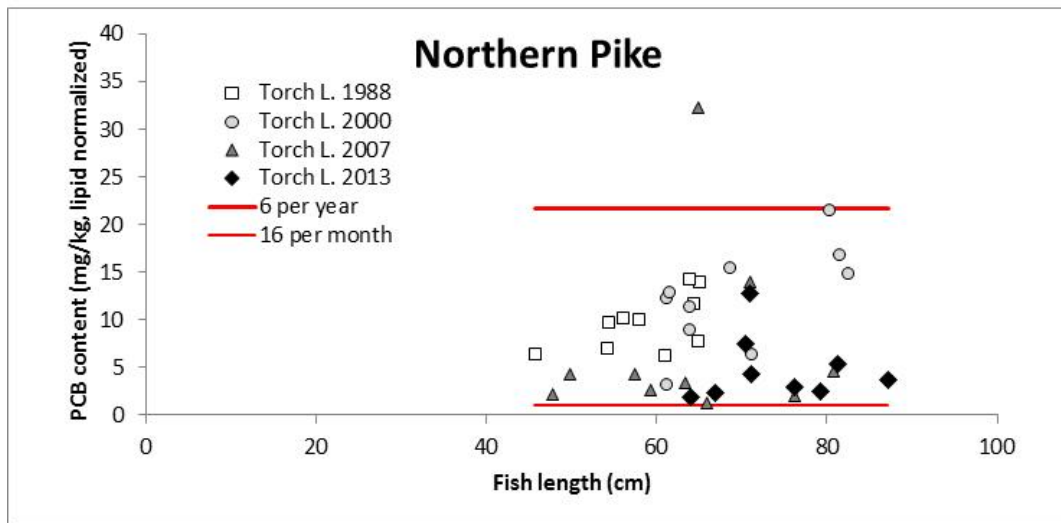
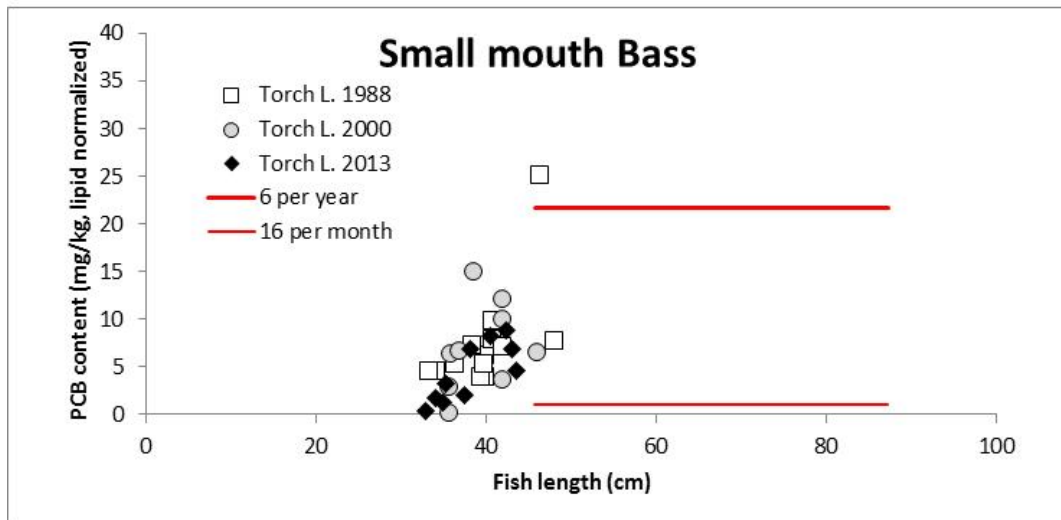
Figure 7-5. Trends with time and fish size in fish PCB content in Torch Lake. Red lines indicate fish consumption trigger levels established by MDCH. All mercury data from the Michigan Fish Contaminant Monitoring Program.

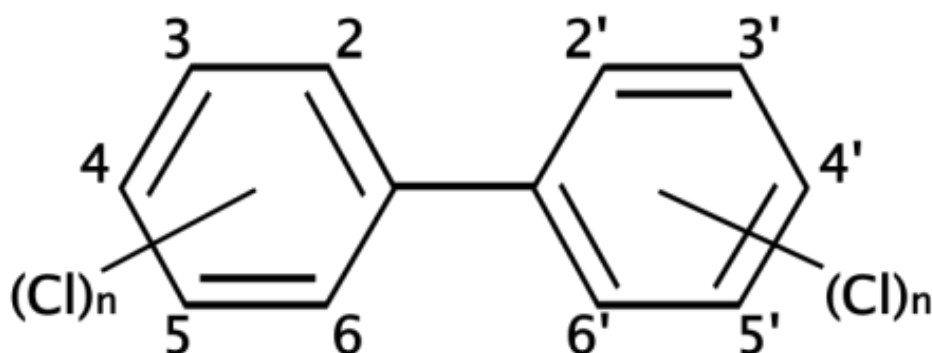
Figure 7-6. Generalized chemical structure of PCB molecule. Two phenyl rings are joined by a single bond. Chlorine atoms may occur at any of the 10 positions labeled 2 to 6 and 2' to 6'.

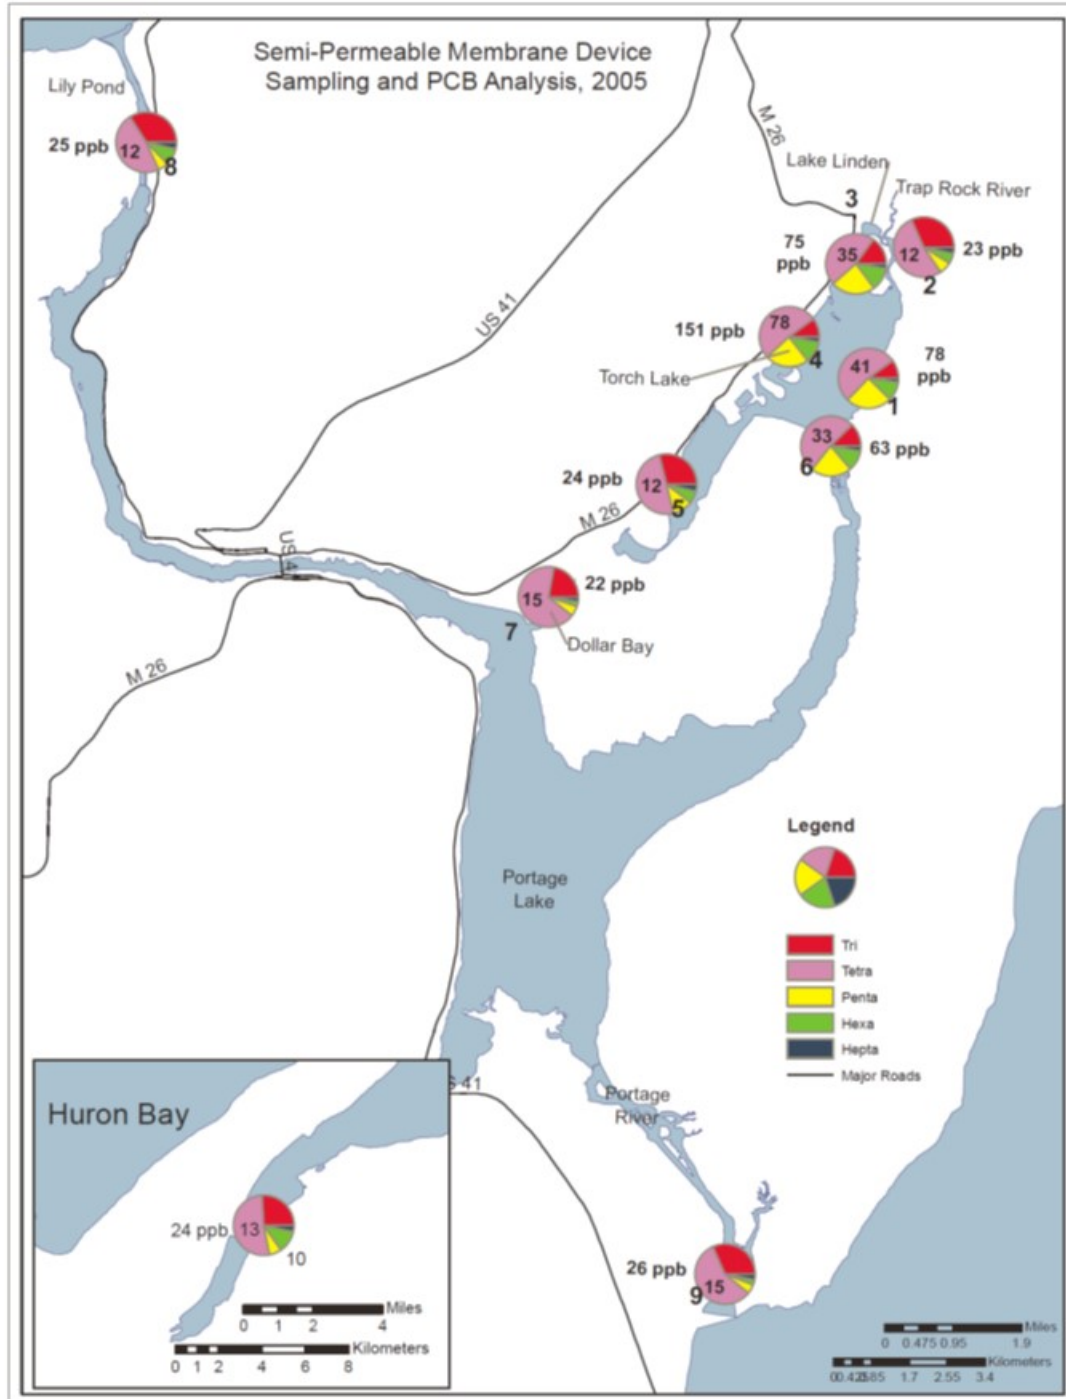
Figure 7-7. Relative abundance of PCB homologs in SPMD devices within Torch Lake and nearby control lakes. The values 1-10 outside the pie charts are site designations. The total PCB concentration (ppb) in the solvent extract from the SPMDs is given alongside each pie chart as well. The concentration of the dominant homolog (tetrachlorinated biphenyls) is given within each pie chart.

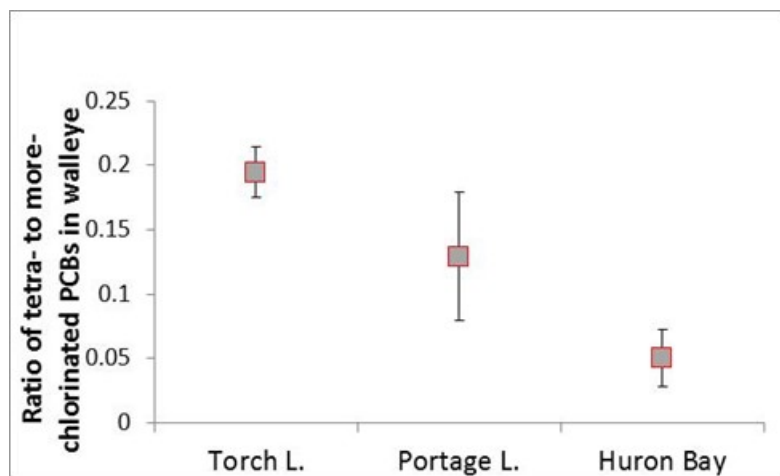
Figure 7-8. Ratios of concentrations of tetrachlorinated biphenyls to (hexa- + hepta- + octa-chlorinated) biphenyls in walleye fillets. Data are taken from the MDEQ Fish Contaminant Monitoring Program results for 2006 and 2007 fish collections. Fish were of comparable size and lipid content in all locations, and ratios were not correlated with fish size. The number of fish ranged from 20 in Torch Lake to 10 in Portage Lake to 16 in Huron Bay.

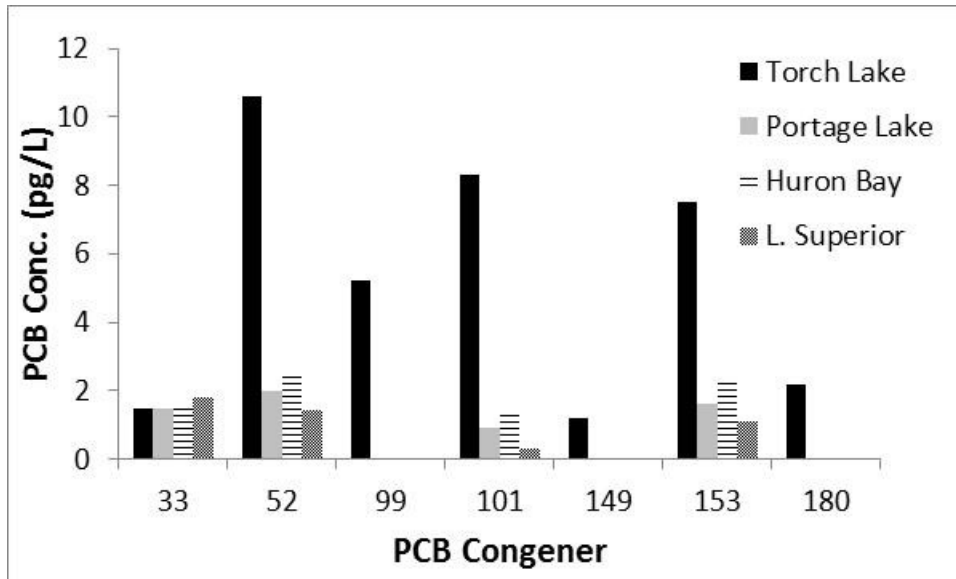
Figure 7-9. Comparison of PCB concentrations in Torch Lake water with those measured in control sites. Shown are concentrations for 7 selected congeners. Concentrations shown for Torch Lake, Portage Lake and Huron Bay were measured with SPMDs. The Lake Superior value is taken from the Great Lakes Aquatic Contaminants Survey (2005).

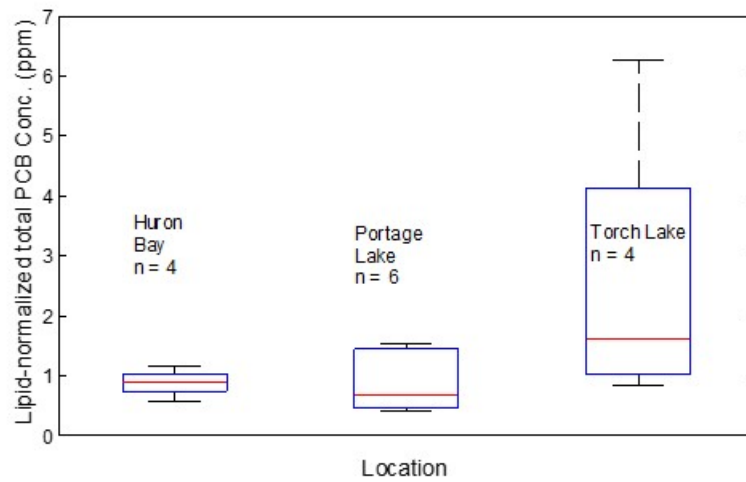
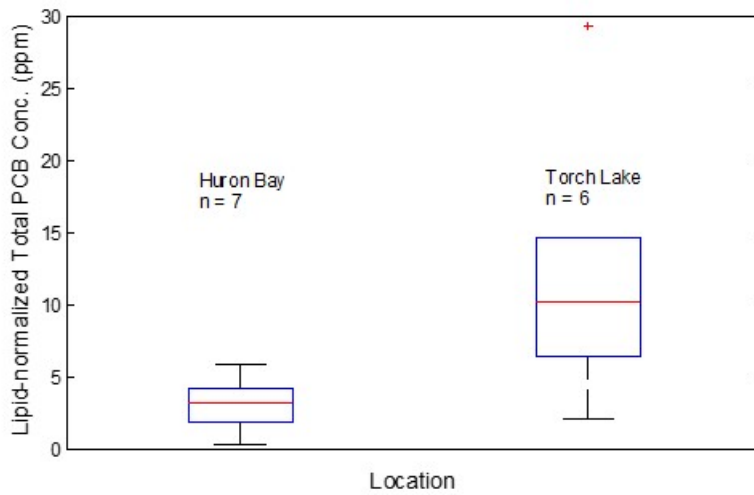
Figure 7-10. Comparison of fish PCB concentrations in Torch Lake and control sites. Upper figure compares male walleyes of length 40-50 cm caught in 2006 and 2007 (means are: Torch Lake 2.57, Portage Lake 0.86, Huron Bay 0.87 ppm). Lower figure compares male walleyes of length 50-60 cm caught in the same years (means are: Torch Lake 12.2, Huron Bay 3.1 ppm). All data are from the Michigan Fish Contaminant Monitoring Program (FCMP).

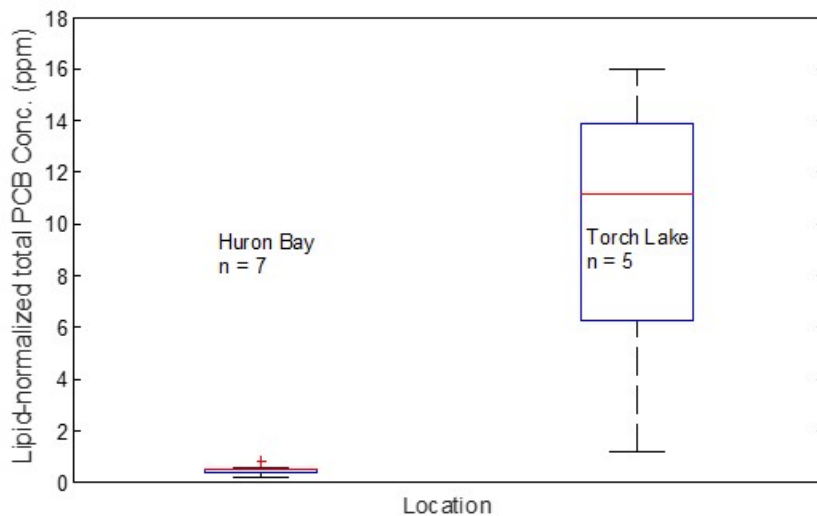
Figure 7-11. Comparison of PCB concentrations in fish caught in 2013. Shown are values for male Walleye between 50 and 60 cm in length. Means are: Torch Lake – 9.9, Huron Bay – 0.48 ppm). Data from Michigan FCMP.
