An Integrated Assessment of Torch Lake Area of Concern

Noel R. Urban, Carol A. MacLennan, Judith A. Perlinger

Michigan Technological University

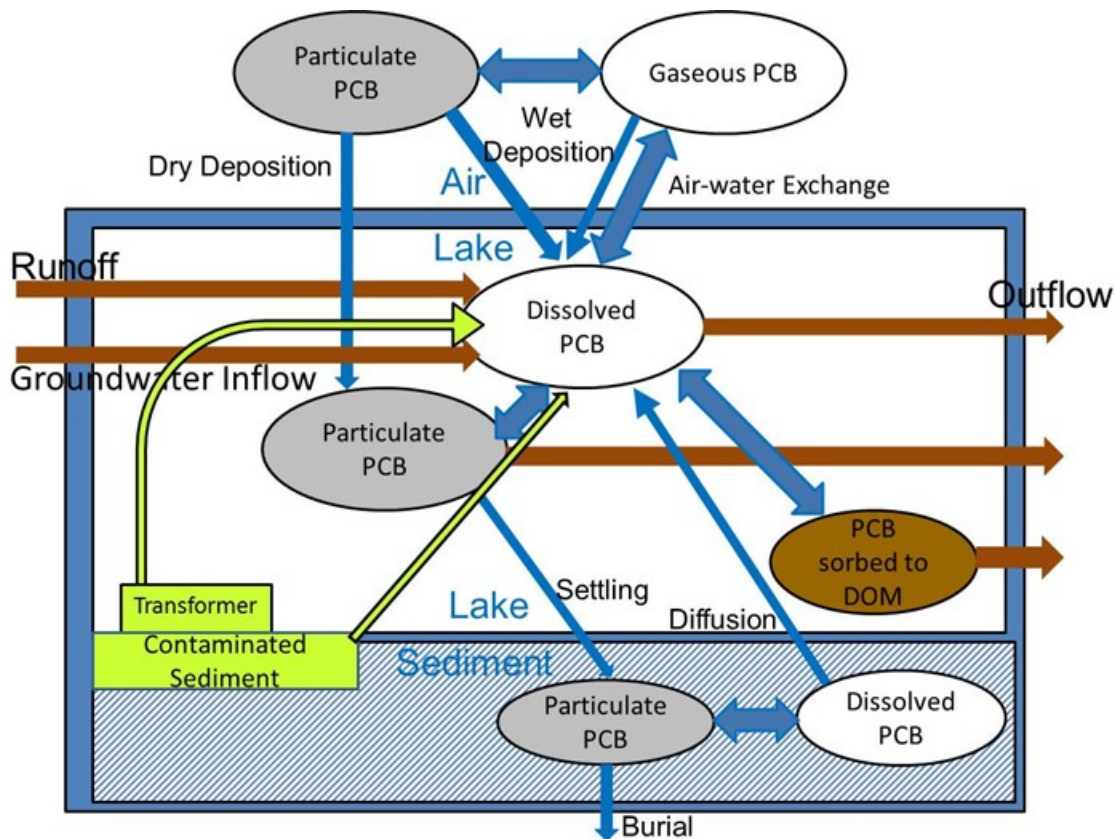
Figure 7-12. Schematic of PCB cycle within Torch Lake. The only features unique to Torch Lake are the presence of contaminated sediments and potentially of concentrated PCB sources such as barrels of waste oil or actual transformers or PCB hotspots in the lake or on its shore.

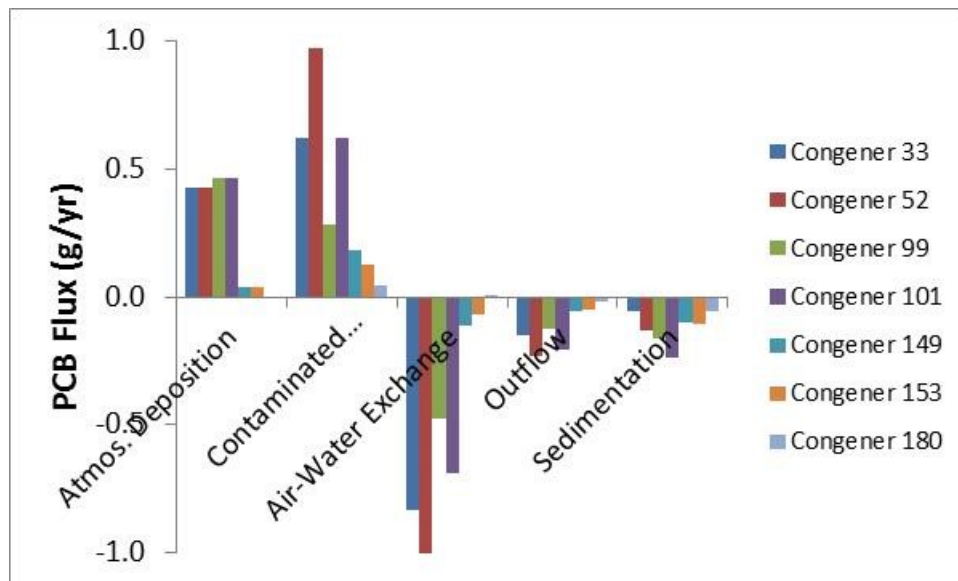
Figure 7-13. Calculated fluxes of PCB congeners into and out of Torch Lake. Positive fluxes are into the lake, negative fluxes are leaving the lake. The second category of fluxes is contaminated sediments.

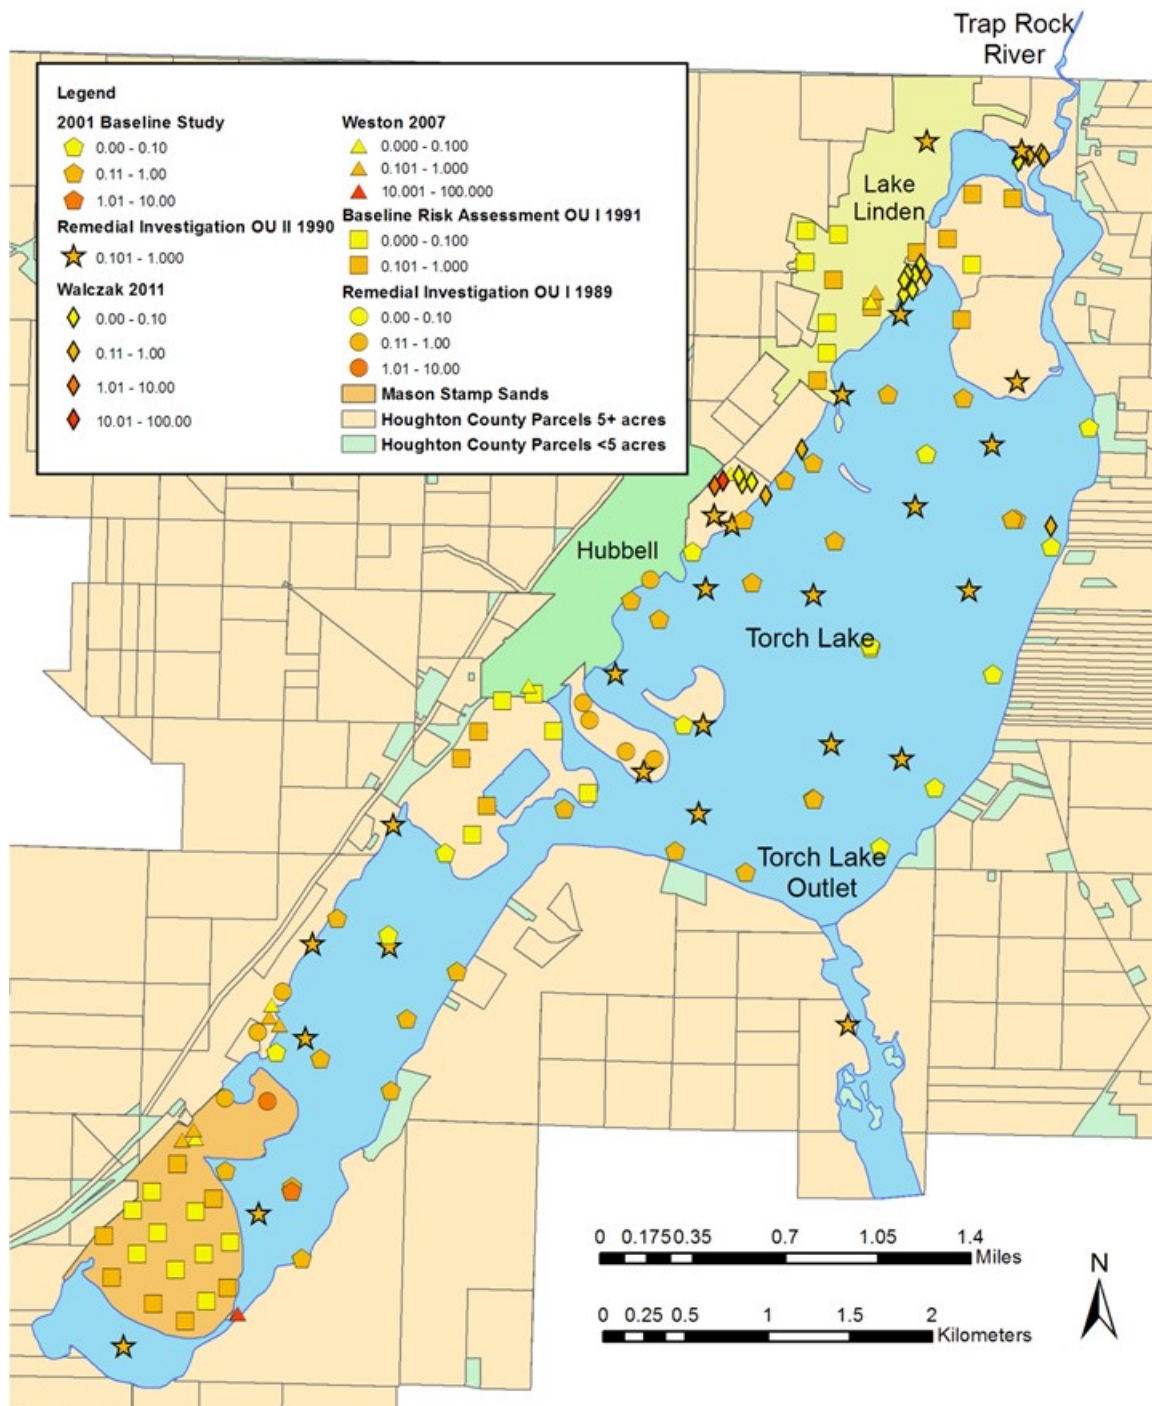
Figure 7-14. Distribution of mercury concentrations in surface sediments of Torch Lake. Data were compiled from EPA and MDEQ reports as summarized in Mandelia (2016). Concentrations are compared to the TEC (0.18) and PEC (1.06) (both in ppm) used by the State of Michigan.

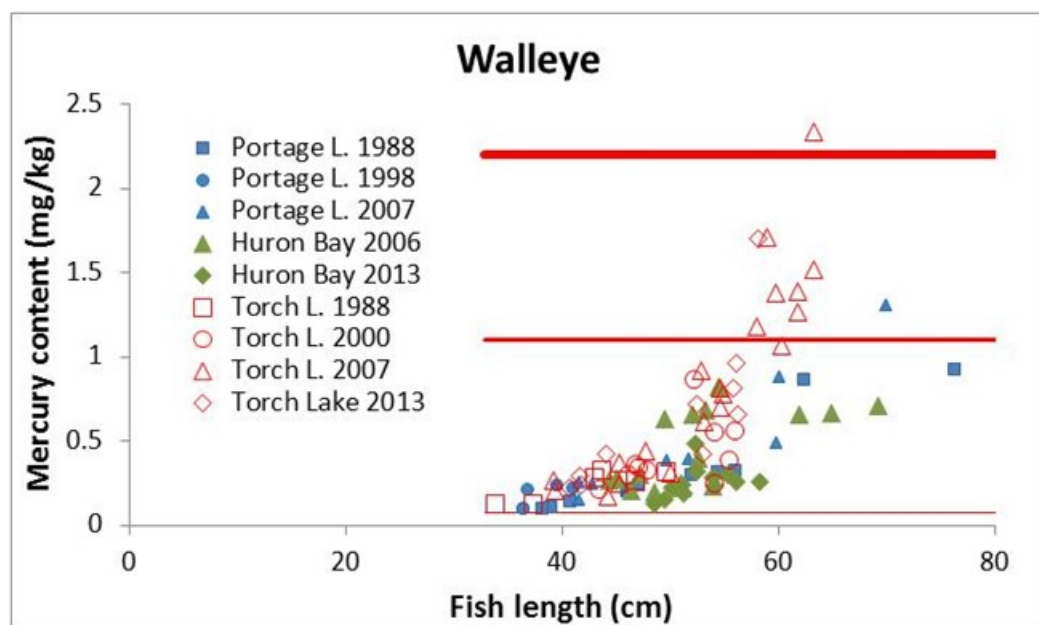
Figure 7-15. Comparison of fish Hg in Torch L. with reference lakes. Large walleye in Torch Lake have higher Hg concentrations than comparably large fish in Portage Lake and Huron Bay.

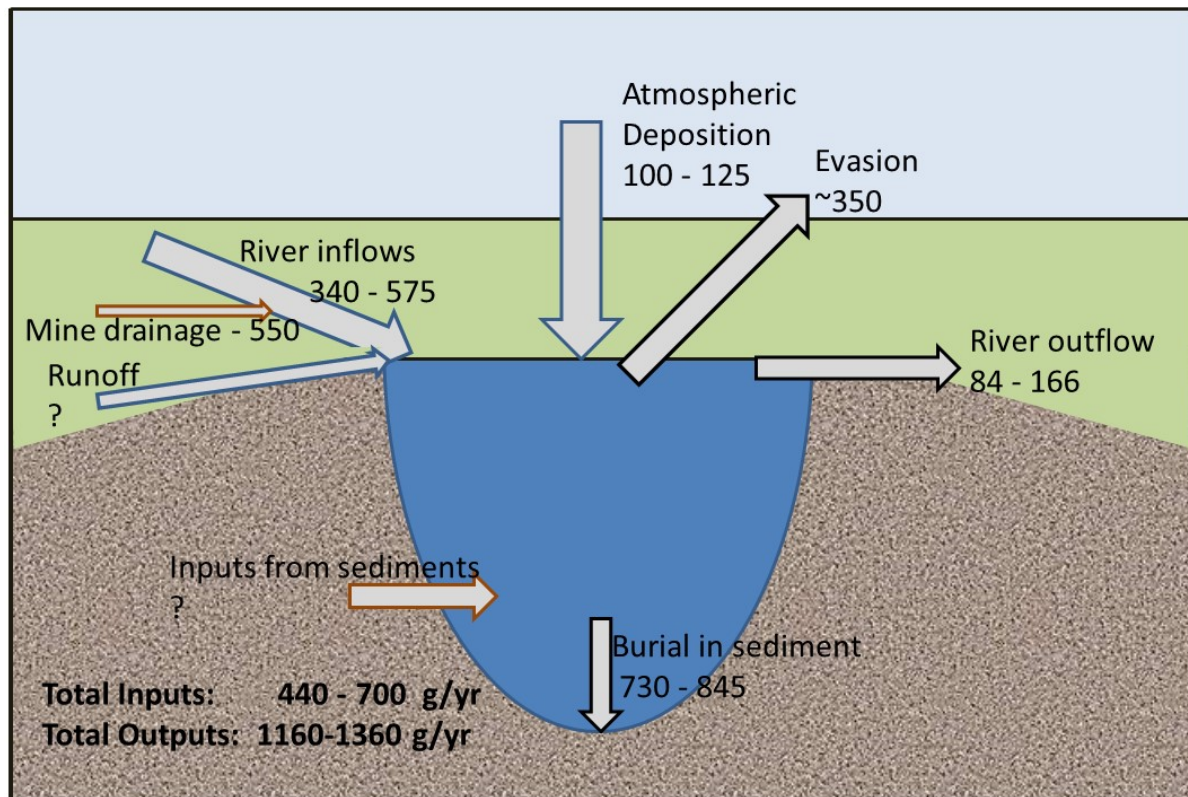
Figure 7-16. Schematic of mercury flows into and out of Torch Lake. All fluxes are in g Hg/yr. Burial fluxes are taken from Kerfoot et al. (2016). Atmospheric deposition to the lake is taken from Drevnick et al. 2012. Mine drainage inputs are from the 2002 survey of mine drainages (Degraeve and McCauley, 2003). River inflows are estimated as a fraction (25%) of annual atmospheric deposition to the catchment or as measured concentration times measured flow. Outflow was calculated as measured concentration range (Degraeve and McCauley, 2003) times lake outflow, and evasion was estimated from application of a simulation model of the mercury cycle in the lake.

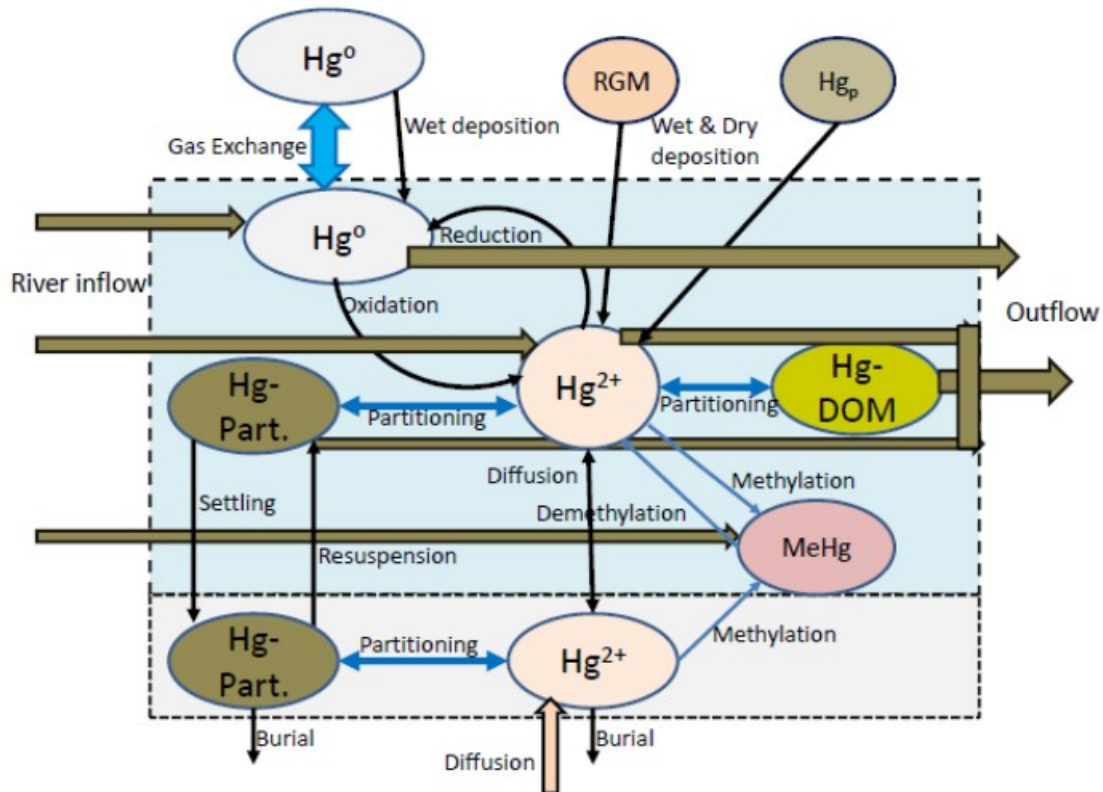
Figure 7-17. Schematic of mercury cycle within a lake. Mercury occurs in two oxidation states (elemental, Hg^0 , and oxidized, Hg^{2+}). In the atmosphere Hg^{2+} exists as reactive gaseous mercury (RGM) or bound on particles (Hg_p). In the lake, Hg^{2+} may bind to particulates (Hg -Part) or to dissolved organic matter (Hg -DOM). The toxic form of concern is methyl mercury (MeHg).

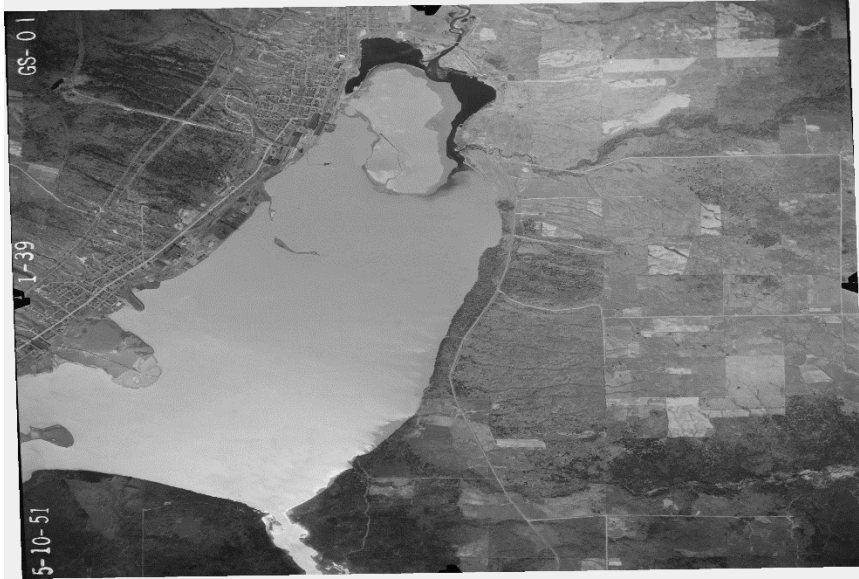
Figure 8-1. Aerial photograph of Torch Lake taken in May 1951. White appearance of the lake results from fine suspended particles throughout the lake. Only water by the inflow of the Traprock River is clear (shown as black in figure).

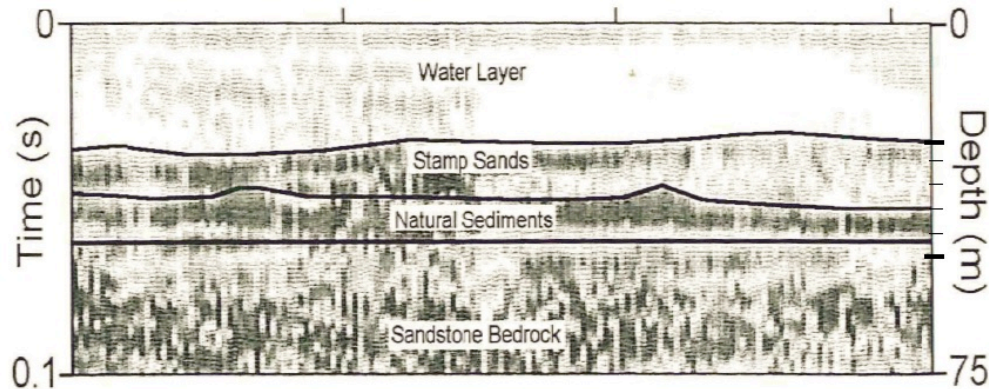
Figure 8-2. Acoustic profile of Torch Lake sediments. Taken from [Trisch and Young \(2005\)](#). Acoustic soundings record the time (left axis) required for sound waves to be reflected back to the transponder. The time of travel of the sound waves corresponds to distance traveled (right axis); sediment layers with different physical properties each cause a reflection. Solid lines have been drawn in the figure to show the inferred divide between water (25-m deep), stamp sands (10-15 m thick), pre-mining sediments (7-15 m thick), and bedrock. The x-axis represents distance across a transect in the lake.

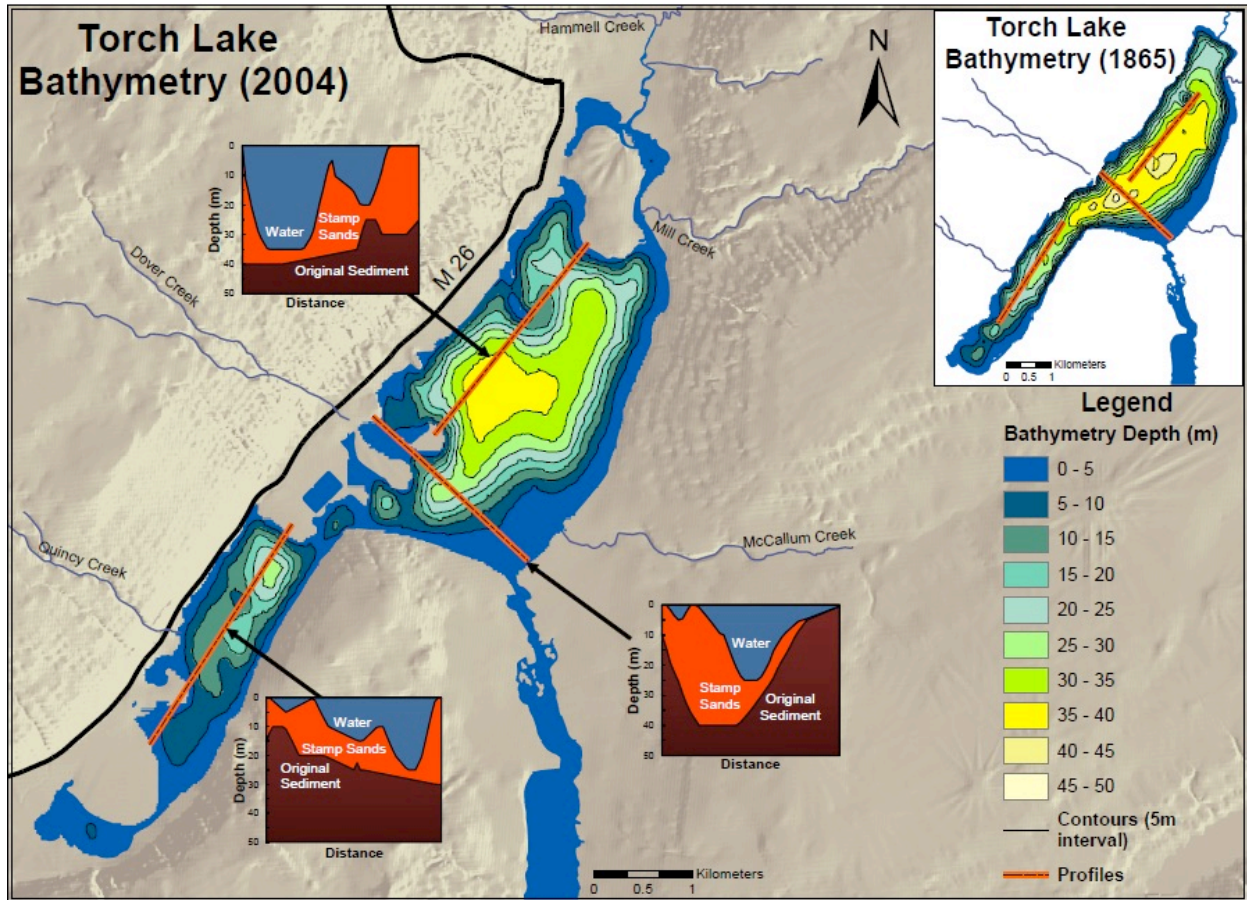
Figure 8-3. Depth of stamp sands in Torch Lake. The original (1865) bathymetry of the lake (inset at upper right) shows a much larger area of deep water than the current (2004) bathymetry indicates. Both bathymetric maps are digitized reproductions of NOAA navigational charts. Comparison of the 1865 and 2004 bathymetries across specific transects of the lake are shown in the small insets; the difference in water depths between the two maps is colored in red and represents the thickness of stamp sand deposits within the lake. The north-south transect in the northern basin indicates that about 5 m of stamp sand underlay the deepest area of the lake. The transect running northwest to southeast indicates that nearly 40 m of stamp sands filled in this formerly deep area of the lake. Subtracting the 2004 lake volume from that in 1865 indicates that 50% of the lake was filled with stamp sands.

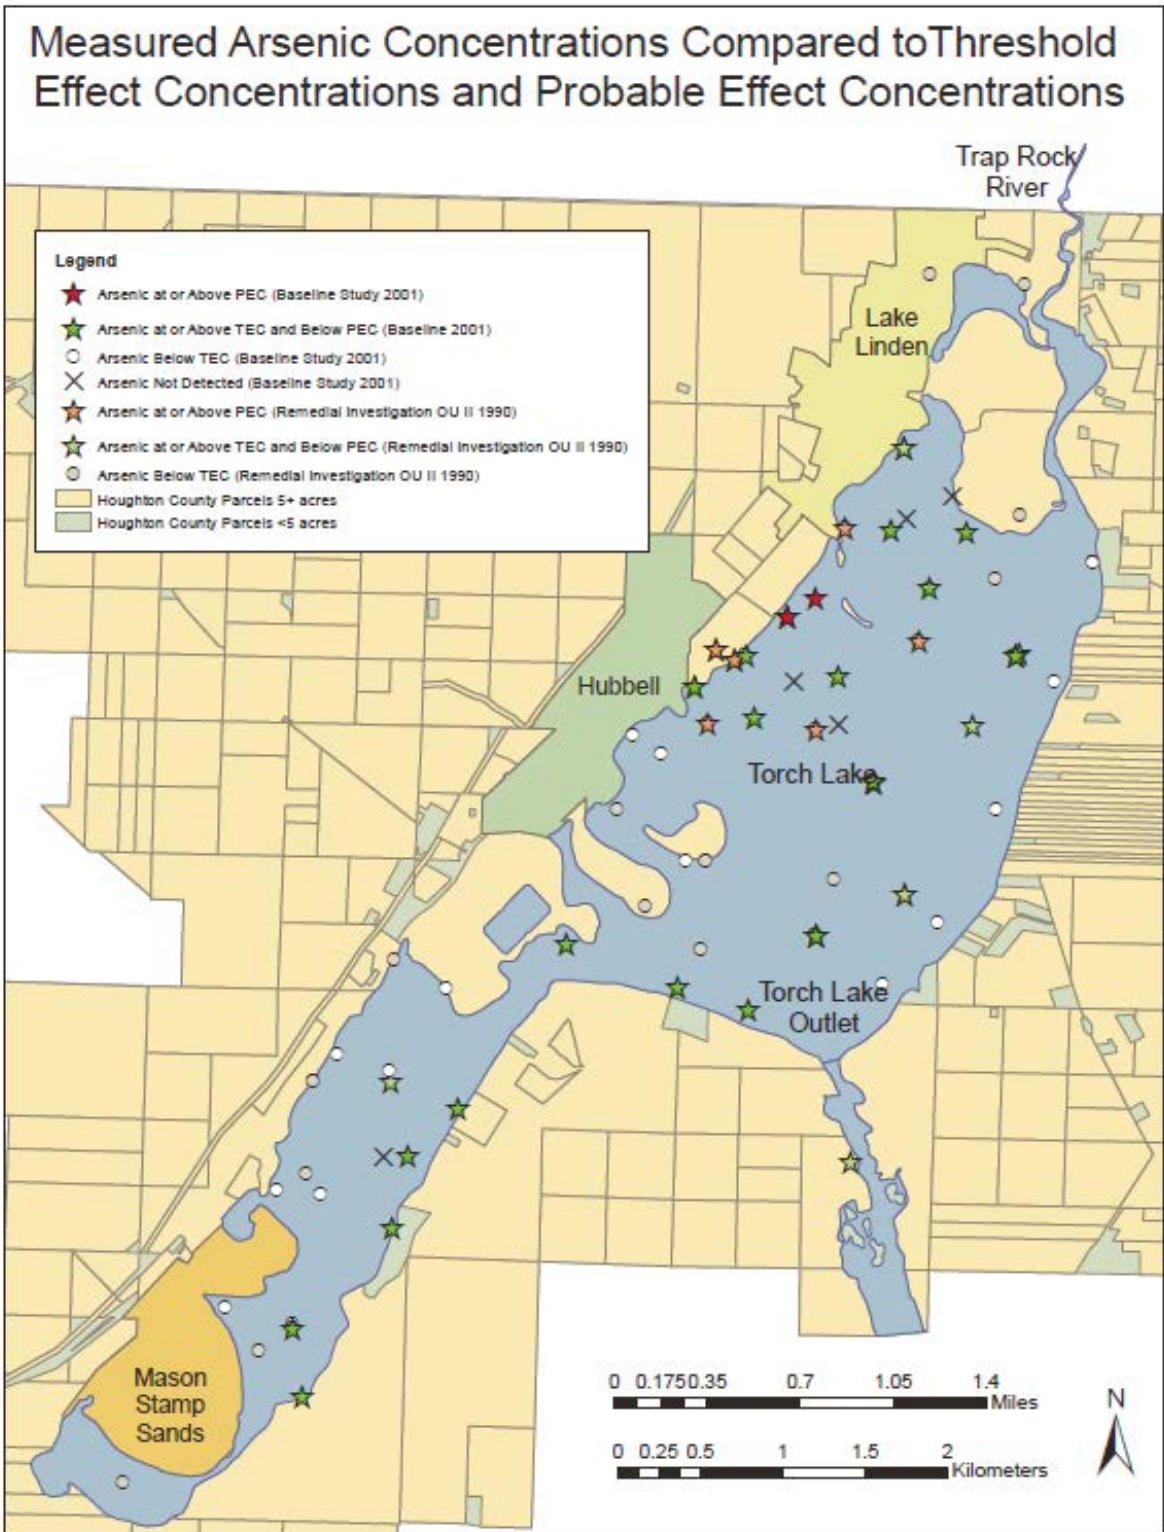
Figure 8-4. Arsenic distribution in Torch Lake sediments. Concentrations are compared to the Probable Effects Concentration or PEC (concentration above which toxic effects are expected to occur frequently) and the Threshold Effects Concentration or TEC (concentration below which toxic effects are expected to occur infrequently). Map reproduced from Mandelia (2016).

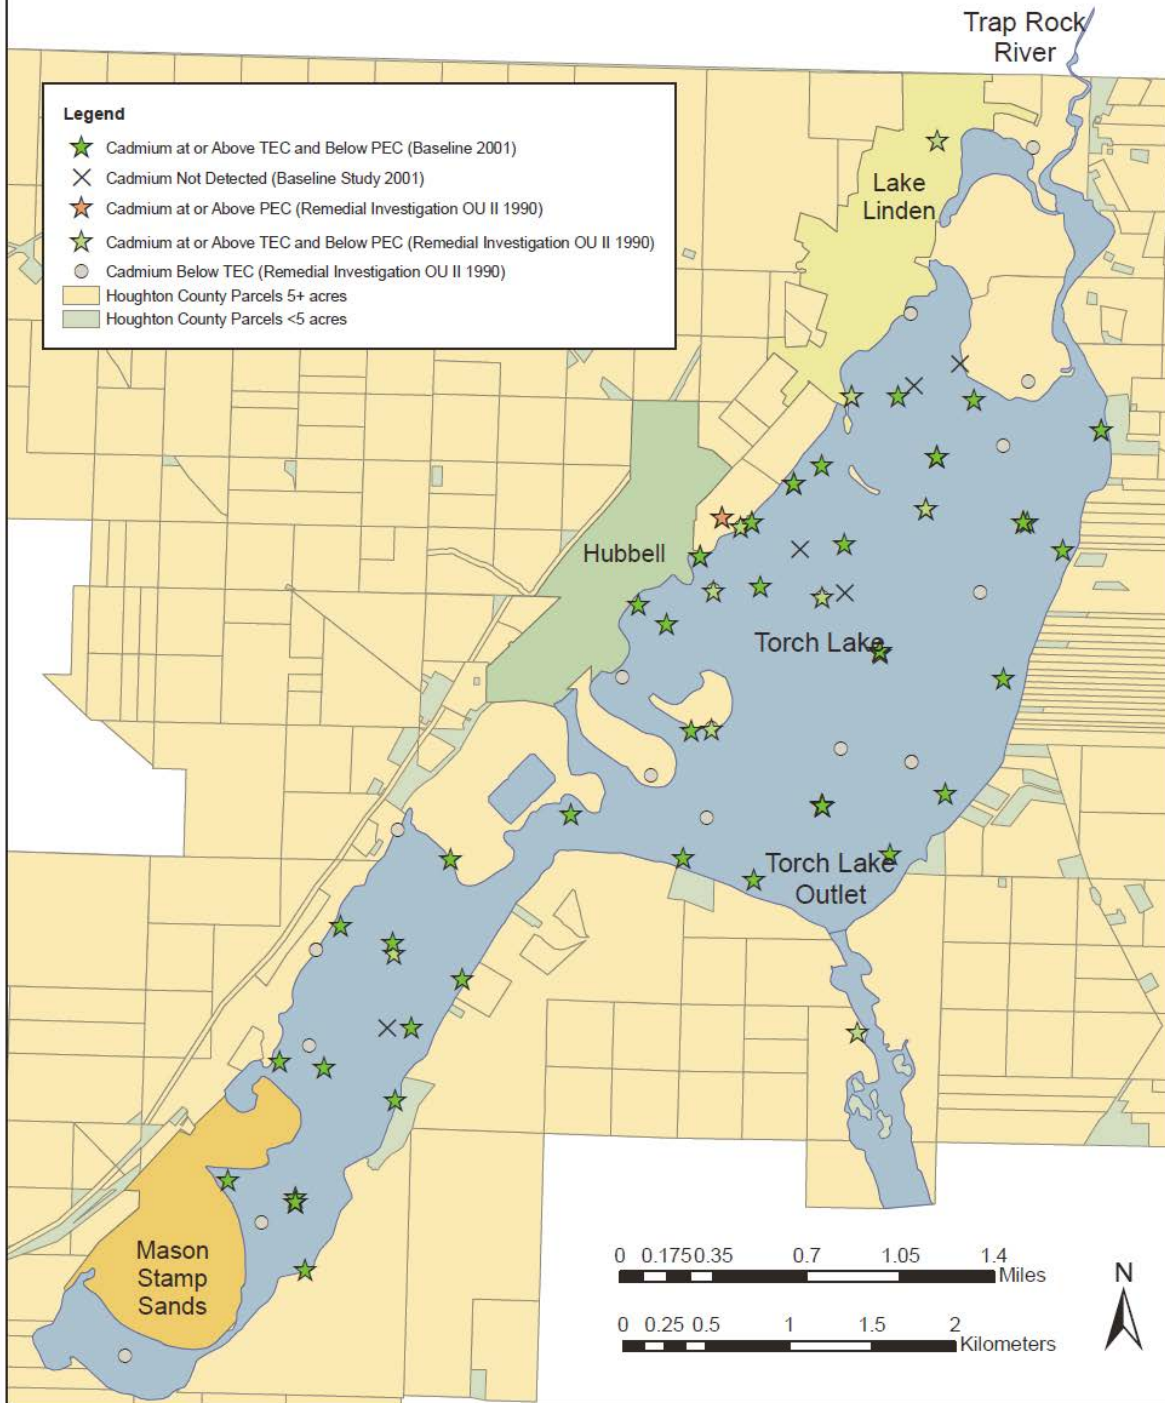
Figure 8-5. Cadmium distribution in Torch Lake sediments. Concentrations are compared to the Probable Effects Concentration or PEC (concentration above which toxic effects are expected to occur frequently) and the Threshold Effects Concentration or TEC (concentration below which toxic effects are expected to occur infrequently). Map reproduced from Mandelia (2016).

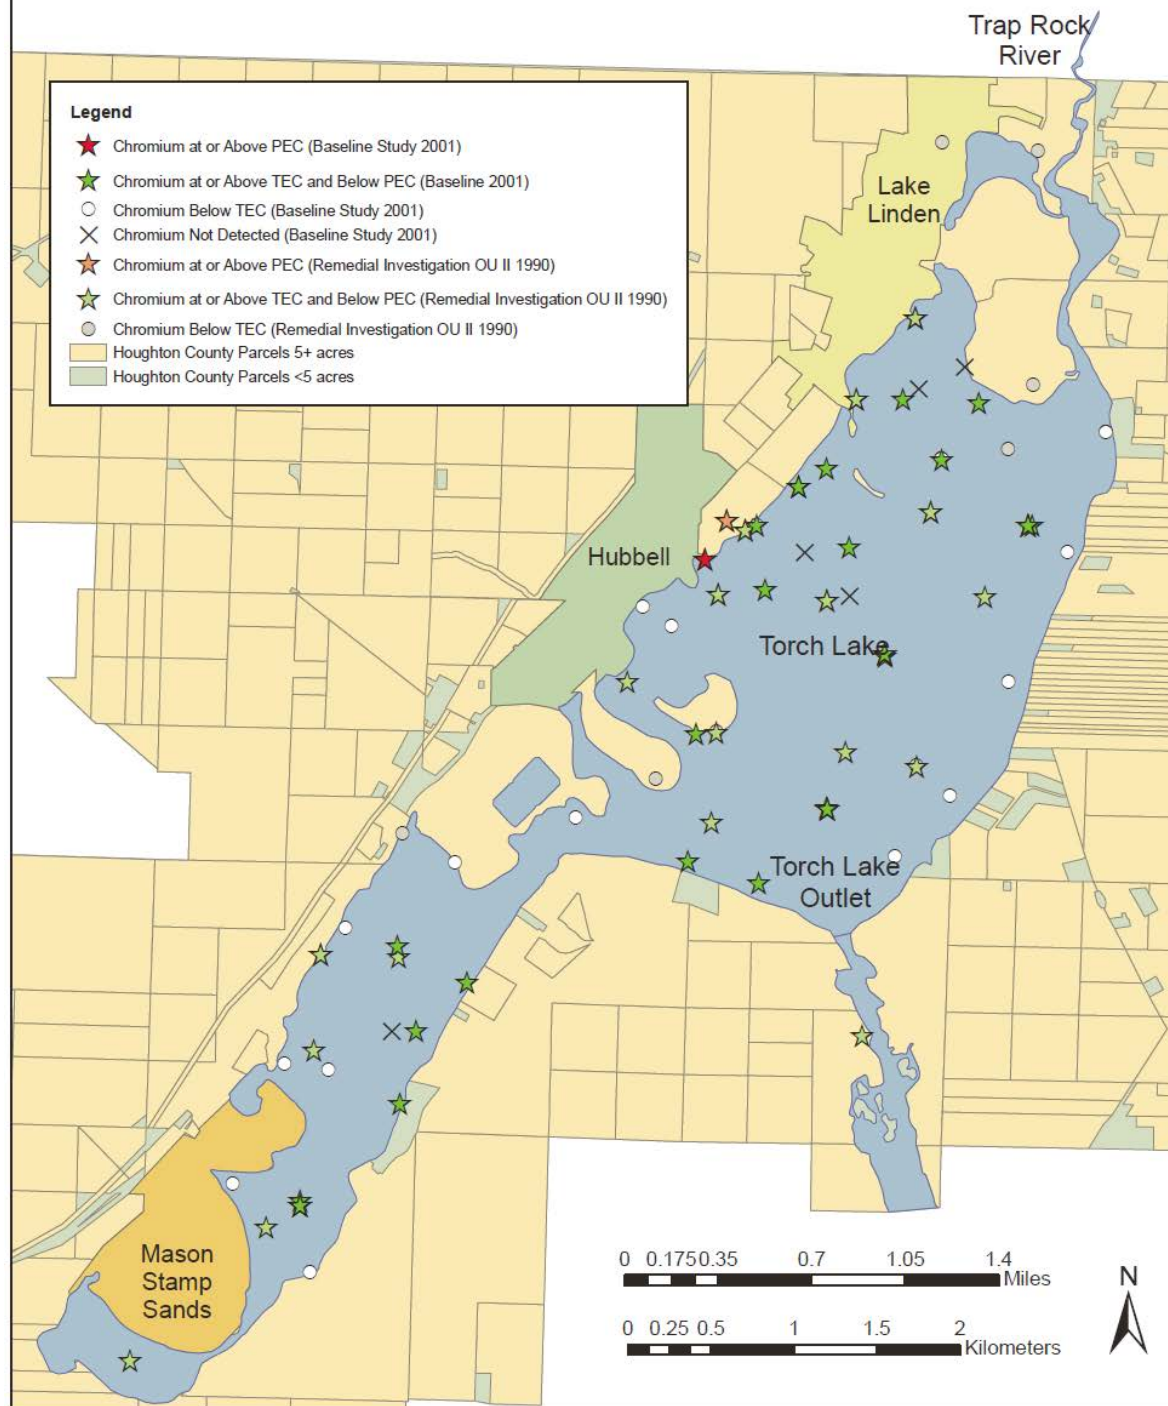
Figure 8-6. Chromium distribution in Torch Lake sediments. Concentrations are compared to the Probable Effects Concentration or PEC (concentration above which toxic effects are expected to occur frequently) and the Threshold Effects Concentration or TEC (concentration below which toxic effects are expected to occur infrequently). Map reproduced from Mandelia (2016).

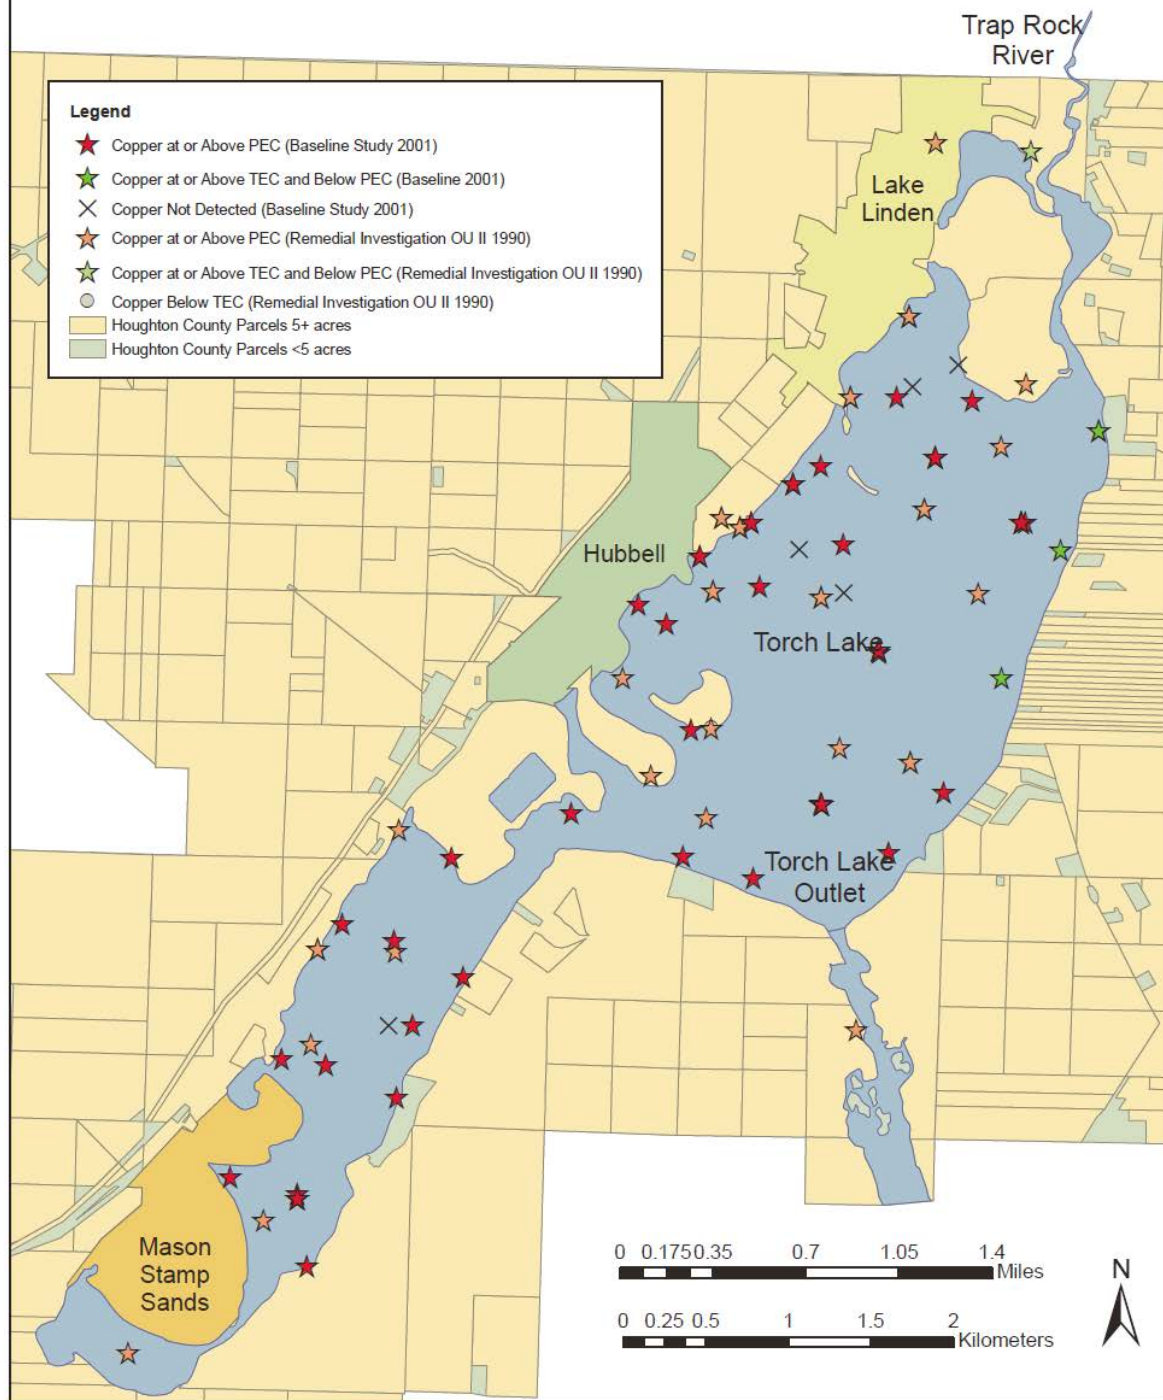
Figure 8-7. Copper distribution in Torch Lake sediments. Concentrations are compared to the Probable Effects Concentration or PEC (concentration above which toxic effects are expected to occur frequently) and the Threshold Effects Concentration or TEC (concentration below which toxic effects are expected to occur infrequently). Map reproduced from Mandelia (2016).

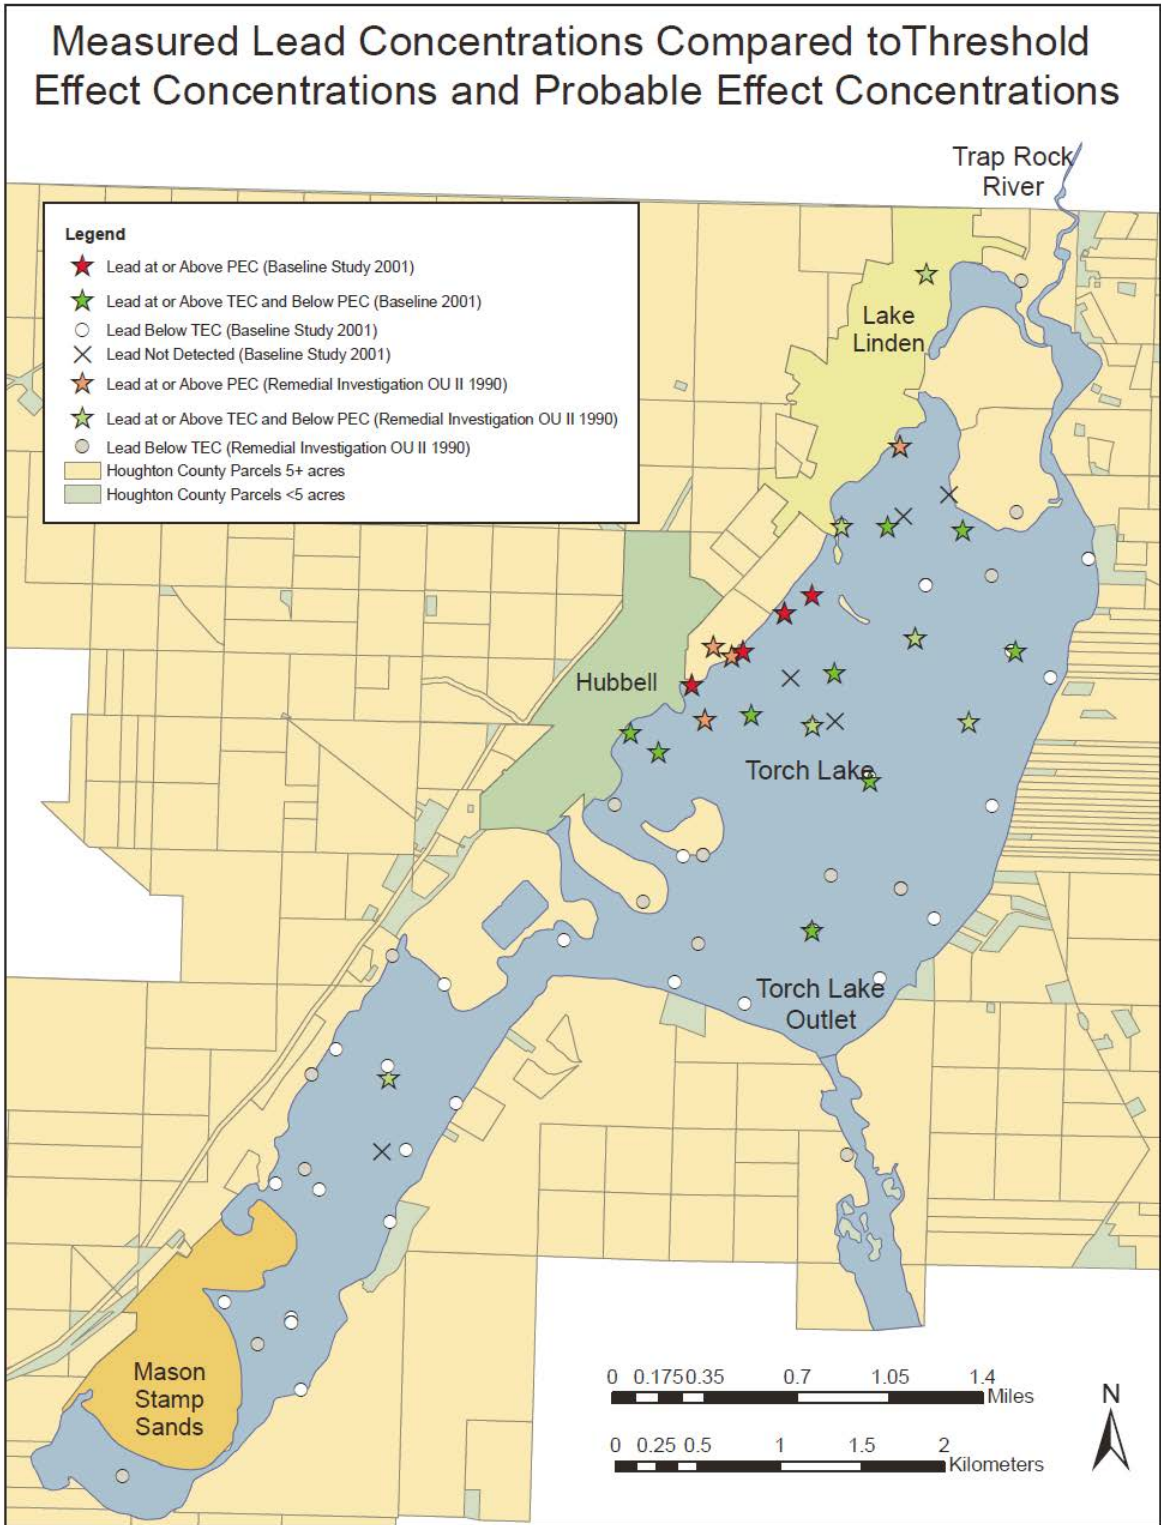
Figure 8-8. Lead distribution in Torch Lake sediments. Concentrations are compared to the Probable Effects Concentration or PEC (concentration above which toxic effects are expected to occur frequently) and the Threshold Effects Concentration or TEC (concentration below which toxic effects are expected to occur infrequently). Map reproduced from Mandelia (2016).

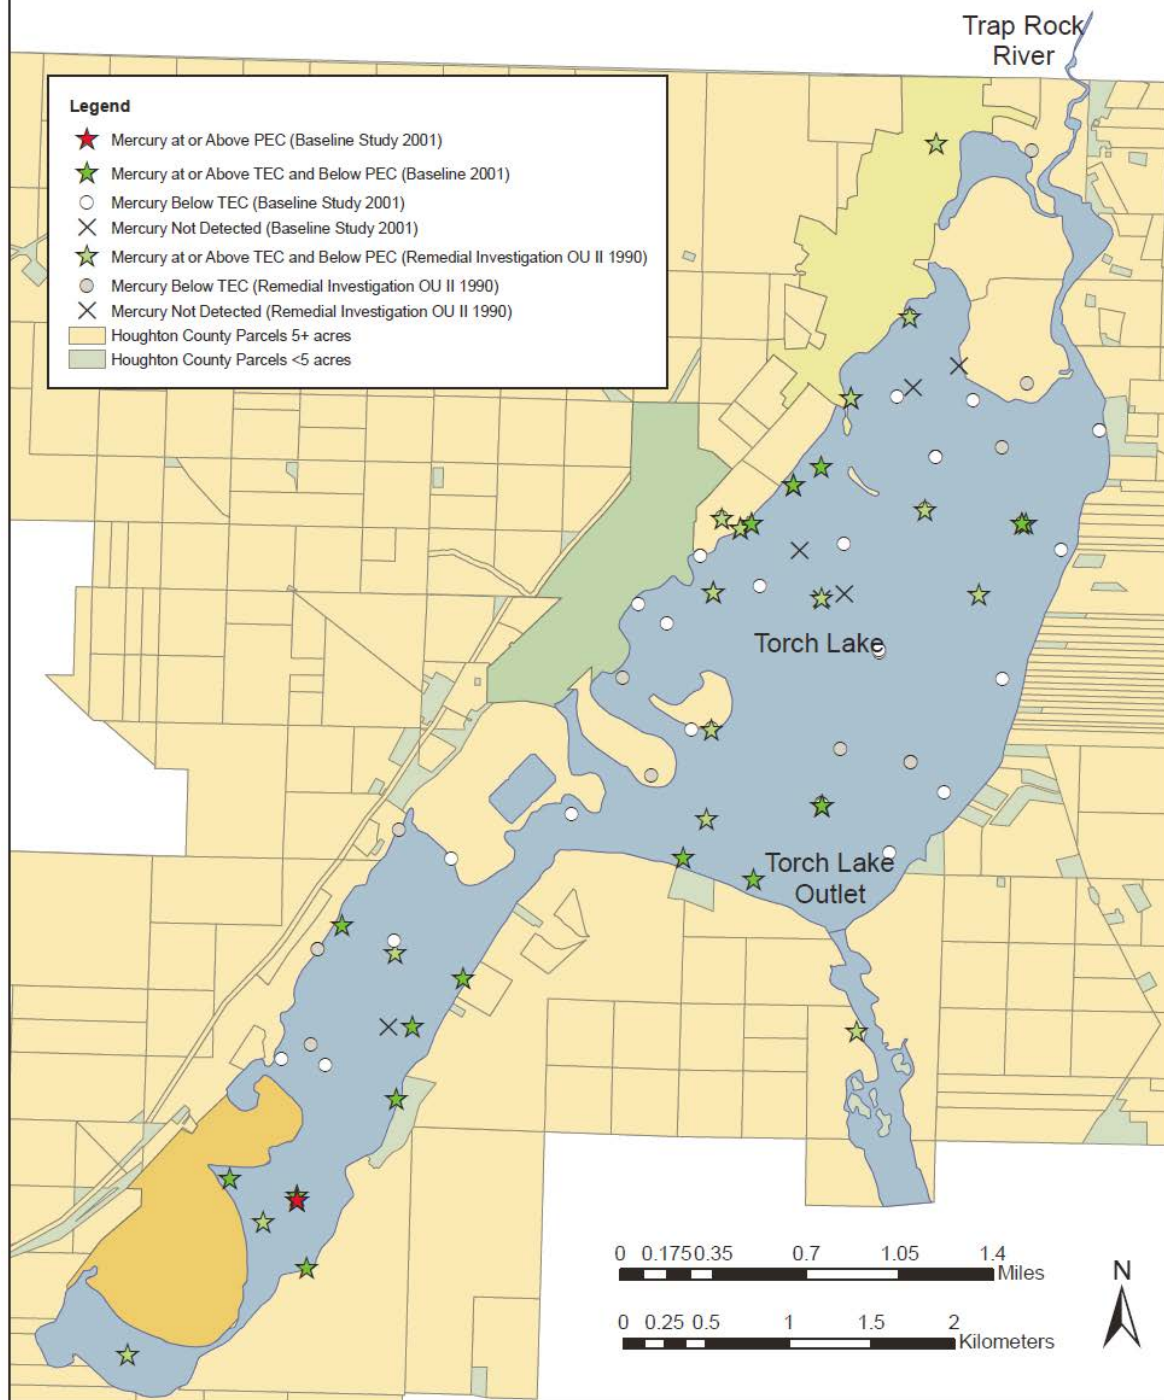
Figure 8-9. Mercury distribution in Torch Lake sediments. Concentrations are compared to the Probable Effects Concentration or PEC (concentration above which toxic effects are expected to occur frequently) and the Threshold Effects Concentration or TEC (concentration below which toxic effects are expected to occur infrequently). Map reproduced from Mandelia (2016).

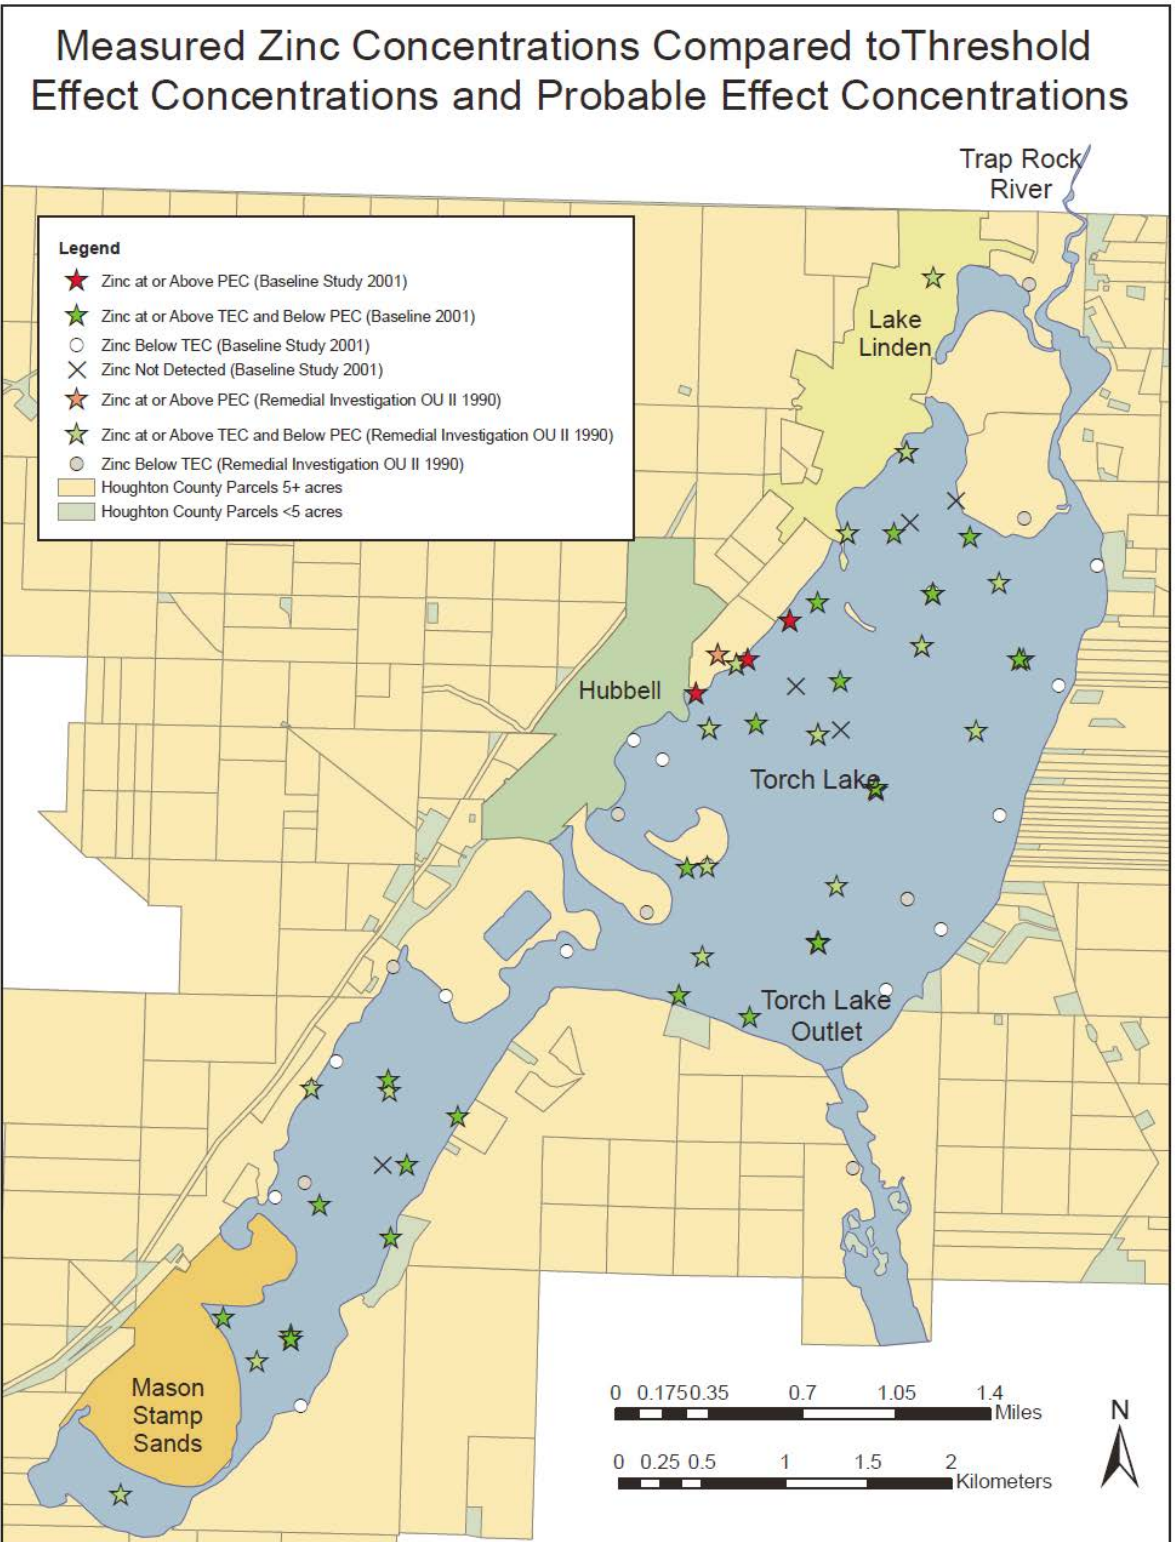
Figure 8-10. Zinc distribution in Torch Lake sediments. Concentrations are compared to the Probable Effects Concentration or PEC (concentration above which toxic effects are expected to occur frequently) and the Threshold Effects Concentration or TEC (concentration below which toxic effects are expected to occur infrequently). Map reproduced from Mandelia (2016).

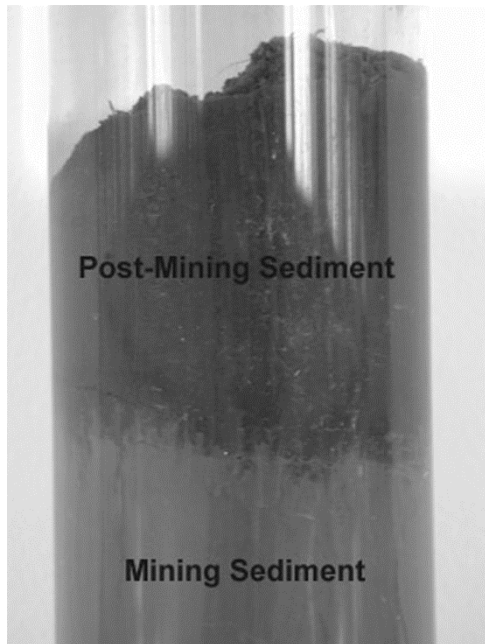
Across most of the lake, a thin layer of “natural sediment” (see Fig. 8-11) has been deposited since the cessation of ore processing and stamp sand reclamation (1963-1968). The thickness of this layer increases with time, although the increment thickness depends on the location in the lake. The largest increment is in the center of the lake in the deepest water ([McDonald et al., 2009](#)). These natural sediments consist of dead algae and riverine sediments eroded from the catchment. It is the accumulation of this fresh sediment on top of the mine tailings that must happen for the sediment toxicity to be attenuated naturally.

Figure 8-11. Photograph of sediment core retrieved in 2004 from 20-m water depth.

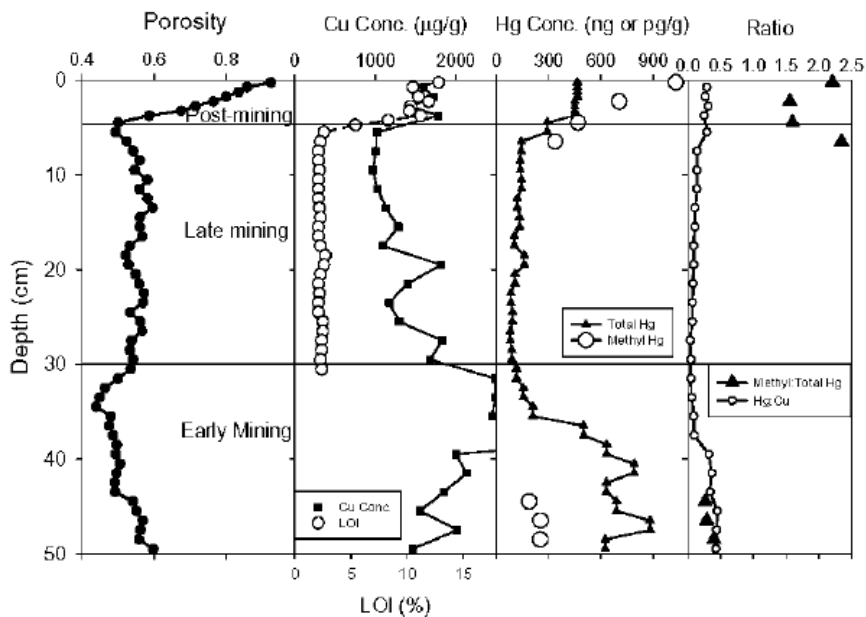
Figure 8-12. . Profiles of porosity, copper, loss-on-ignition (a measure of organic matter content), total and methyl mercury in a sediment core from Torch Lake. Reproduced from Kerfoot et al. (2008).

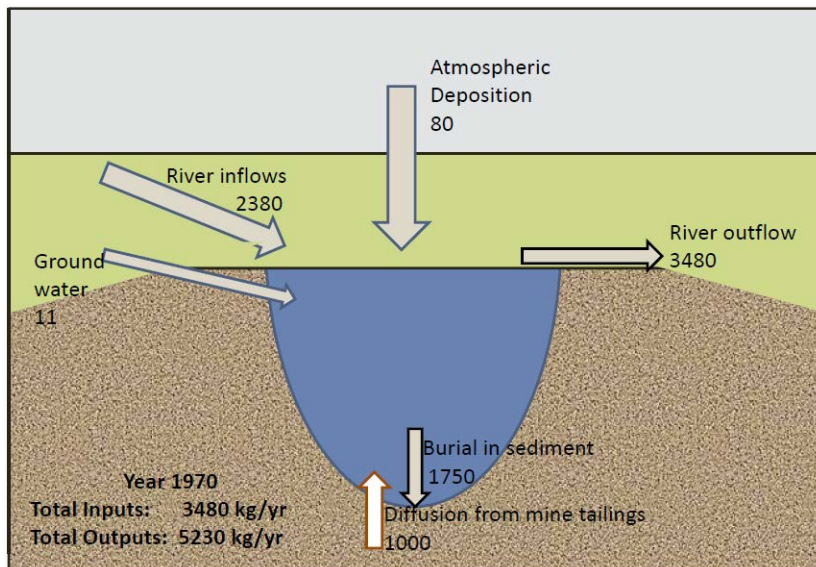
Figure 8-13. Copper Mass Balance for Torch Lake in 1970. All fluxes are in kg/yr. Data from Warburton (1987) are based on measured water flows and copper concentrations. Diffusive flux from McDonald (2005) is based on a mathematical model incorporating diffusion and sorption. Burial flux was based on dated sediment cores.
