An Integrated Assessment of Torch Lake Area of Concern

Noel R. Urban, Carol A. MacLennan, Judith A. Perlinger

Michigan Technological University

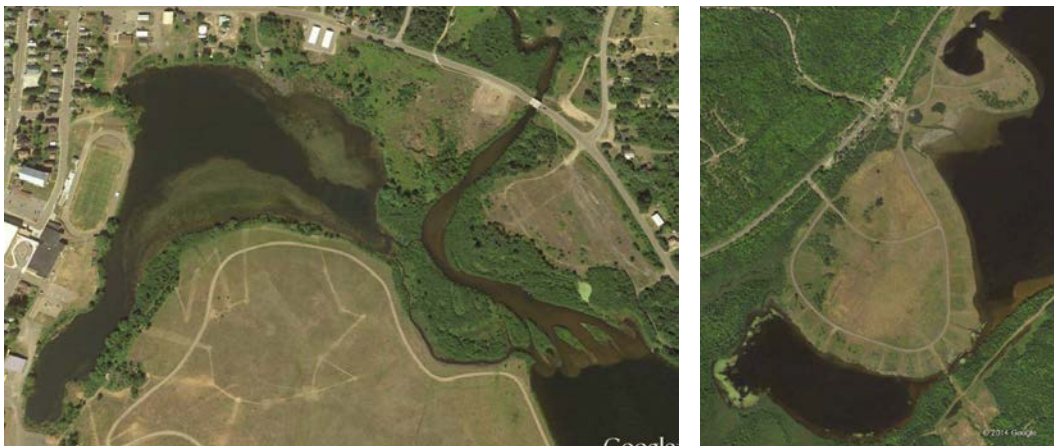
Figure 9-1. Aerial images of north and south ends of Torch Lake showing isolated sections with large macrophyte beds.

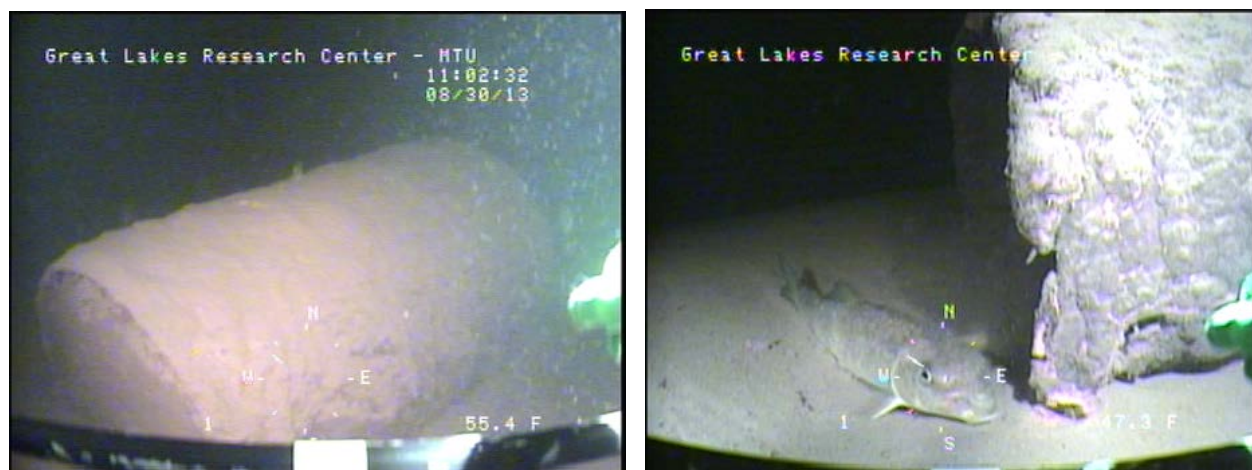
Figure 9-2. Images of debris at the bottom of Torch Lake. Pictures taken with video camera on an ROV deployed off of the smelter area in Hubbell.

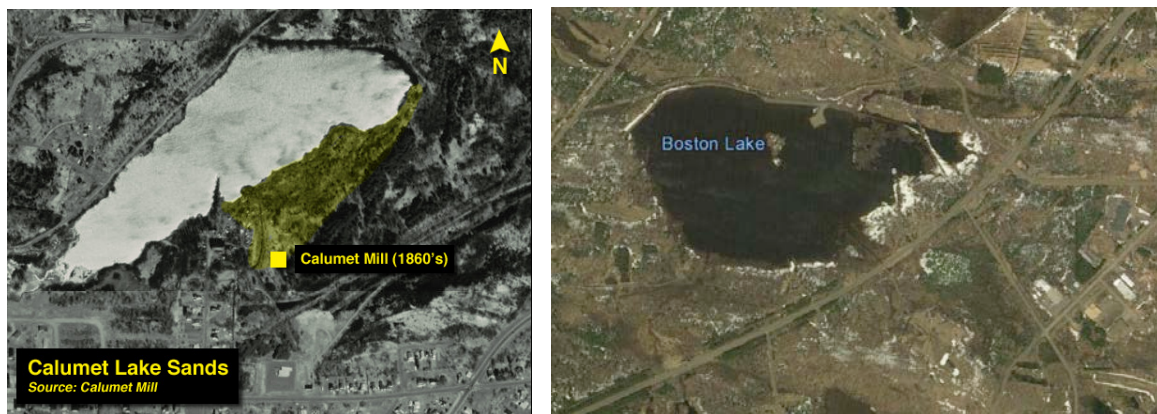
Figure 9-3. Areal images of Calumet Lake (left) and Boston Pond (right). Image on left from CopperCountryExplorer.com; image on right from Google Earth.

Linden Recreational Park (Fig. 9-3) and that planned for removal in 2018. The EPA identified a 200x200 foot area with a clay-like material rich in lead (78,000 mg/kg) and a second, smaller area (3’x200’) contaminated with arsenic. A total of 1000 cubic yards of material was excavated from the two areas. The Emergency Removal did not attempt to remove all contaminated soil; as stated in the Pollution Report ([U.S.EPA, 2007a](#)):

Both Calumet Lake and Boston Pond were included in both Operable Unit III (on-land stamp sands) and Operable Unit II (below-water sediments) of the Torch Lake Superfund site (Fig 9-3). However, in both locations, the only remediation applied was to exposed tailings/stamp sands. Sediment contamination at both sites, although specifically noted in the Feasibility Study ([U.S.EPA, 1992e](#)), the Remedy Position Paper ([U.S.EPA, 1994](#)), the RODs ([U.S.EPA, 1992c](#), [1994](#)), and the third 5-year assessment report ([U.S.EPA, 2013](#)), was never remediated; the no-action alternative and delisting in 2002 applied to both of these water bodies as well. There was never a thorough limnological analysis of either water body. While a large portion of Boston Pond was not directly impacted by mine tailings, the extent to which the benthos and fish reproduction were impacted throughout the lake has not been assessed. Because of the smaller size of both water bodies relative to Torch Lake, remediation via capping or dredging might be feasible.

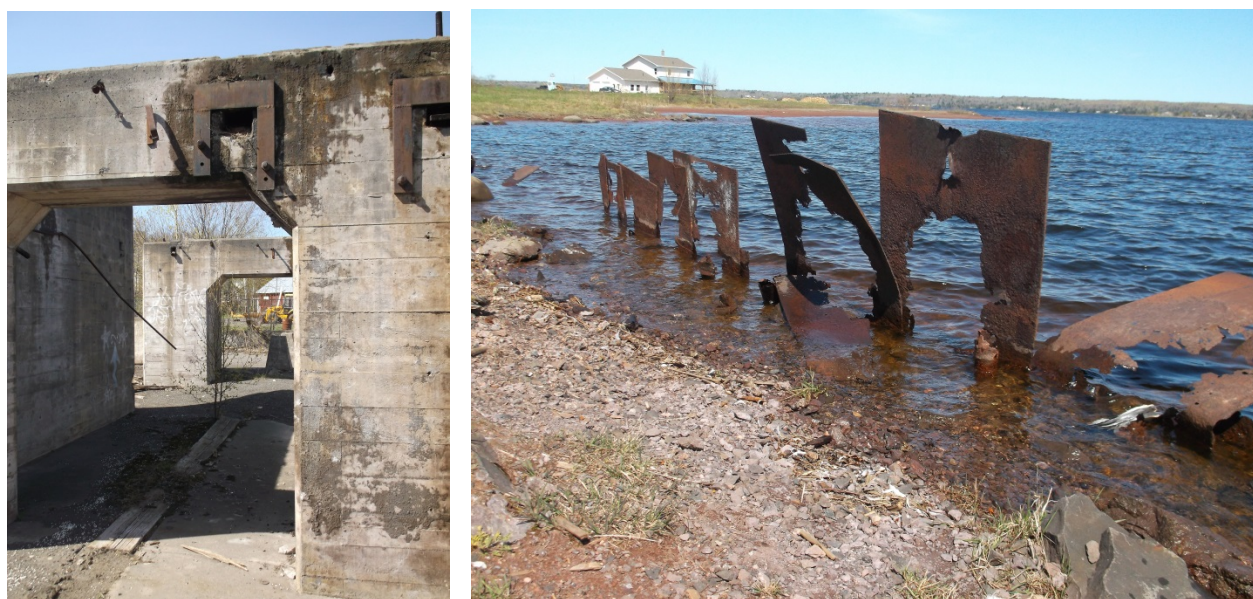
Figure 9-4. Examples of some existing physical hazards on or near shoreline of Torch Lake.
