An Integrated Assessment of Torch Lake Area of Concern: Summary

Noel R. Urban, Carol A. MacLennan, Judith A. Perlinger

Michigan Technological University
Great Lakes Research Center Contribution No. 53

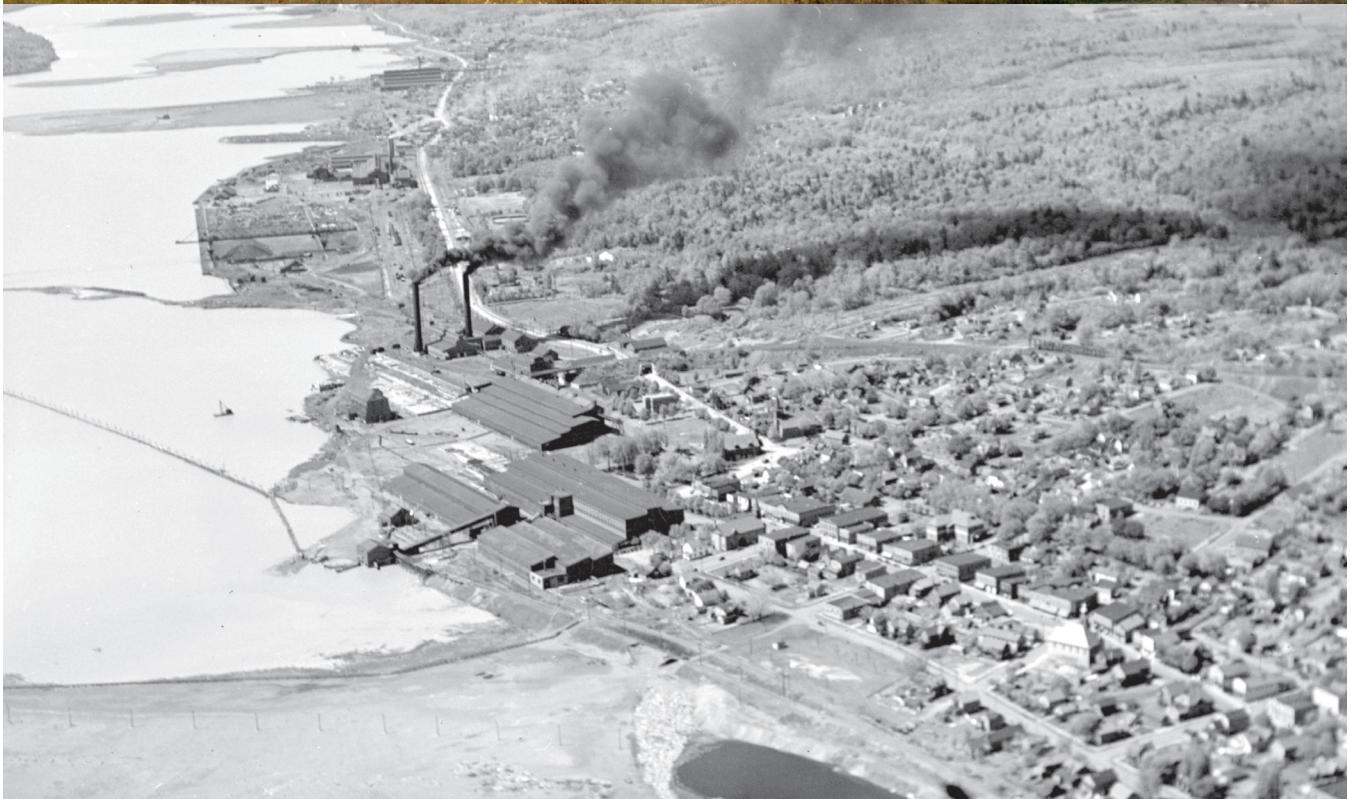
Beached remains of Quincy Dredge #2, Mason, Michigan. Photograph by Todd Marsee, Michigan Sea Grant, 2012. Calumet & Hecla operations in Lake Linden ca 1940. In the foreground are the Calumet and Hecla stamp mills with the stacks of the power house. Photo provided by the Michigan Technological University Archives and Copper Country Historical Collections.

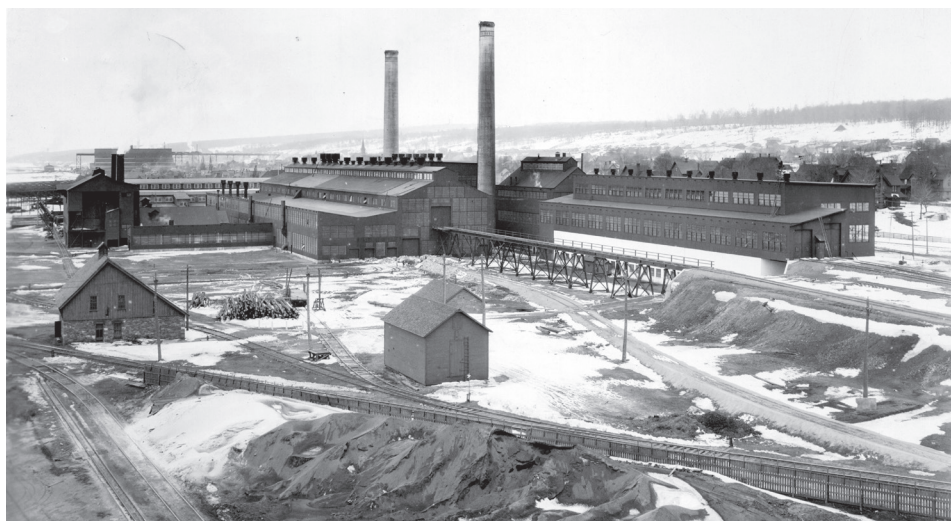
Photograph of C&H smelter and concentrate storage building in Hubbell, MI about 1950. Photo provided by the Michigan Technological University Archives and Copper Country Historical Collections.

A smelter located in Hubbell was operated by Calumet and Hecla for nearly one hundred years, and two large coal-handling facilities were built at Hubbell (C&H) and Mason (Quincy). Auxiliary buildings such as sub-stations and chemical laboratories added to the infrastructure and potential waste disposal in and around the lake. The original sole focus on production of copper metal was broadened to include production of secondary copper chemicals, and this also brought new waste streams.

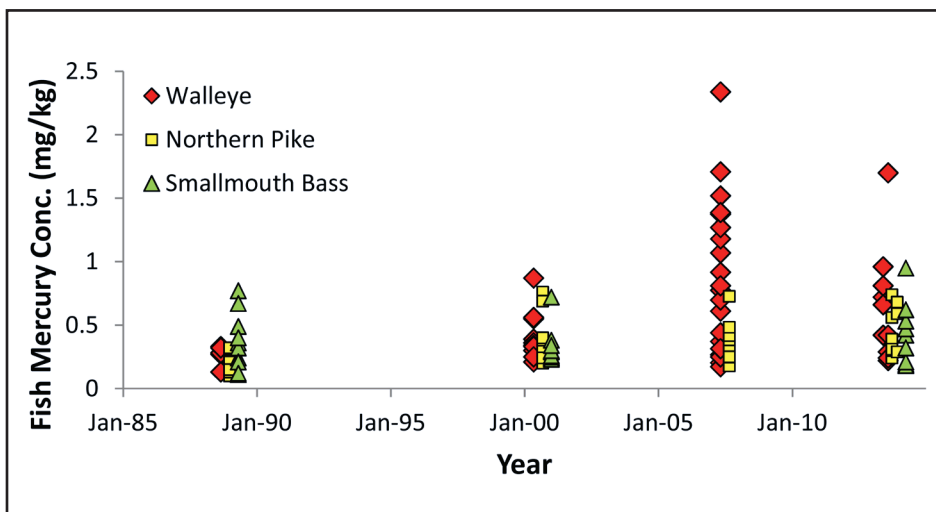
Mercury in Torch Lake fish has been high (> 0.3 mg/kg) since at least 1988. There is no evidence of a decline in mercury content in northern pike or smallmouth bass. Changes in mercury content of walleye likely result from fish community changes resulting from stocking.

Although the fish tumors reported between 1970 and 1986 have disappeared because the causative agent likely disappeared, issues of fish contamination remain in Torch Lake. The Beneficial Use Impairment related to fish tumors under the AOC program was removed in 2007. However, re-evaluation of evidence of high levels of mercury and PCBs in the fish prompted fish consumption advisories in 1993 (mercury) and 1998 (PCBs) that still persist today. The BUI related to restrictions on fish consumption remains in effect today. The Superfund program never responded to the evidence evaluated in their early risk assessment for local sources of mercury and PCBs. This report assembles all monitoring records by EPA, MDEQ, and MDNR and discusses the history surrounding the identification of PCBs and mercury contamination. We conclude that contrary to MDNR assessments which argue for a decline in concentrations of PCBs and mercury in Torch Lake since the 1980s, that in fact there is evidence of increased concentrations in Torch Lake fish. This report provides a thorough historical comparison of fish consumption advisories in Torch Lake and its control sites, and demonstrates that consumption advisories for both contaminants in fish have consistently been stricter in Torch Lake than in the control sites. As a result, we argue that there is no basis at present for removal of this BUI. In fact, mass balances for both substances point to continued local inputs of mercury and PCBs to Torch Lake that were caused, indirectly,

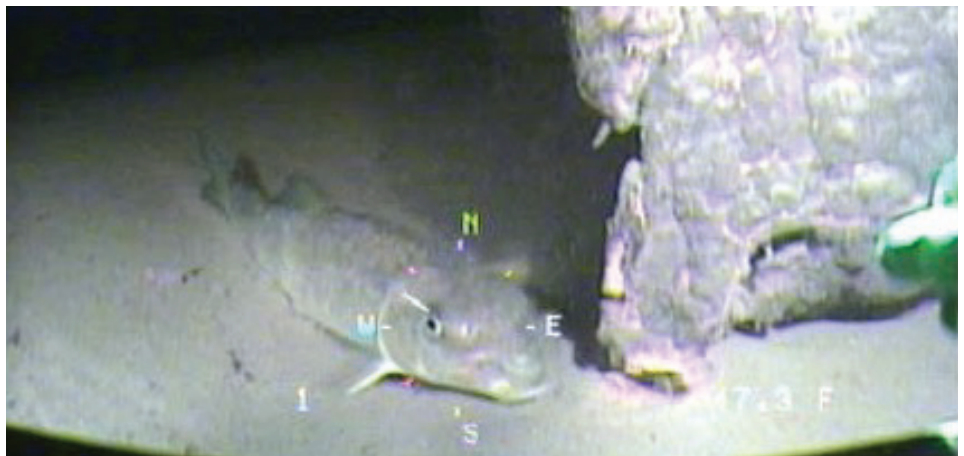
Underwater photograph of marine debris in Torch Lake. A white sucker (*Catostomus commersonii*) is shown adjacent to a corroded metal barrel in this photograph taken with Michigan Tech's Remotely Operated Vehicle (ROV) in 2014.

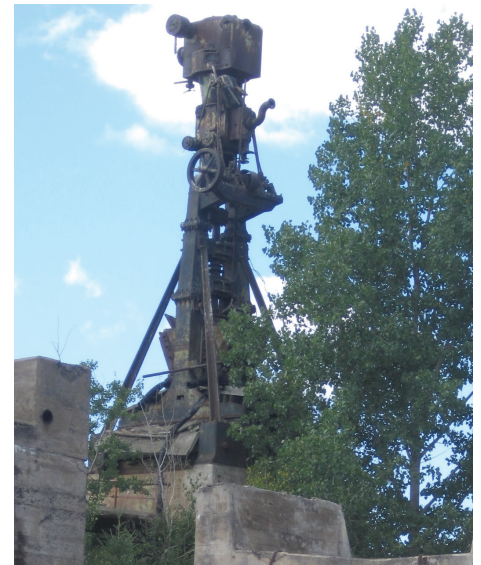
Photograph of last standing steam stamp at the remains of the Ahmeek stamp mill in Tamarack City (1990).
