Hope and Carton Hill Road Management Plan

January 2013

1.0 INTRODUCTION

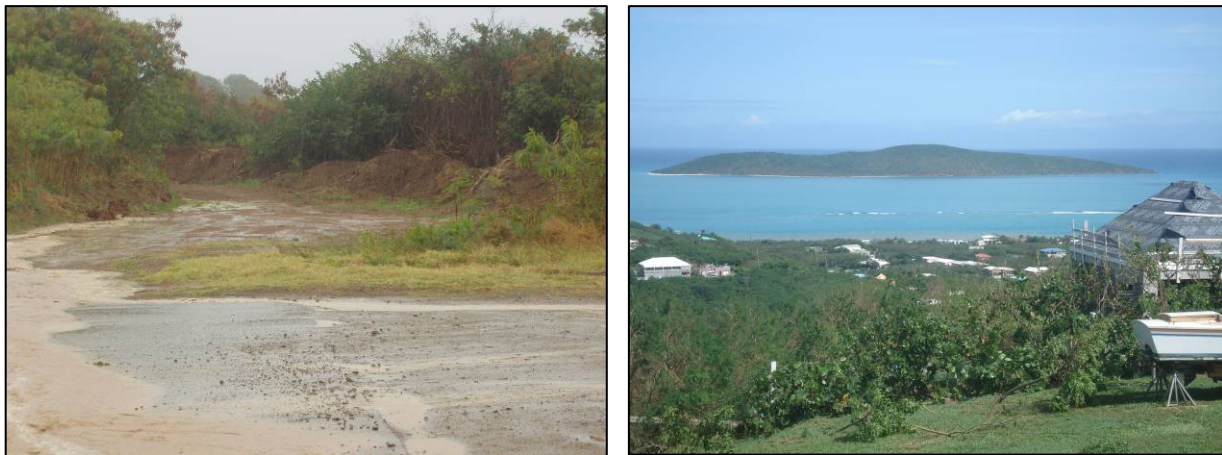
Figure 2. Sediment plume discharge into Solitude Bay, St. Croix, USVI (photo on right) from sources such as the Hope and Carton Hill road network (photo on left) after Hurricane Omar in 2008.

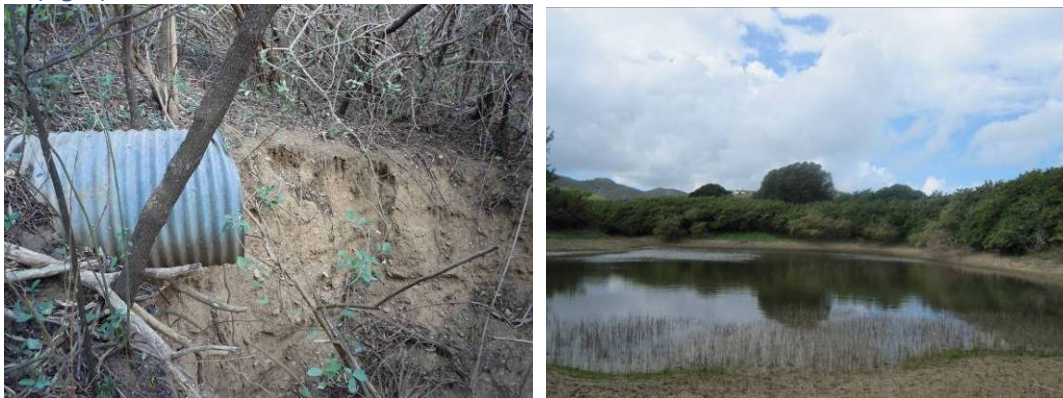
The main gut crosses the neighborhood entrance via a 30-inch corrugated metal culvert shown in Figure 4. Based on GIS mapping, the drainage area to that point is 441 acres, with 4.1 miles of gut. The existing culvert does not have the capacity to handle all of the runoff and has created a large (20 ft wide x 50 ft long x 15 ft deep) scour hole on the downstream end. Downstream from the gut crossing is an in-line pond that has a total drainage area of 560 acres, with a total of 5 miles of gut draining to it. This pond provides storage to help mitigate flooding and trap sediment, as well as potential wildlife habitat. It currently has no formal outlet and has been separated from the historical gut channel by a small residential road. As a result, this pond now overflows onto the main road (Cotton Valley Road) during large storm events, resulting in flooding near the Fire Station.

Figure 4. Large scour hole in the main gut, downstream of the 30-inch culvert under Pony Club Trail at entrance of Hope and Carton Hill (left). Further downstream, a large pond provides storage and habitat in the gut (right).

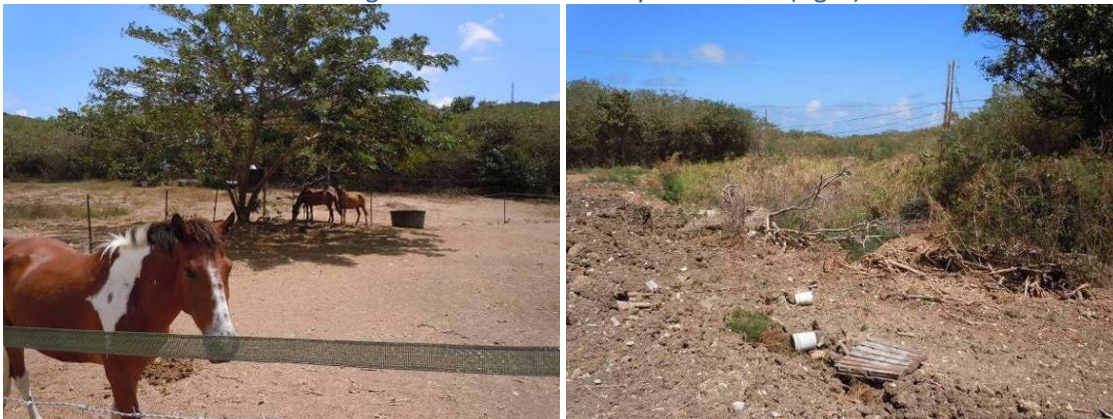
Figure 6. Horses are currently kept in pastures directly in the gut (left), and a small pond that had existed near the entrance to the neighborhood has recently been filled (right).

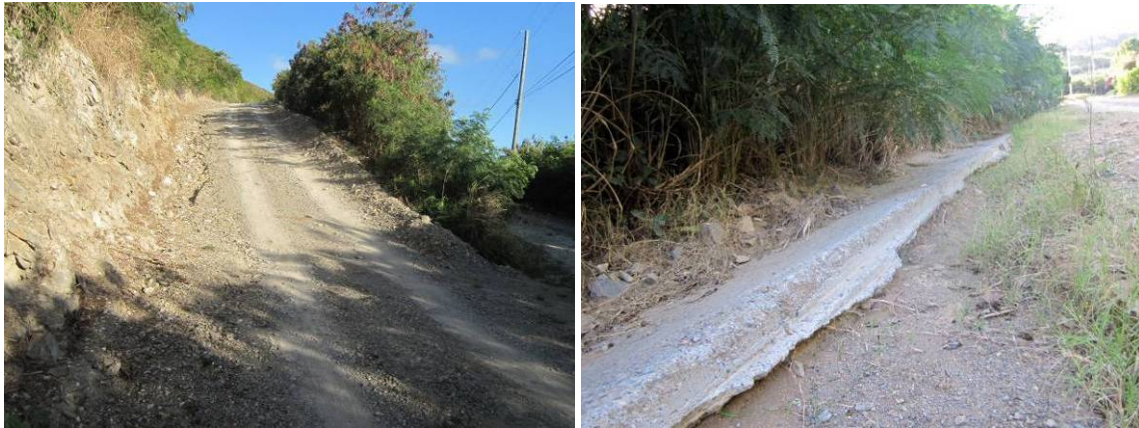
Figure 7. Roads in the Hope and Carton Hill Neighborhood are unpaved and very steep (left). Runoff from this road bypasses and undermines the paved swale (right).

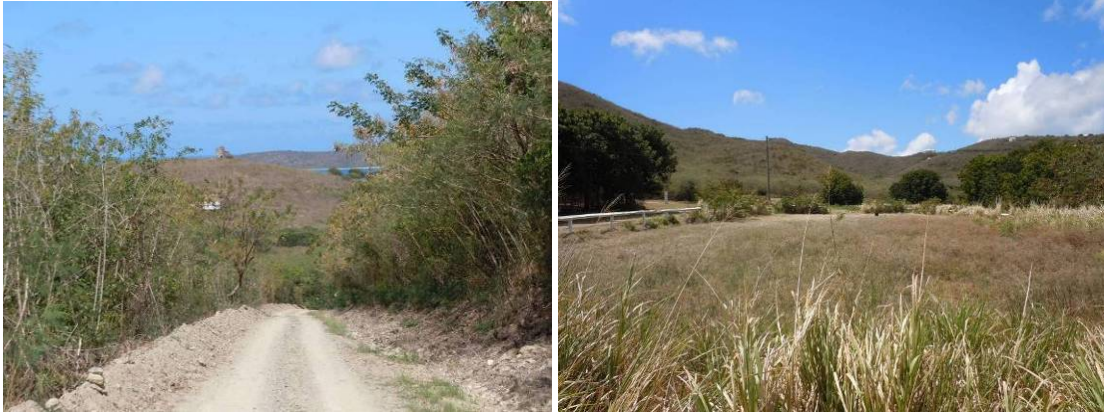
Segment 1 starts at the gut crossing near the main entrance to the neighborhood and climbs to almost the highest point in the neighborhood. The first portion of Pony Club Trail is quite flat with some areas where runoff ponds on the road. This northern section of land between the road and the gut is public land that the local pony club is allowed to use for their horses (Figure 9). As Pony Club Trail turns uphill to the south, drainage issues become evident as the road has been graded towards the inside slope (inslope) creating a severely eroded ditch (Figure 9). About halfway up Pony Club Trail, there is an 18-inch corrugated metal culvert under a driveway; this culvert is damaged and undersized. Further uphill, Pony Club Trail intersects with Hawks Nest Trail, which becomes the main road, while Pony Club Trail continues straight and becomes a dead-end road. In total, over a mile of road contributes to the drainage problems along this segment.

Figure 9. Pony Club Trail is very steep with an extremely eroding ditch on the inside (eastern) slope (left). The flat area between Pony Club Trail and the gut is currently used as a practice corral for the pony club (right).

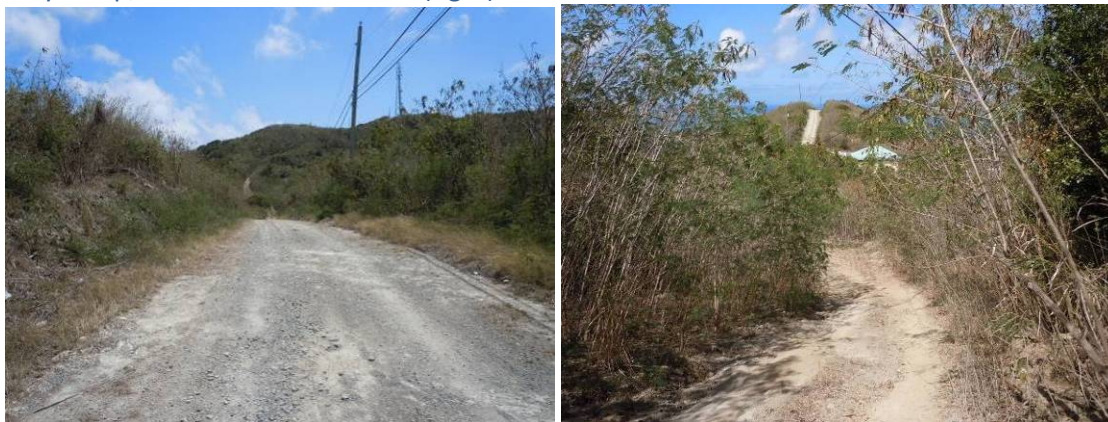
Figure 10. Coral Reef Trail in this area runs along the top of a ridge (left); this photo is looking down the extremely steep, eroded cell tower road (right).

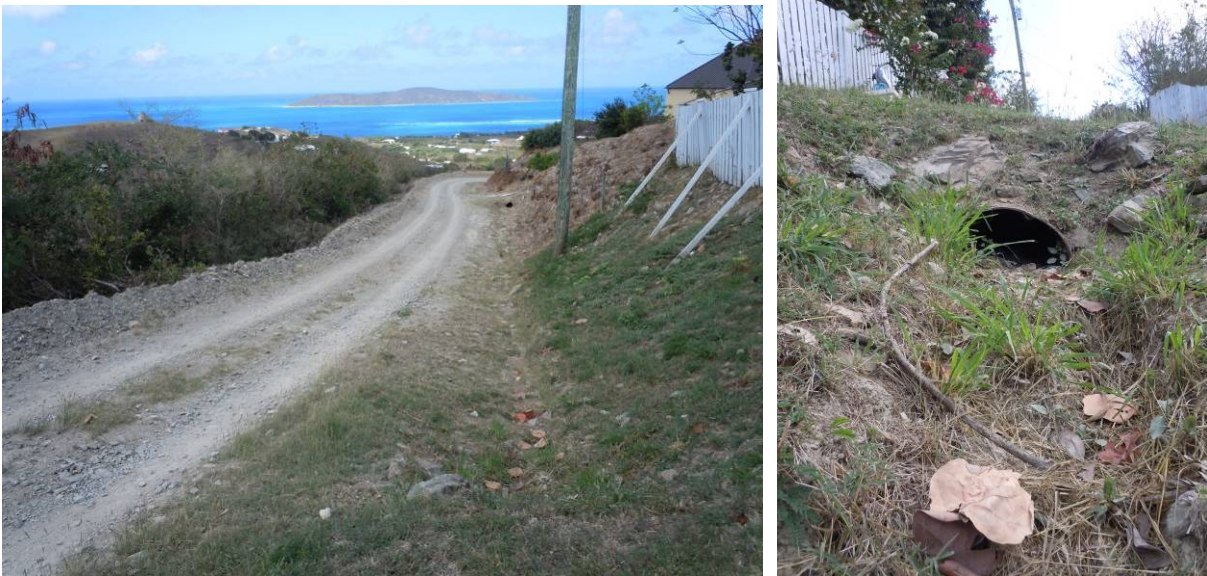
This section of Coral Reef Trail is extremely steep and is graded such that road runoff collects along the inslope, creating an eroded ditch along the whole segment (over 0.5 mile). There are two clogged/damaged 18-inch culverts under driveways along the upper portion of this segment (Figure 11). The roadside ditch along the last portion of this segment (near upper Divi-

Figure 11. Coral Reef Trail in this area is very steep (left) with damaged/clogged driveway culverts (right).

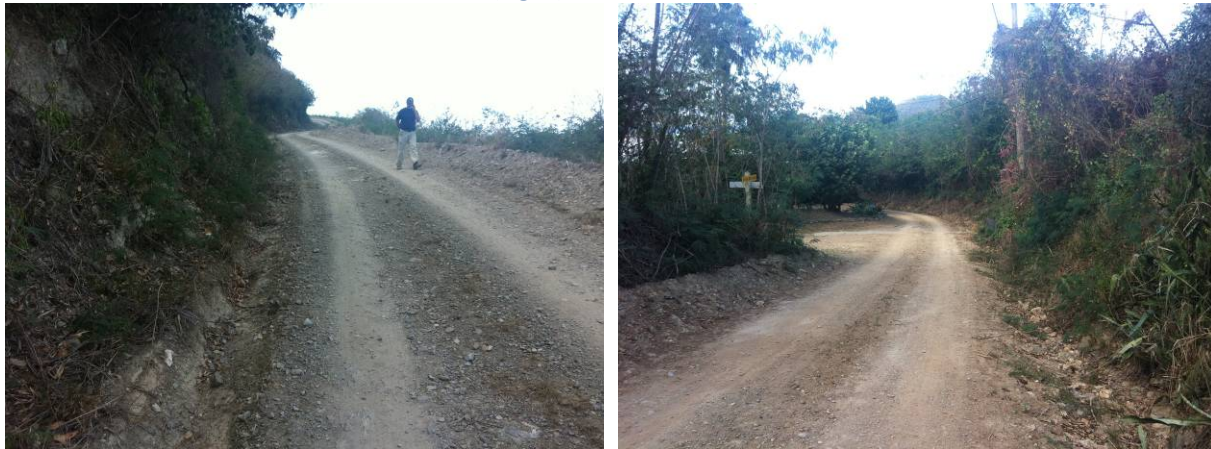
Figure 12. In some areas, the road has been graded down to the bedrock (left) with an eroding ditch on one side and earthen berm on the other (right).

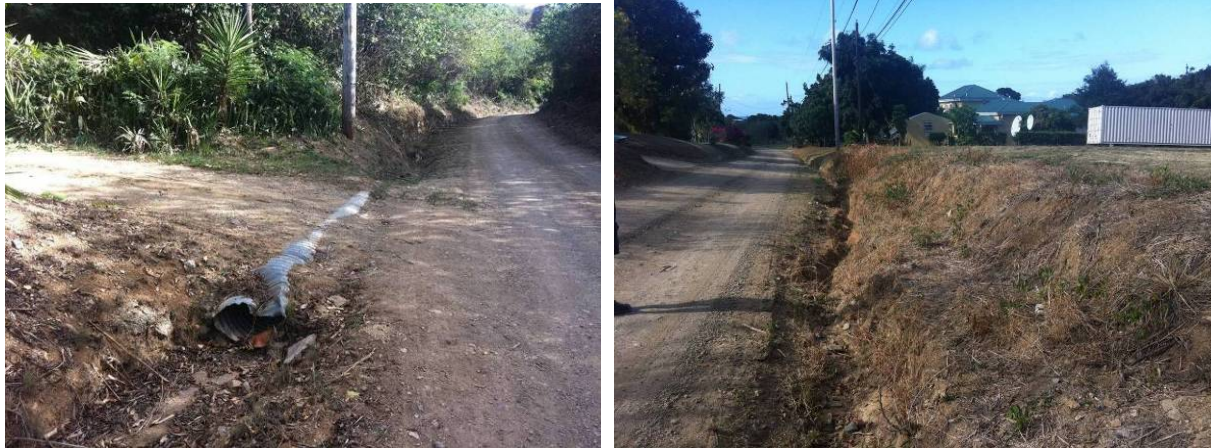
Figure 13. Damaged driveway culvert (left) and the eroding ditch serving as the gut (right).

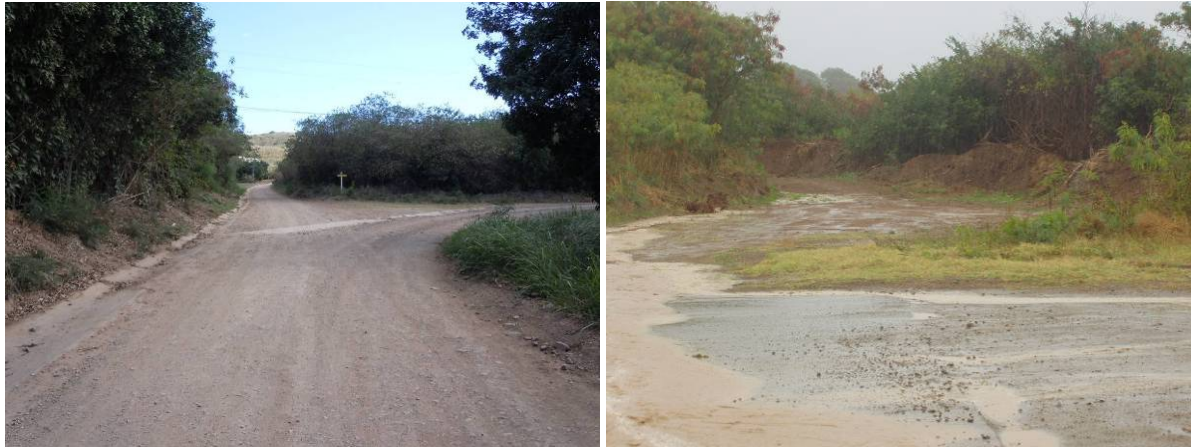
Figure 14. Shallow, paved swales at the downgradient end of Segment 4 (left), and a manmade drainage path created to help runoff reach the main gut – note piles of sediment exposed to runoff (right).

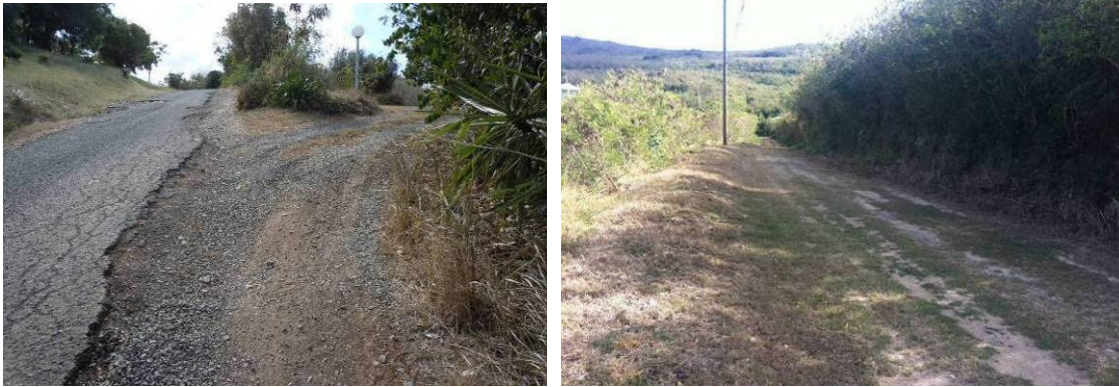
Divi-Divi Trail starts and ends on Segment 4, Coral Reef Trail. The first portion of the road (nearest the neighborhood entrance) climbs steadily uphill to the west, with an eroding paved swale on the south side of the road. The upper, steepest portion of this stretch was paved with asphalt at some point, which is now broken up and creating more drainage issues along the edges (Figure 15). The road then takes a sharp curve back towards the east, where there is another stretch of broken asphalt. A low point in the road coincides with two driveways (for Lots 46 and 60). The road continues on to the south where there is a long stretch (~1,000 ft) where runoff ponds along the inslope due to flatter slopes, rather than eroding a ditch. The road surface in this area even has some grass cover (Figure 15).

Figure 15. Broken asphalt along Divi-Divi Trail (left), and a grassy section of the road where the slope is flatter, little erosion has occurred, and some evidence of ponding was observed (right).

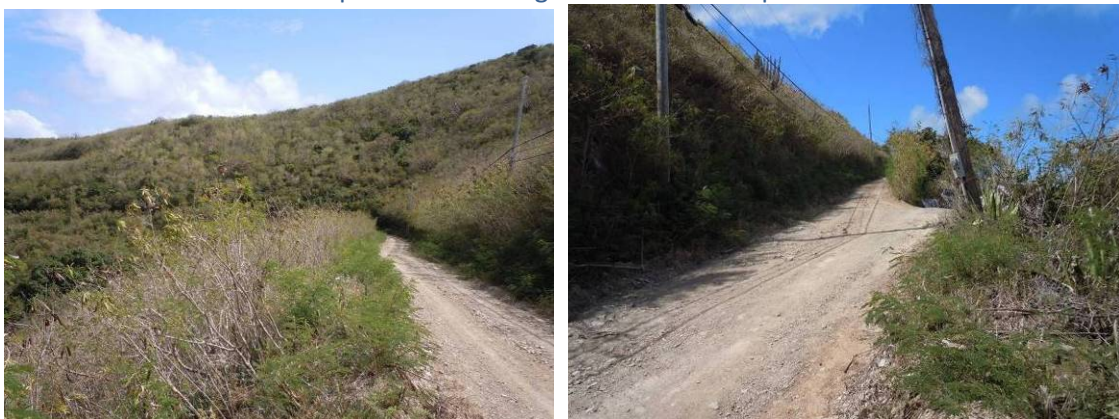
Segment 6 starts at the end of Segment 2 and ends at the confluence of Segments 7 and 9. This upper portion of Yellow Cliff Trail is extremely steep, with an eroded roadside ditch on the inslope (Figure 16). The whole segment (0.3 miles) drains to a 24-inch ductile iron culvert under the road, which also carries flow from the gut. This culvert was clogged on the upgradient end, with a deep scour hole on the downgradient end (Figure 17).

Figure 16. Yellow Cliff Trail is steep with an eroding ditch on the inslope.

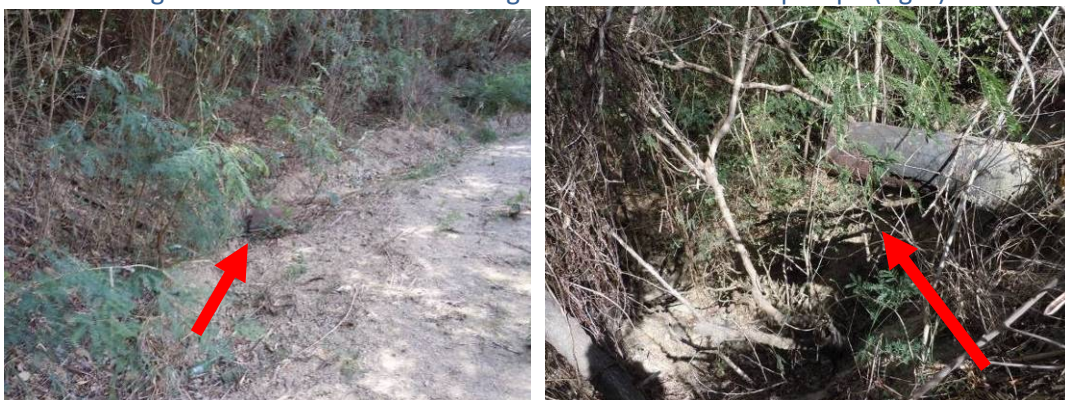
Figure 17. The upgradient end of the culvert is clogged with sediment, severely reducing its capacity (left), and the downgradient end has created a large scour hole on a steep slope (right).

Station	Associated Road Segment(s)	Description	Site Photo
17 – Yellow Cliff Culvert	6	<ul style="list-style-type: none"> • Replace damaged culvert and construct stabilized inlet that is easy to maintain and will prevent clogging. • Construct a stabilized, terraced swale at the culvert outlet. This culvert discharges through Lot 105; this lot should be preserved for stormwater management.

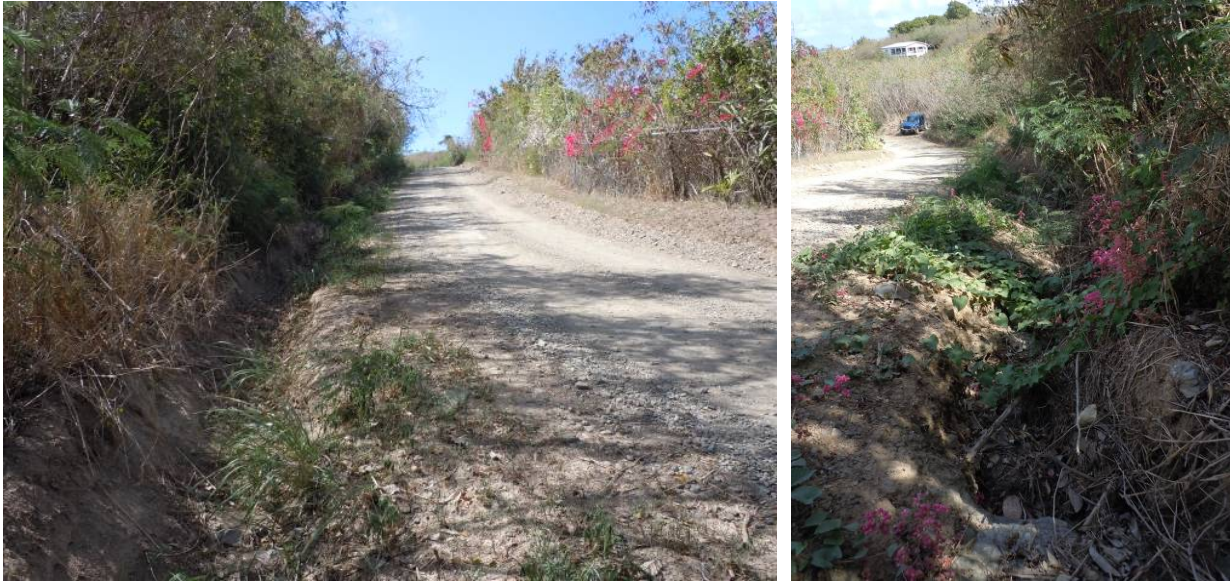
Figure 18. Looking uphill and downhill along the steep portion of this segment; the eroding ditch on the inslope is evident.

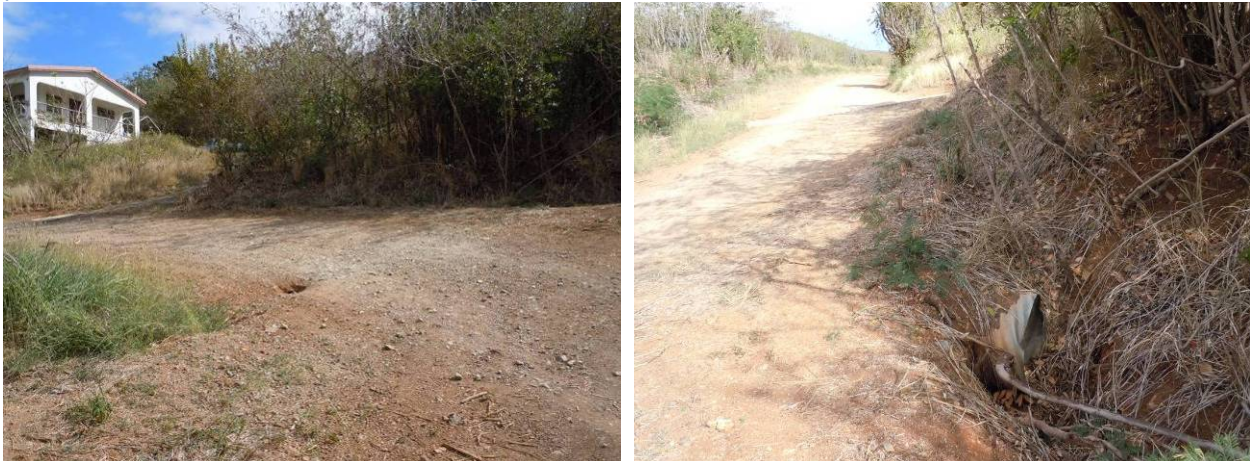
Figure 19. Clogged and damaged 24-inch corrugated metal culvert that carries runoff from the south portion of Hibiscus Circle across to the gut.

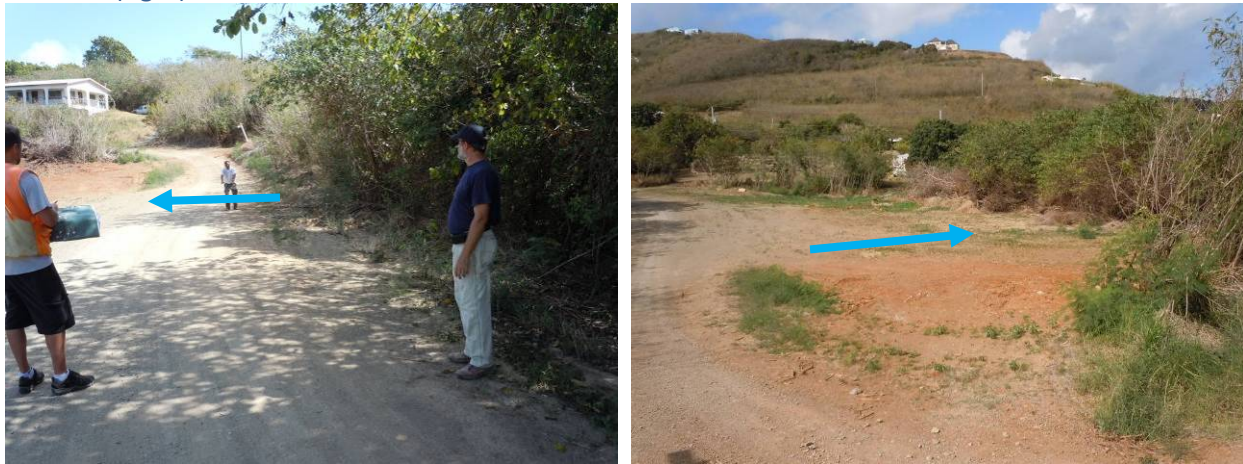
Figure 20. The gut flows over Yellow Cliff Trail at this location (left); the maintenance contractor has cleared the private lot in this area in an attempt to better accommodate gut flows to prevent flooding of the road (right). Flow arrows shown in blue.

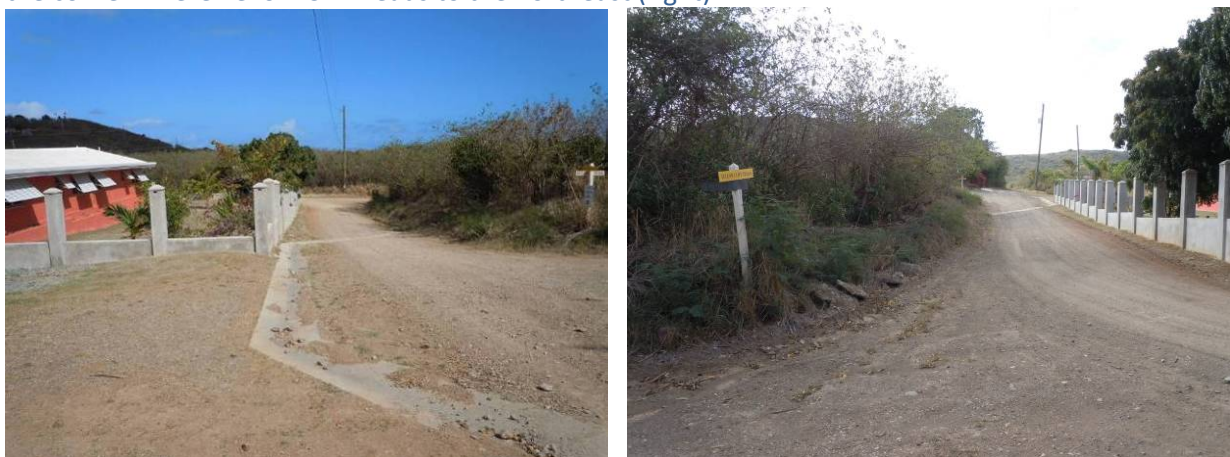
Yellow Cliff Trail continues on past the intersection with Hibiscus Circle, where there are three connected sections of paved swale for runoff (Figure 21). The road then forms a “T,” with a short section going west toward the neighborhood entrance, and the other section heading east/northeast towards a gut crossing. This gut flows under the road via two 24-inch corrugated metal culverts that are in relatively good condition with little blockage and only slight scouring at the downstream end. The upstream end is a depression that dries out in the dry season. While these culverts are not currently a significant problem, issues could arise if the upstream watershed (60 acres with very little development) becomes more developed. This gut flows into the large pond discussed in Section 2.1.

Figure 21. Shallow, paved swales at intersection with Hibiscus Circle (left), and the eroded ditch along the corner where Yellow Cliff heads to the northeast (right).

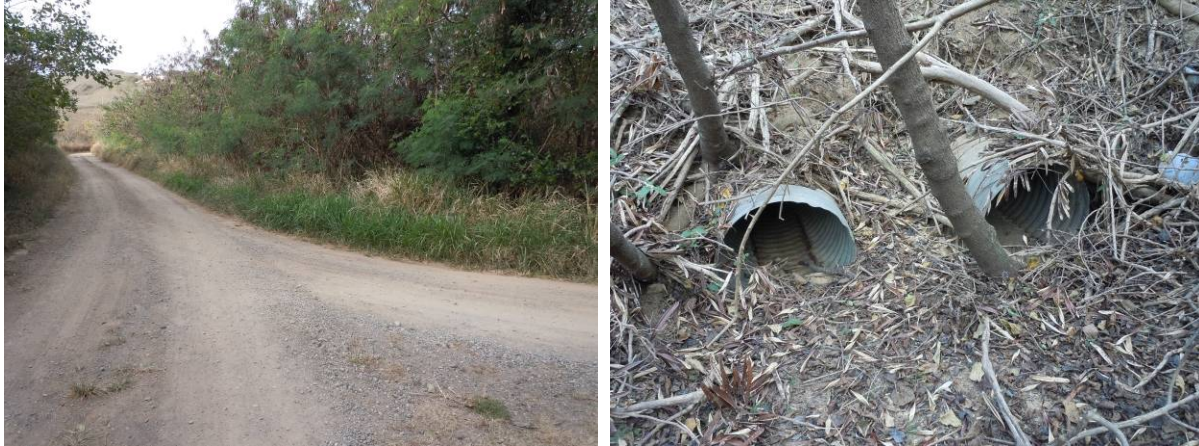
Figure 22. Portion of road that crosses the gut to the northeast (left), and the two 24-inch corrugated metal culverts at the gut crossing (right).

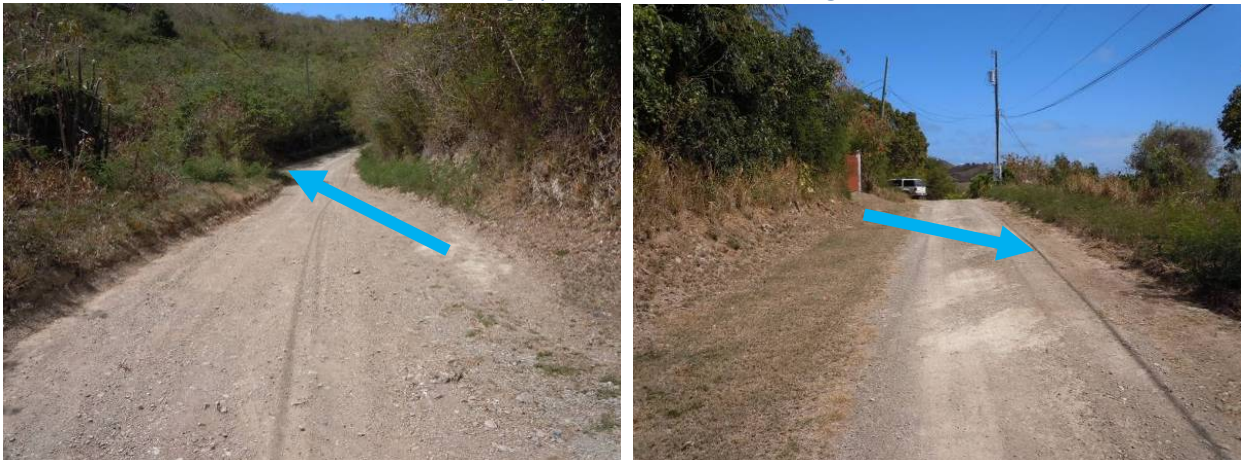
Figure 23. The first low point along Ginger Thomas Trail is shown here looking downhill to the southwest (left); the same stretch of road, but looking uphill to the northeast (right).

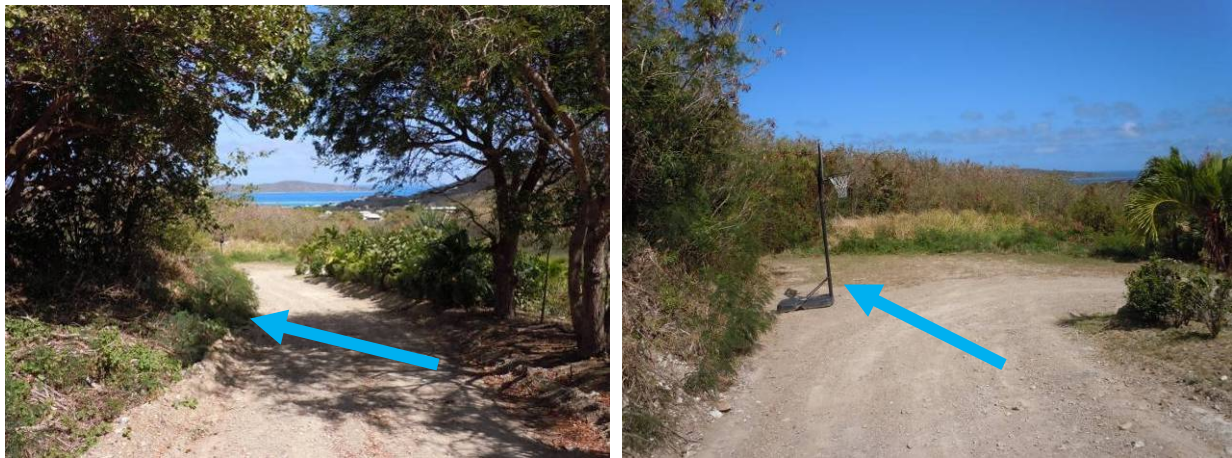
Figure 24. Runoff from the last portion of Ginger Thomas Trail flows to the western side of the road (left), towards the flat turnaround area where there were some signs of ponding (right).

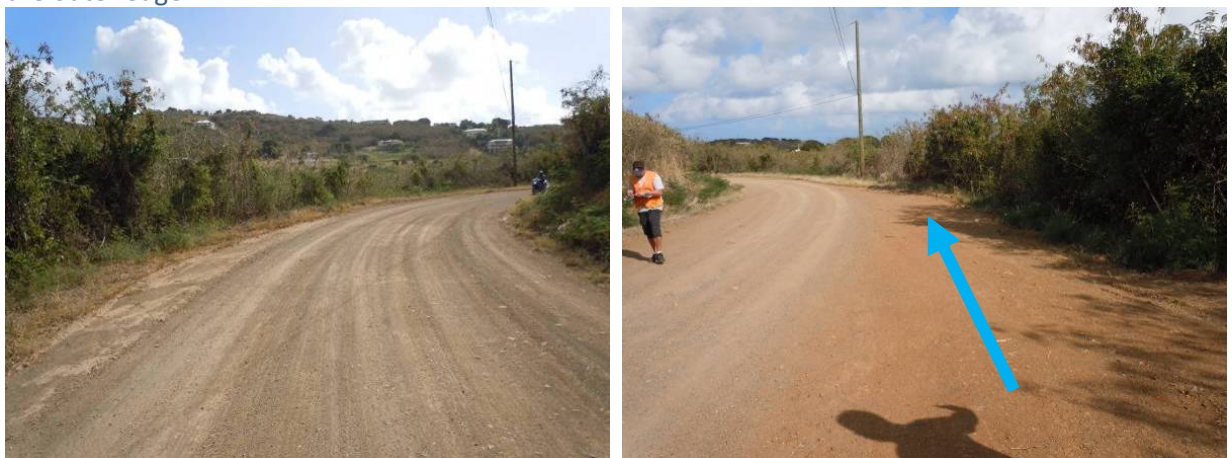
Figure 25. The entrance to Hibiscus Circle is wide and mostly flat, with some evidence of ponding along the outer edge.

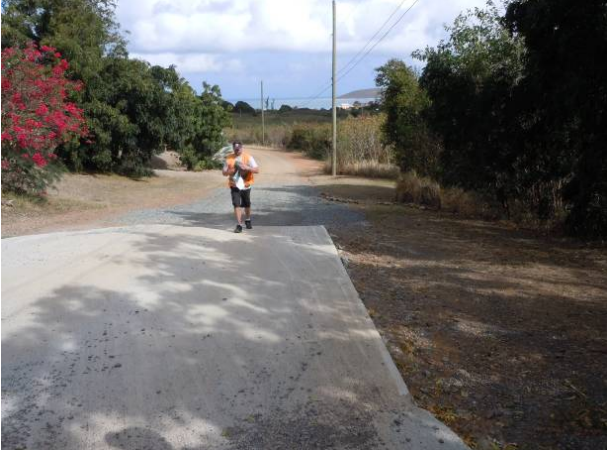
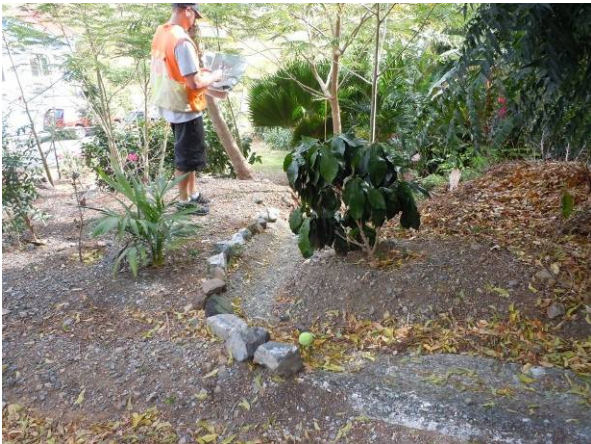
The final segment evaluated in the Hope and Carton Hill Neighborhood Assessment is actually in Yellow Cliff Estate. Hibiscus Circle is immediately adjacent to Hope and Carton Hill to the east. It is accessed from Yellow Cliff Trail, and while the road layout makes a complete circle, driving is blocked along the south portion of the circle where the road surface becomes mostly grass instead of gravel. Near the entrance to the circle, the road is very wide (over 30 feet) and relatively flat. Evidence of ponding along the outer (northern) edge of the road was observed (Figure 25). As the road heads south, it climbs in elevation. A paved intersection has been installed at the entrance to a driveway; the section of dirt road at the downhill edge of this pavement has become eroded. Nearby, homeowners have attempted to redirect runoff off the road using various rock and paved channels to carry stormwater to the eastern gut, which crosses Yellow Cliff Trail at Segment 8 (Figure 26).

Figure 26. Some erosion is occurring at the edge of the paved intersection (left), and a manmade drainage path created to help runoff reach the eastern gut (right).

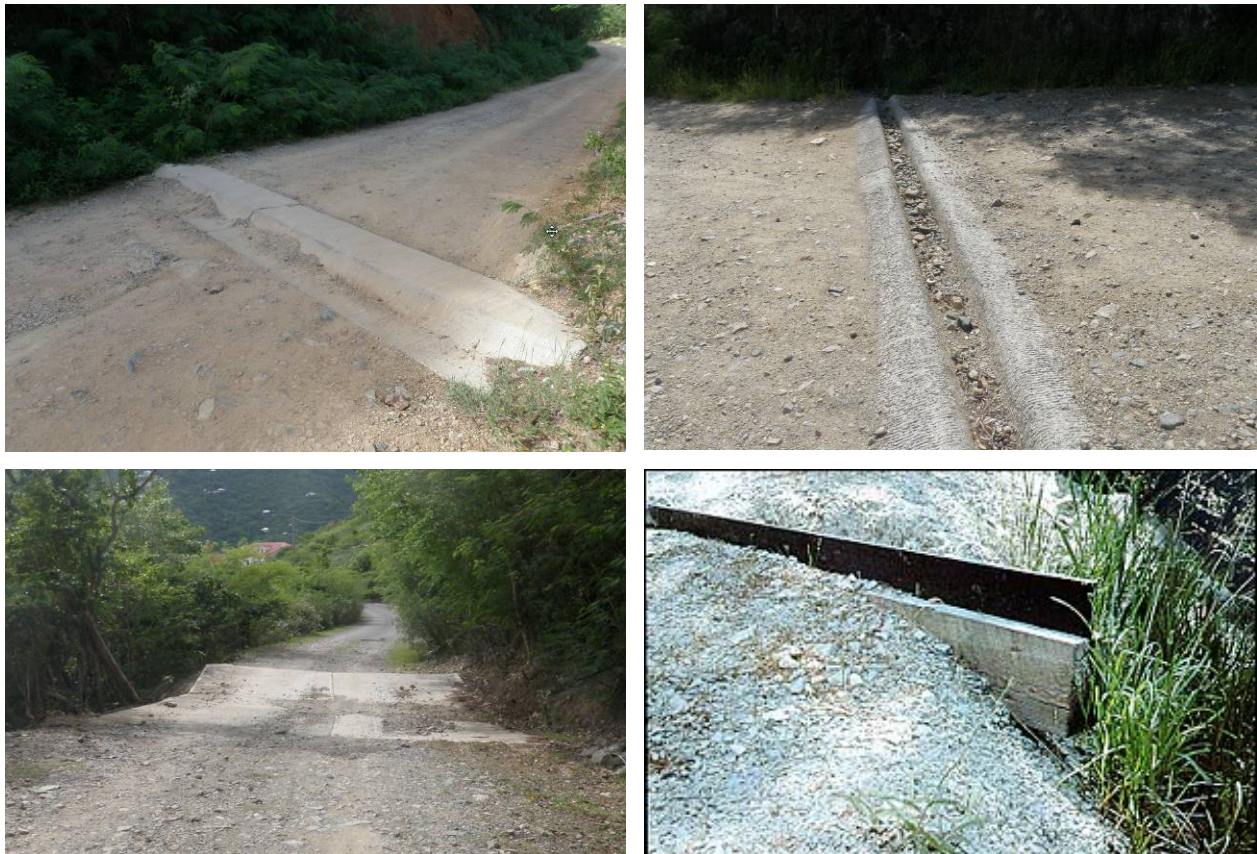
Figure 27. Waterbars (top left), open top culverts (top right), and dips (bottom left) installed by Coral Bay Community Council can have different design variations, but serve to divert surface flows off the road before erosion occurs. Deflectors (bottom right) are an alternative design (USDA). These practices should be spaced according to road slope, discharge to stabilized outlet, and be routinely maintained in order to function properly.

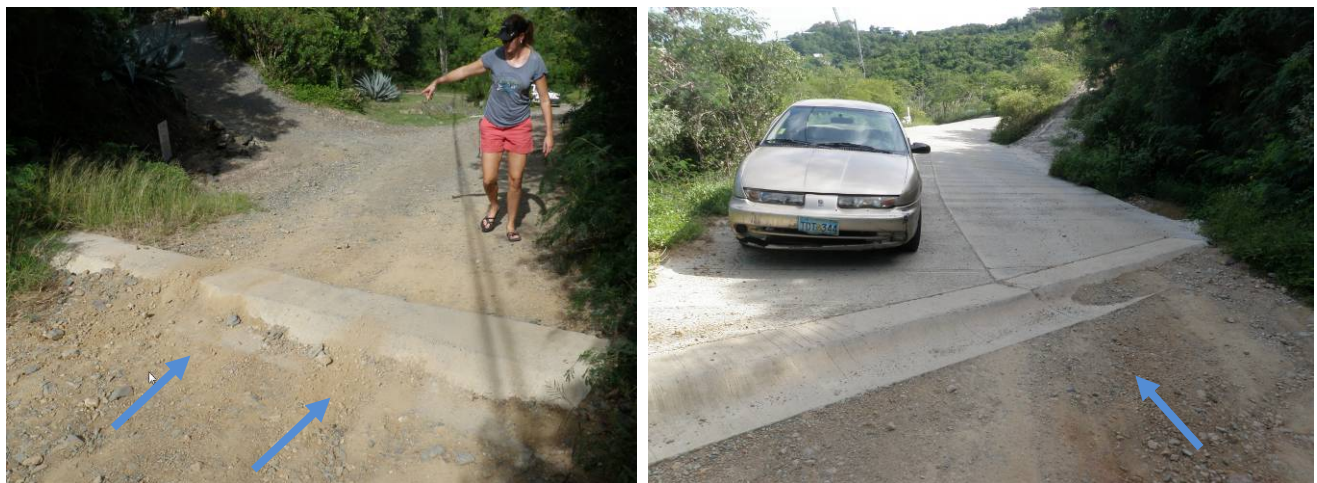
- Pitch the waterbar so that the outlet end is at least 3 inches lower than the upper end (~3% slope). The improper angling and pitch can reduce self-cleaning of sediment accumulated in the swale portion of the waterbar.

Figure 29. Proper angling and pitch of waterbar will help keep sediment from accumulating in swale

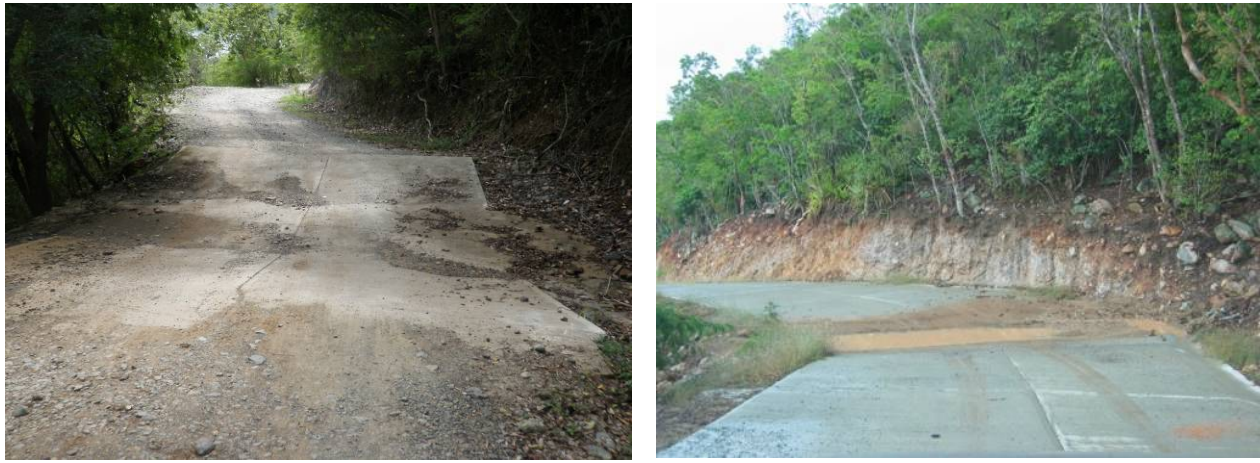
Figure 30. Dip constructed on an unpaved road (left) and one used on a paved road (right) in Coral Bay as an alternative to convey flow from both the road surface and from the inslope ditch to outslope.

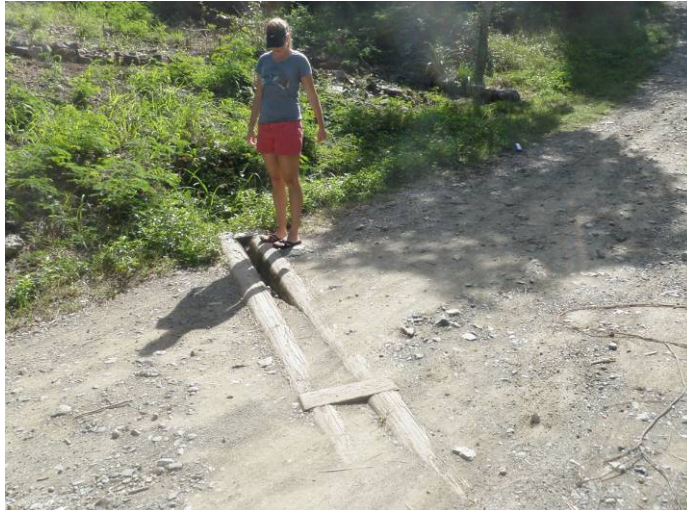
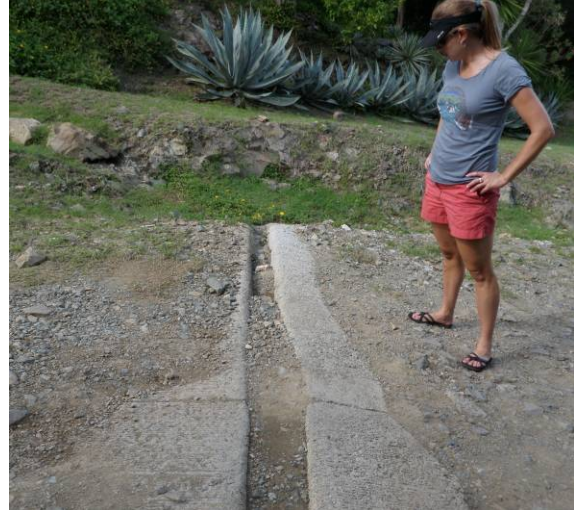
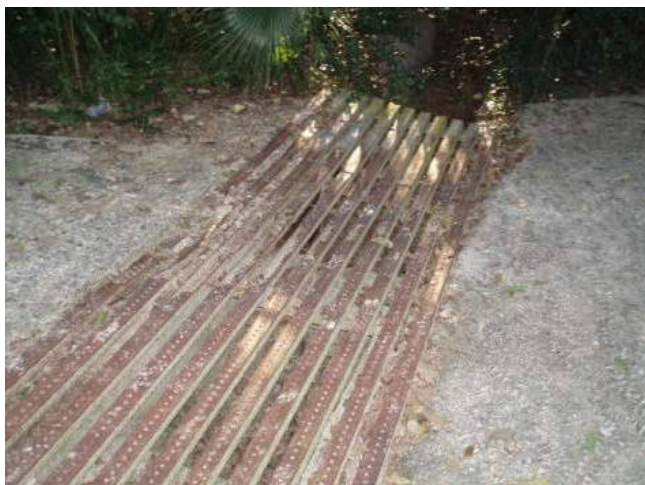
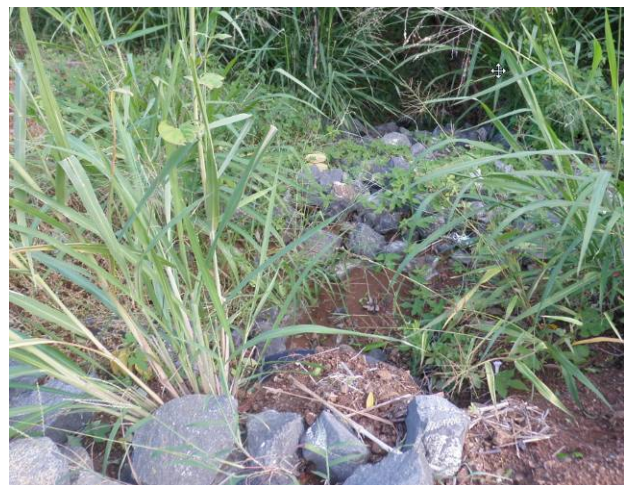
Figure 33. Open top-culverts have to be designed for maintenance access. The spacing should be wide enough to fit a narrow shovel. Top left and right photos here show clogged practices with reduced functionality. The grated cross-drain (bottom left) works on paved surfaces, and the grate can be lifted for easy cleaning. Be sure to provide outlet protection (bottom right) and remove deposited sediment on a regular basis.

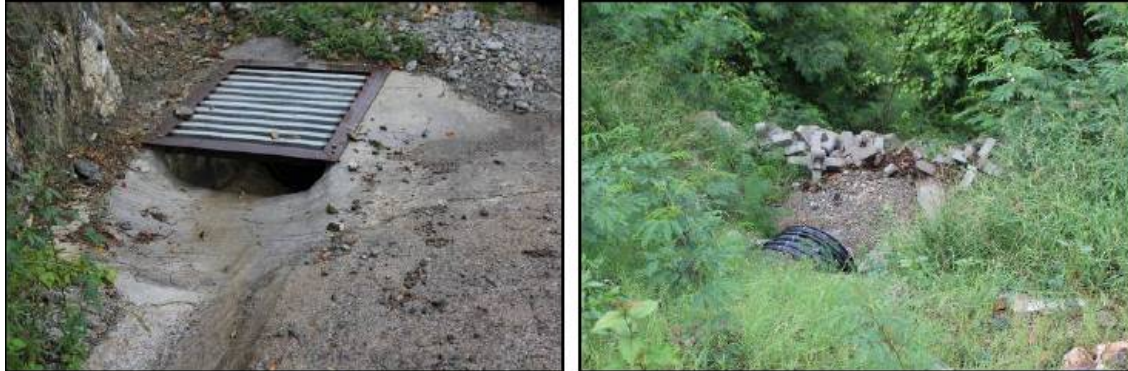
Figure 34. A drop inlet and culvert installed as a road improvement project in Coral Bay (Source CBCC).

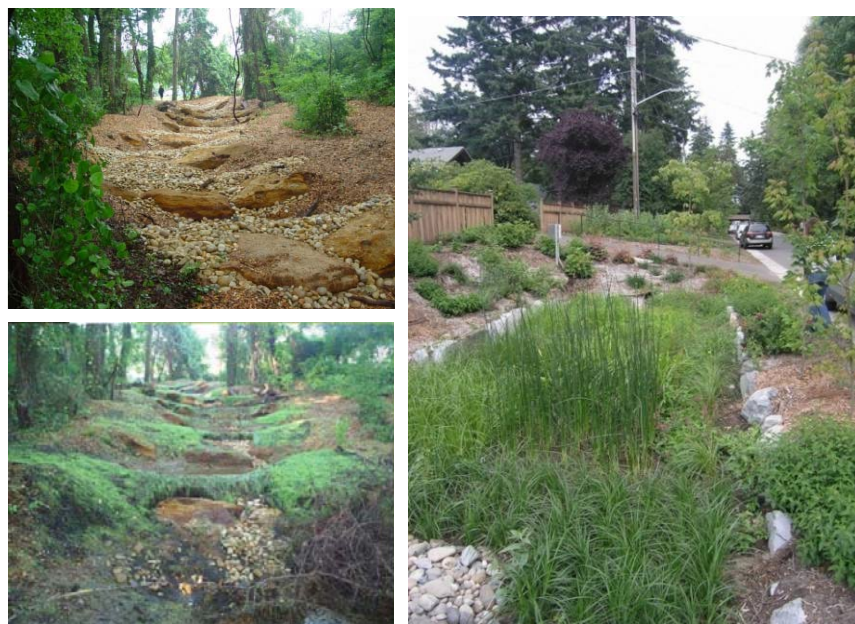
Figure 38. Photos showing stepped conveyance systems in channel from Anne Arundel County, MD (two photos on left), and a linear bioretention facility along a residential street in Seattle, WA (on right)

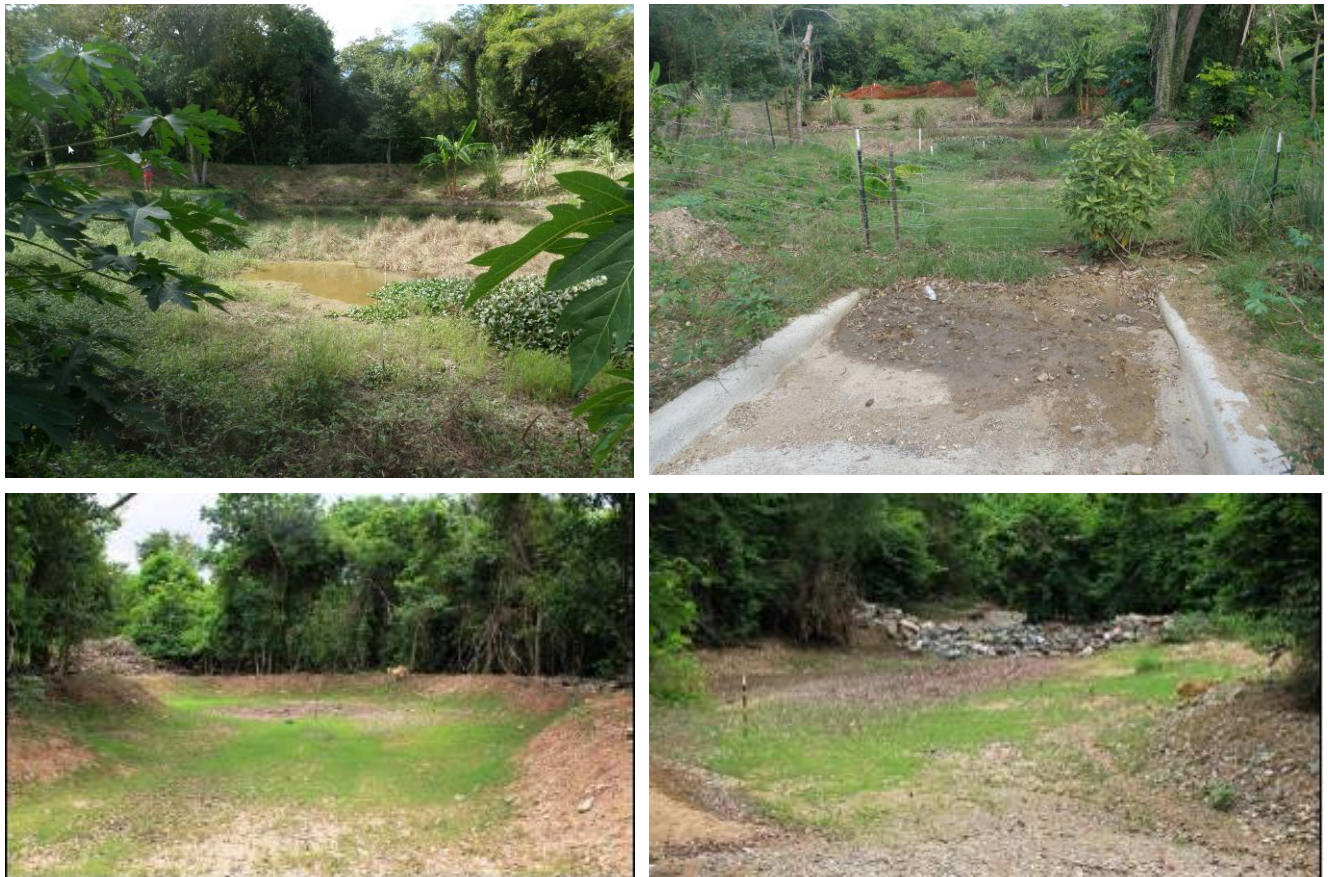
Figure 39. Wet vegetated pond retrofit in Coral Bay that manages runoff from Kingshill Road. Sediment accumulation is evident in the paved flume from the road leading to the practice (Top). The facility is being monitored to determine how much sediment is collected. Infiltration/sediment basin constructed in Carolina drainage in Coral Bay (Bottom, photos courtesy of CBCC).

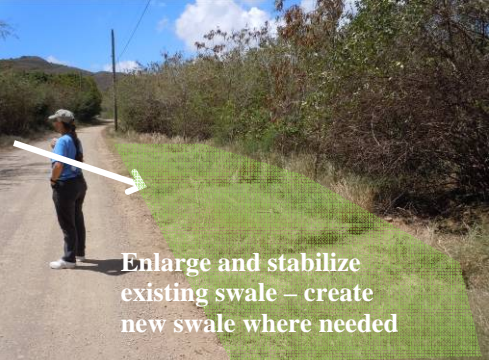
Station	Associated Road Segment(s)	Description	Site Photo
2 – Lower Pony Club Trail	1	<ul style="list-style-type: none"> Utilize right-of-way for large vegetated swale for both storage and conveyance to the gut. Use appropriately spaced waterbars to ensure drainage along this portion of Pony Club Trail reaches the swale.

<p>Enlarge and stabilize existing swale – create new swale where needed</p>
3 – Pony Club Gut Restoration	1	<ul style="list-style-type: none"> Move Pony Club activities out of the gut to reduce erosion and water quality impacts (e.g., bacteria and nutrients), as well as to reduce safety concerns during large storms. Upland property appears to be available further to the west. Restore gut capacity and vegetation.

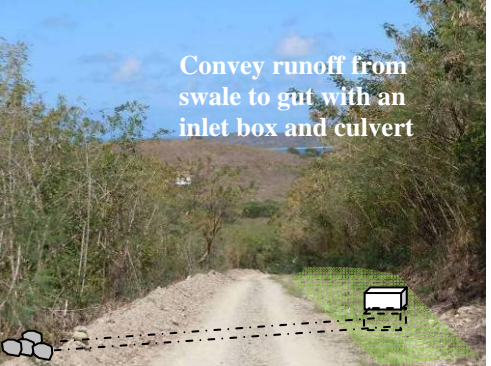
<p>Convey runoff from swale to gut with an inlet box and culvert</p>

5 – Upper Pony Club Trail	1	<ul style="list-style-type: none"> Create a stabilized swale with step pools along the inslope. Install inlet box/pipe structures to convey runoff to outlets in stormwater (sw) easements created along property lines; design outlet for energy dissipation and flow distribution across forested slope. The lots to the west are laid out along a gut. These parcels should be preserved if possible; if not, development should occur in a way that preserves the capacity of the gut.

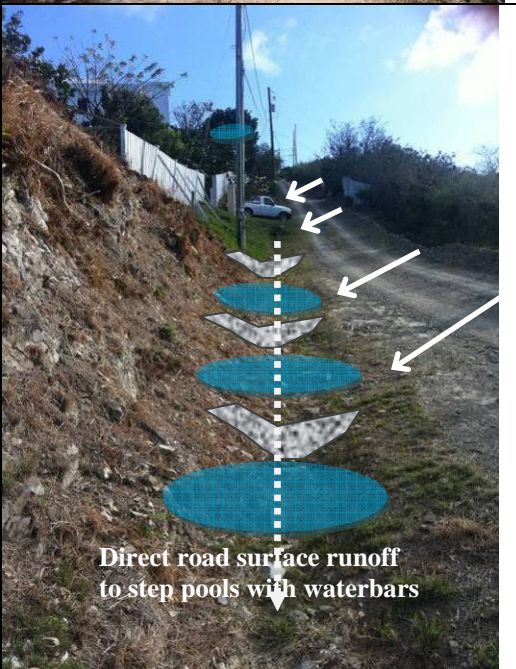
<p>Direct road surface runoff to step pools with waterbars</p>

7 – Upper Coral Reef Trail Step Pools	3	<ul style="list-style-type: none"> • Replace the existing damaged 18-inch corrugated metal driveway culverts with larger (at least 24-inch pipe), sturdier pipe with riprap on the downstream ends to prevent/reduce scour. • Install six (6) waterbars to divert runoff into an enlarged swale along the inside of road. Use four (4) in the upper 200 feet of this section of Coral Reef Trail (which has a 20% slope) and two (2) more in the lower 200 feet (which has a slope of 10%). Consider water “trenches” for the four upper waterbars given steeper slope. • Create step pools to slow flow and trap sediment.

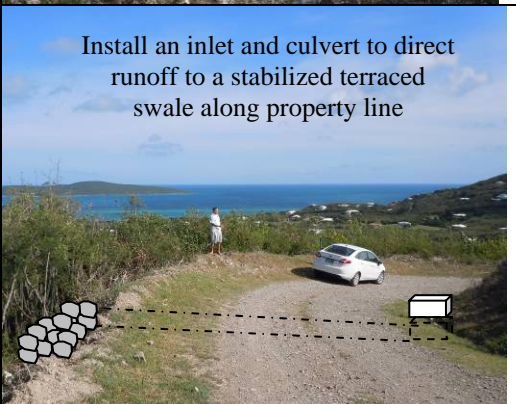
8 – Upper Coral Reef Trail Terraced Swale	3/5	<ul style="list-style-type: none"> • Install inlet box/pipe structure to collect and carry flows from inside ditch to discharge into a stabilized terraced swale down the outer slope along the property line. Need to establish a sw easement here. • Size the pipe for 25-year storm event. • Requires installation and maintenance of upslope controls at Station 7.

<p>Install an inlet and culvert to direct runoff to a stabilized terraced swale along property line</p>

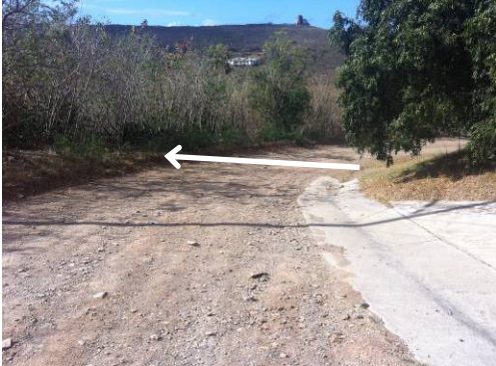
Station	Associated Road Segment(s)	Description	Site Photo
13 – Divi-Divi Waterbar	5	<ul style="list-style-type: none"> • Install a waterbar at the base of the existing concrete swale to direct runoff down the forested slope. Ensure flow is dissipated non-erosively down slope using stone and/or a level spreader. • Evaluate broken asphalt just upgradient of this location; remove if necessary.

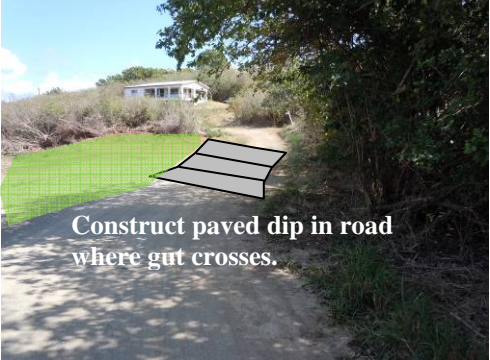
19 – Yellow Cliff Gut Restoration	7/4	<ul style="list-style-type: none"> • Construct a paved dip in the road where the gut crosses Yellow Cliff Trail. • Restore cleared gut area, ensuring sufficient capacity. • Create stormwater storage areas on either side of restored gut for easy maintenance. • The lots located in the gut both upstream and downstream from this crossing should be preserved such that development never compromises the gut capacity.
