Hope and Carton Hill Road Management Plan

January 2013

1.0 INTRODUCTION

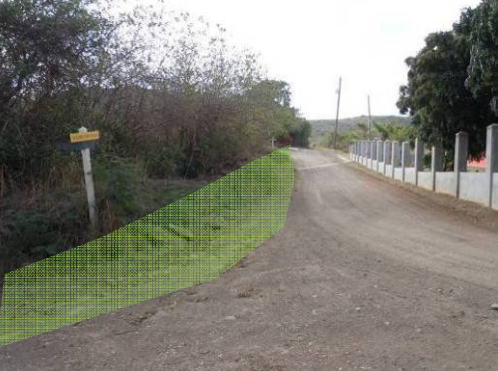
20 – Lower Yellow Cliff Trail	8	<ul style="list-style-type: none"> • Enlarge and stabilize existing drainage swales, increasing their capacity and reducing erosive potential by using check dams and vegetation.

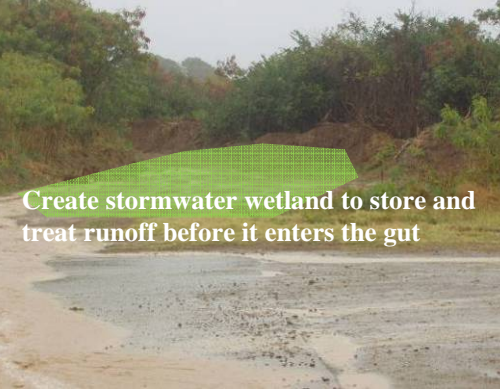
Station	Associated Road Segment(s)	Description	Site Photo
21 – Neighborhood entrance	8/1	<ul style="list-style-type: none"> • Create a large constructed stormwater wetland with a sediment forebay for easy maintenance. This stormwater storage practice will slow and treat the runoff before it flows into the gut. • Note: If other, upstream stations are not constructed first, this storage facility should be sized to, at a minimum, safely convey the runoff from the full 130-acre drainage area. • Ownership needs to be confirmed, and the land preserved if possible.

<p>Create stormwater wetland to store and treat runoff before it enters the gut</p>
22, 23 – Ginger Thomas Trail	9	<ul style="list-style-type: none"> • Create small stormwater storage practices, such as bioretention areas, in the road layout. Consideration would need to be given to any future development plans/expansion of existing roadways.

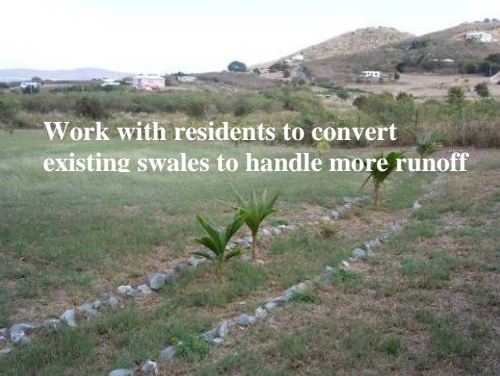
24 – Hibiscus Circle 1	10	<ul style="list-style-type: none"> • Convert swales built by residents into larger, vegetated bioswales that can handle more flow. Install waterbars to ensure road drainage reaches swale. Need to establish a sw easement here.

<p>Work with residents to convert existing swales to handle more runoff</p>
25 – Hibiscus Circle 2	10	<ul style="list-style-type: none"> • Convert a portion of this wide road into a vegetated bioswale (2-3 feet deep, 8-10 feet wide) to reduce erosion and ponding issues. Use check dams where needed. • Use waterbars where necessary to direct road runoff into swale. Specifically, install a waterbar at the downstream edge of the paved intersection. • Discharge any overflows into the eastern gut via a stabilized channel in a stormwater easement between Lots 24 and 25.

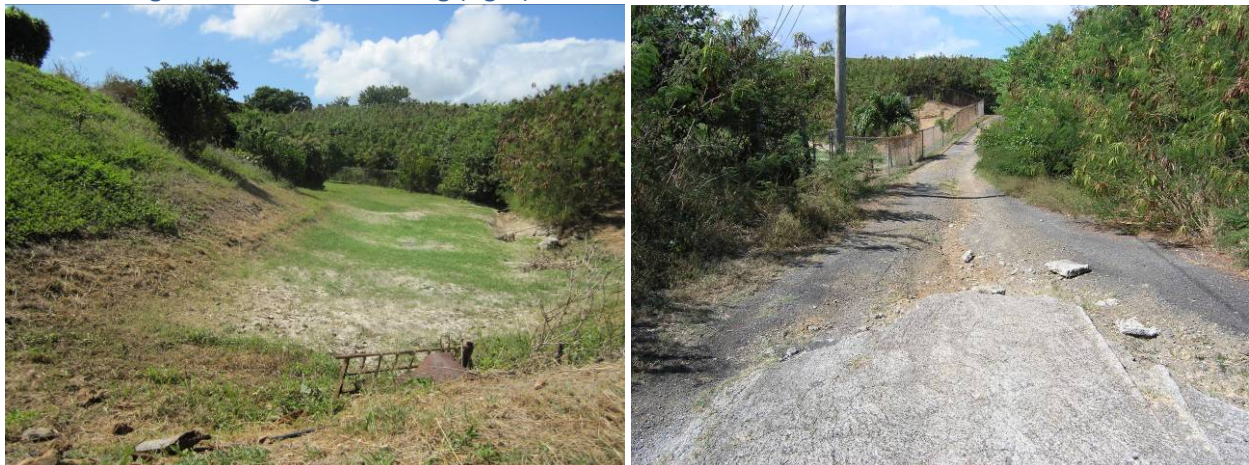
Figure 43. Gut downstream from large pond with two damaged/clogged culverts (left); the deteriorating road at the gut crossing (right).

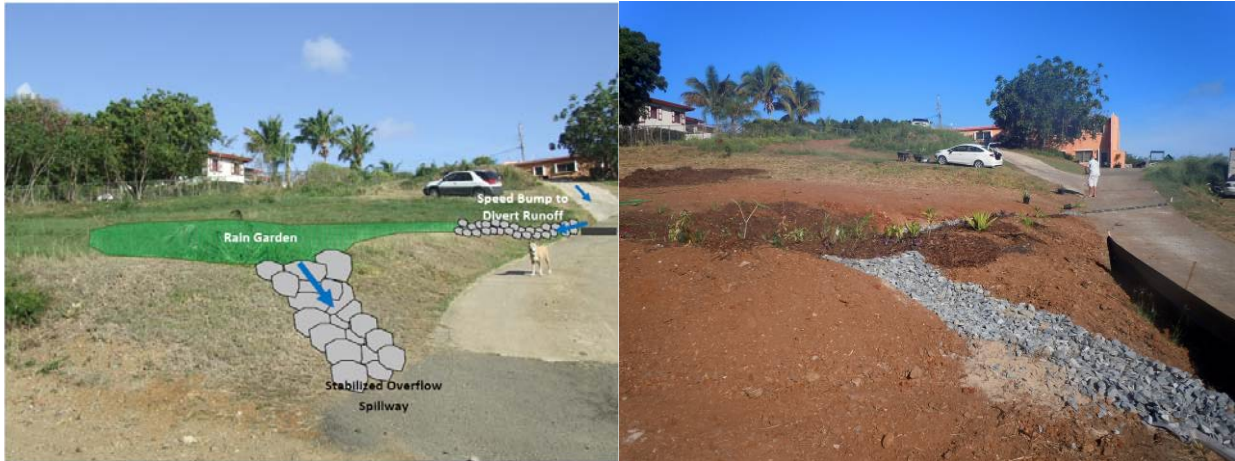
Station 12 is a demonstration project that was constructed with volunteer help in late October 2012. The demonstration project involved the creation of a small residential rain garden in an existing grassed area adjacent to a driveway (see Figures 40, 41, and 42 below and the site plan in Attachment C) at 53 Hope and Carton. The purpose was to minimize surface runoff from the property onto the adjacent road and to serve as an example for other residents of the Hope and Carton Hill neighborhood and beyond. This is a great example of what homeowners should consider for their own driveway runoff.

Figure 40. Initial rain garden concept (left) and finished rain garden (right), constructed as a part of a volunteer work day in October 2012.

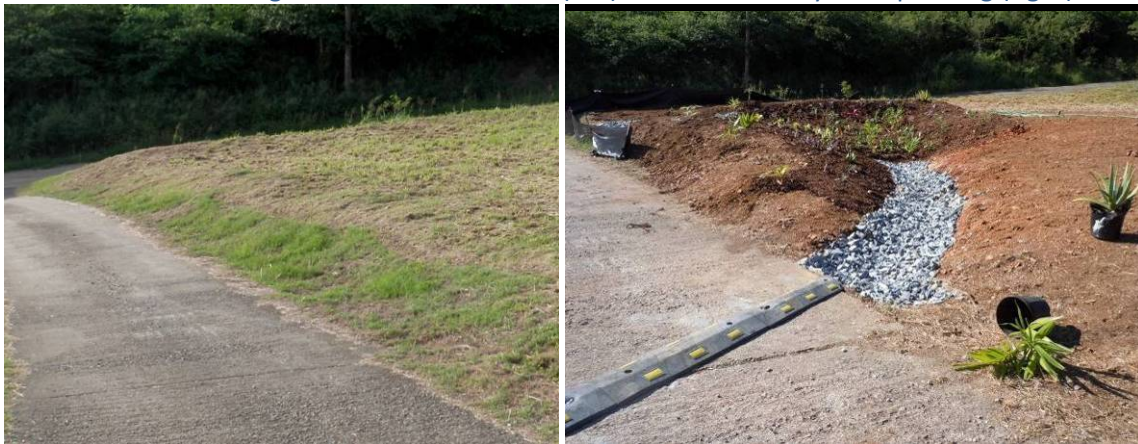
Figure 41. Before the rain garden was constructed (left) and immediately after planting (right).

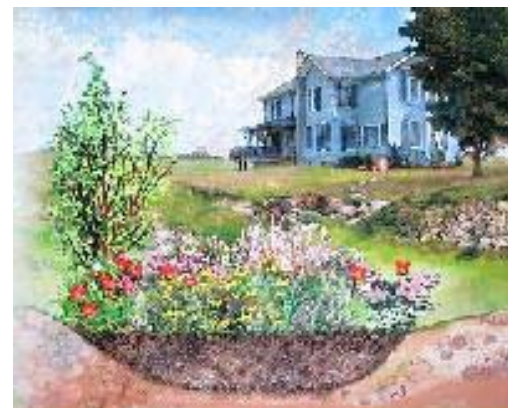
Rain gardens are a very good option to help lower the impact of impervious surfaces and polluted runoff because they are low-tech, inexpensive, sustainable and aesthetically pleasing. A Rain Garden will:

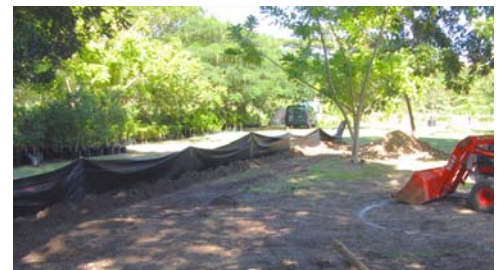
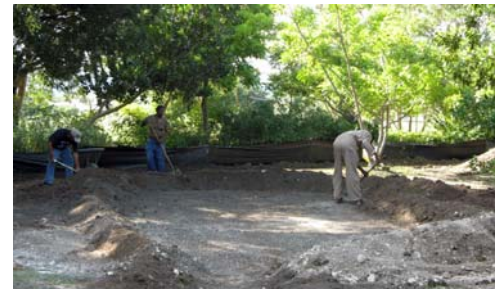
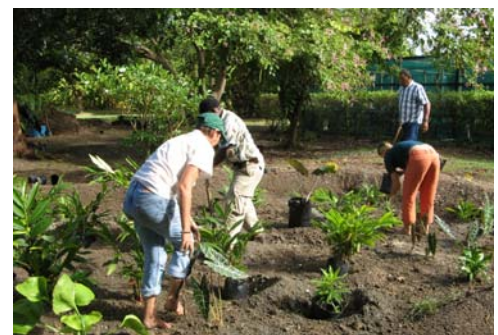
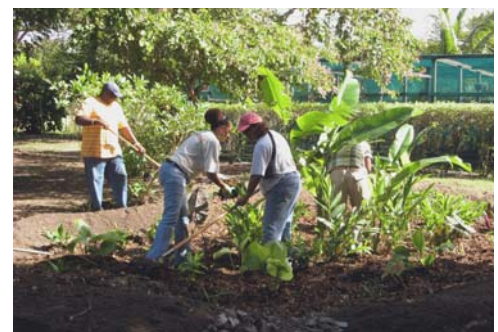
Dig a flat depression 6-12 inches deep, located at least 10 feet away from building foundations, septic systems and utility lines. Once your garden is dug, give it a trial run. Put a hose or sprinkler on in the garden for 30 to 60 minutes to see how well water soaks in (infiltrates). Once plants are mature, infiltration will be much quicker. Be sure to let the garden dry out before planting. If the bed does not drain, remove 3-4 inches of soil. Add compost or sand. Till deeply, about a foot, to loosen compacted soil. On slopes, use some of the excavated soil to create a berm on the down-stream edge of the rain garden to help hold storm water from small storms. In the first year, you may also cut a notch at the top of the garden to let rain flow out; the bed will not fill to the top, allowing plants to establish root systems for infiltration.

Place plants in pots on the bed, according to your design. Gently remove plants from pots, break up the roots, and plant. A rain garden planted with plugs or container plants benefits from a layer of shredded hardwood mulch. Mulch reduces weeds and conserves water, helping to establish the plants. It also prevents surface sealing of the rain garden and removes some pollutants from pavement runoff. Water the bed once a week with one inch of water until plants are established.

The most common cause of rain garden failure is **soil compaction**. **Avoid soil compaction during all phases of construction.** Place and grade soil in the rain garden from the side. Prevent vehicles from driving on the rain garden. Place barriers to protect the rain garden from foot and construction traffic.

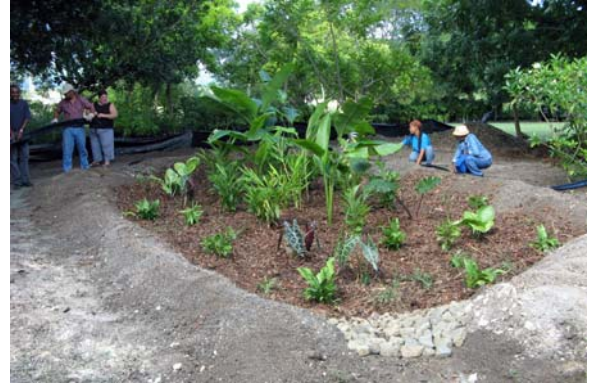
Rain gardens are not completely maintenance-free. It is important to weed, clean-up and re-mulch the garden periodically, and especially after heavy rains. Regular maintenance is required to keep your rain garden looking good and functioning well. Be sure to include this in your plan and your budget!

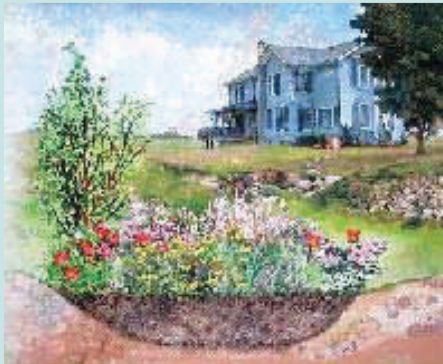
Build a Rain Garden in 10 Steps

Step 2: Pick a location. A rain garden should be at least 10 feet from foundations and fence posts, and 25 feet from septic system drain fields and well heads.

Step 5: Outline the garden location. Use string and wooden stakes or a garden hose to mark the general placement. Think about the land's slope and where heavy rain may come in and flow out; don't orient the garden so that overflow runs into your foundation or septic system.

Step 6: Dig in. The depression should be within your marked outline and to the depth you determined in the previous steps. Note: The most common cause of failure of a rain garden is soil compaction. ***It is essential to avoid compaction of soils during all phases of construction.***

Step 7: Check the drainage rate again. Fill the depression with water, then measure the infiltration rate as in Step 3. If the drainage is poor, remove 3–4 more inches of soil and till in some sand, gravel or compost to a depth of 1 foot, then check drainage again.

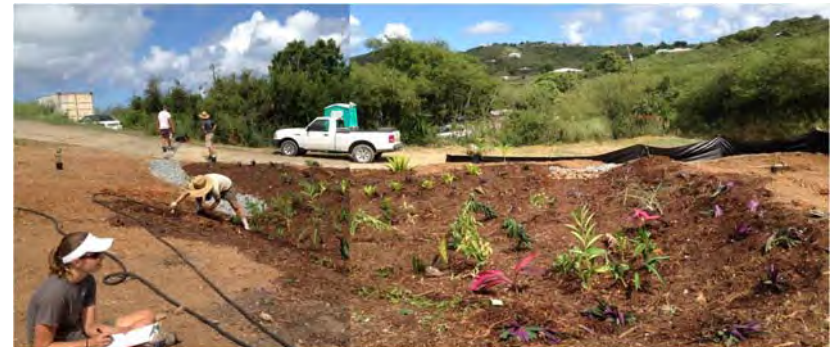
The Cullen's rain garden is a pilot project in the Hope & Carton Hill neighborhood to show how residents can capture storm water runoff from their driveways and retain it on their properties. Removing driveway runoff from the neighborhood road network helps to reduce road deterioration, improve road drainage and provide homeowners with a beautiful landscape.

20% of the total Hope & Carton Hill road network is driveways. Runoff from driveways that drain to our roads contributes to road erosion and overall road maintenance costs. If each homeowner managed the runoff from their driveway with a rain garden, our road problems would be greatly reduced!
