The Vegetation of the Lake Michigan Shoreline in Wisconsin

by Peter J. Salamun and Forest W. Stearns

Advisory Report No. WIS-SG-78-420

University of Wisconsin Sea Grant College Program

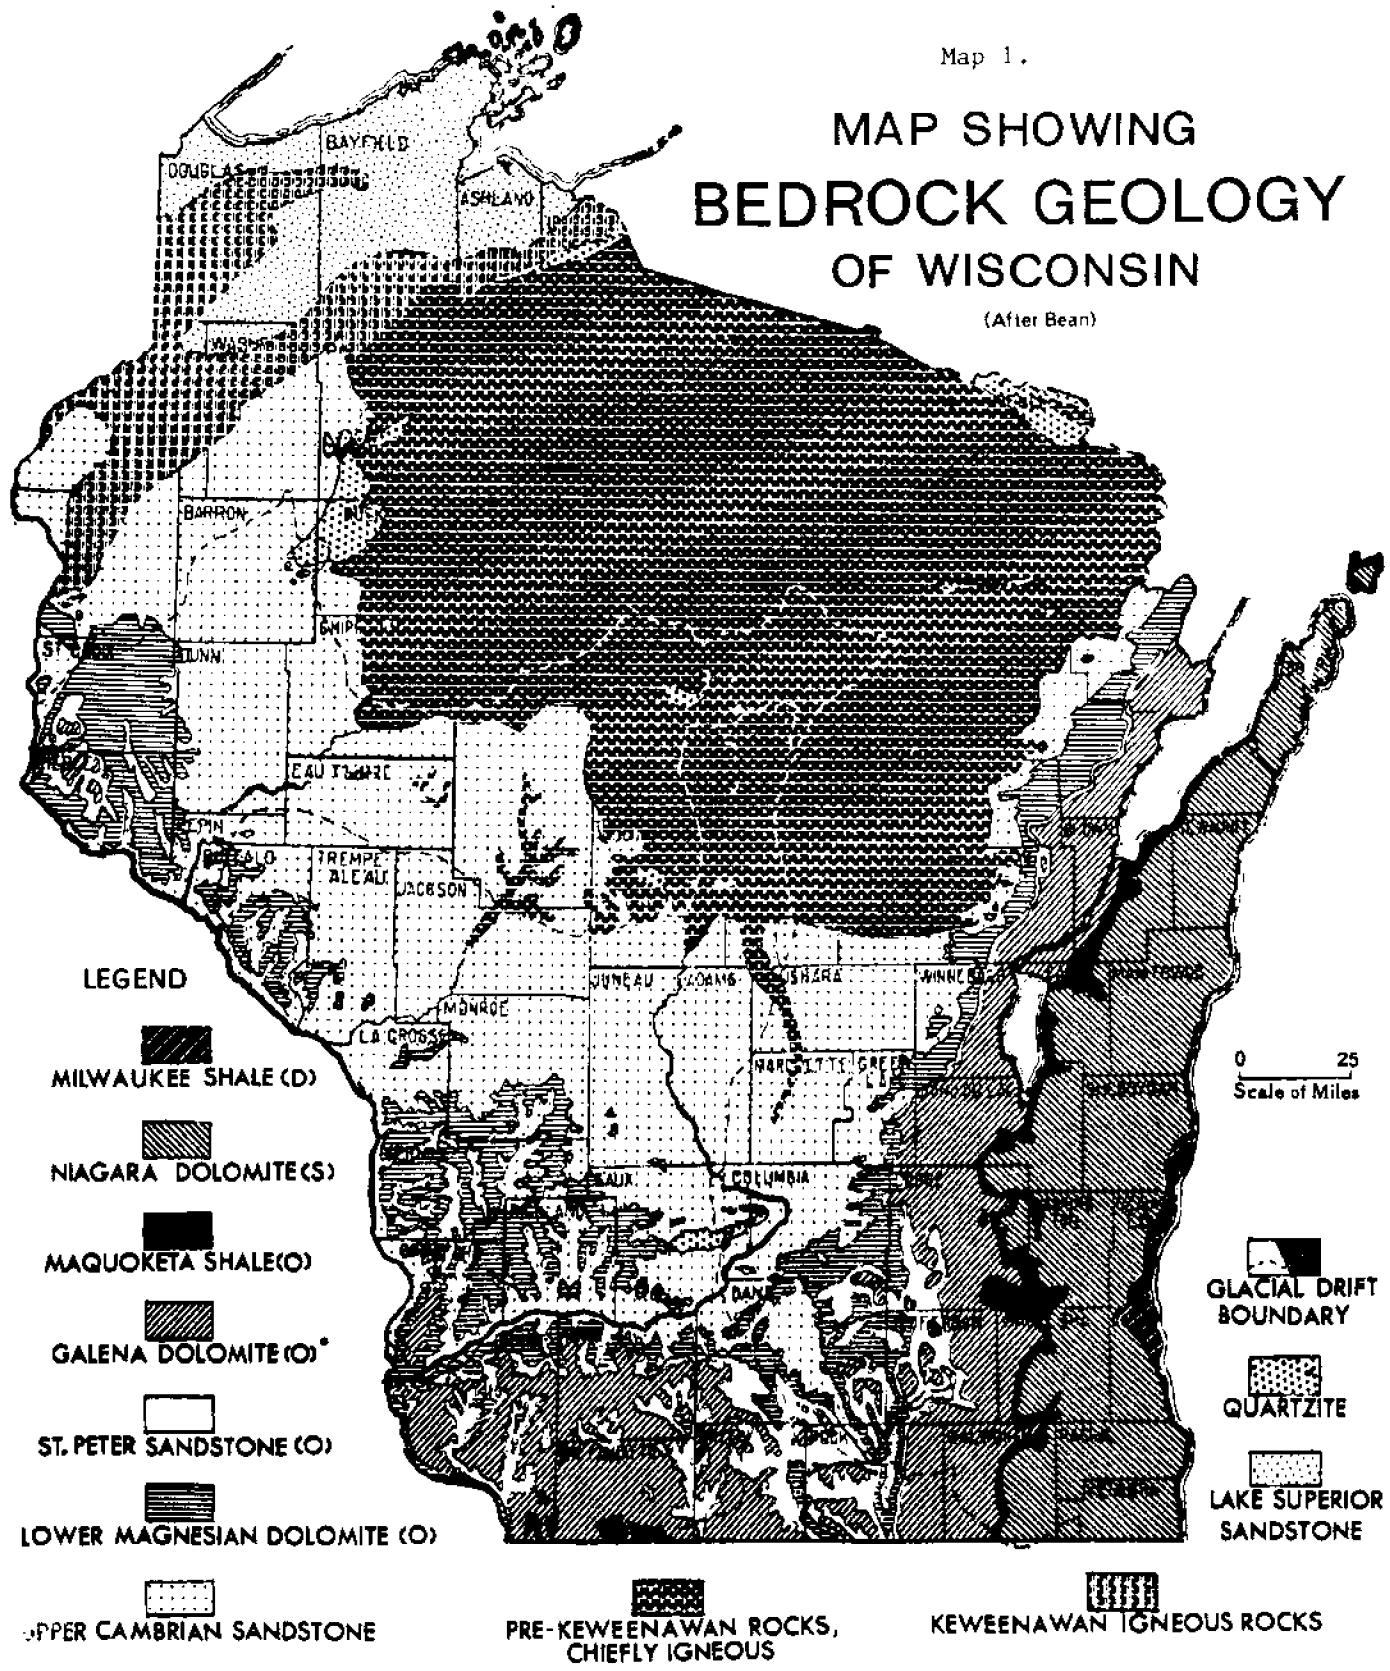
Map 1.

MAP SHOWING BEDROCK GEOLOGY OF WISCONSIN

The bedrock is exposed at several places in eastern Wisconsin (Map 1). Dolomitic shale (Devonian) appears in northeastern Milwaukee County and the eastern portions of Ozaukee and Sheboygan Counties but is inundated by the present high levels of Lake Michigan. Niagara dolomite (Silurian) outcrops in several localities in Door County. At Cave Point (Site 27), these outcrops extend 2-3 meters above the lake level forming low cliffs (Fig. 1(F)), that are subjected to considerable wave action but erode only gradually over very long periods of time. Other outcrops were observed at Toft Point (Site 31) along the southeastern shore of Moonlight Bay and along the causeway extending to Cana Island. These latter two outcrops are generally less than one meter above the present lake level (Fig. 1(G)) and are frequently inundated by high waves. The bare, exposed nature of these habitats makes them unsuitable for vascular plants, but they support several species of algae including *Cladophora glomerata* and *Bangia atropurpurea* (Blum, pers. comm.). The role of algae in these habitats has not been explored. Shoreward, beyond the extent of wave action, the vascular plant community consists chiefly of species of boreal or northern hardwood forests (Curtis 1959). These communities have been discussed in the section on Beaches, ridges and dunes.

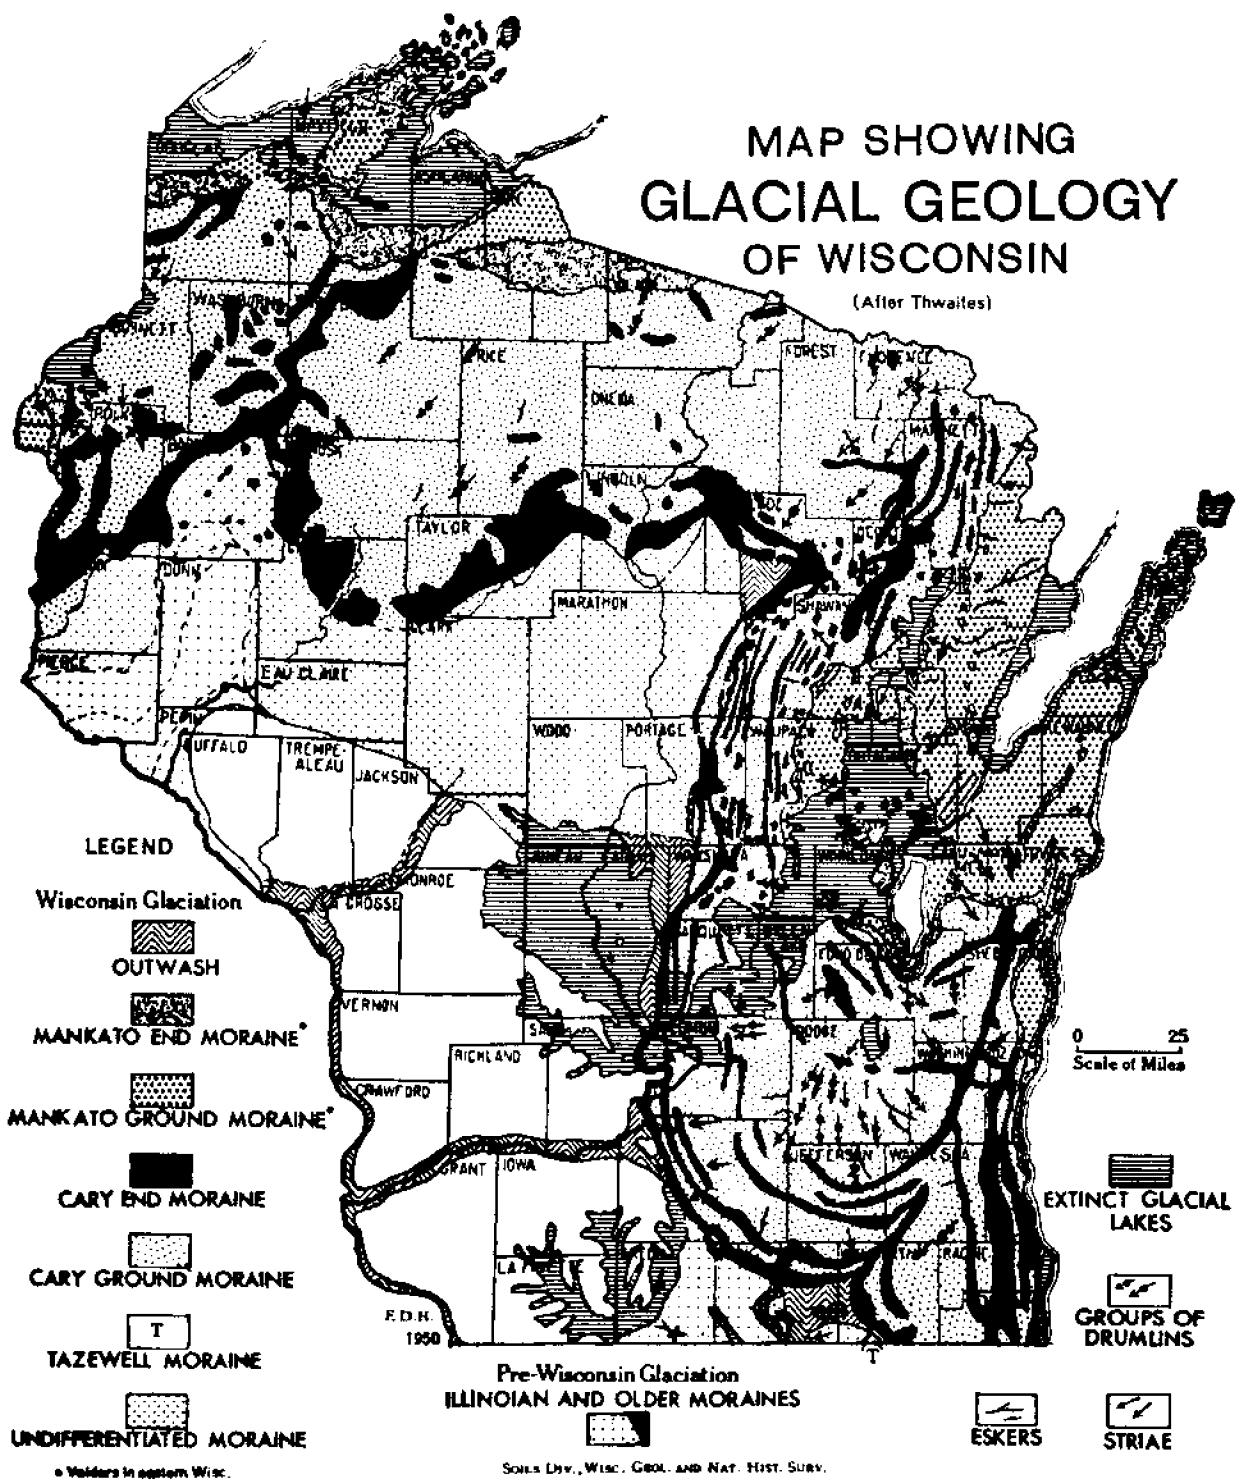
Map 2. Glacial Geology of Wisconsin.

MAP SHOWING GLACIAL GEOLOGY OF WISCONSIN

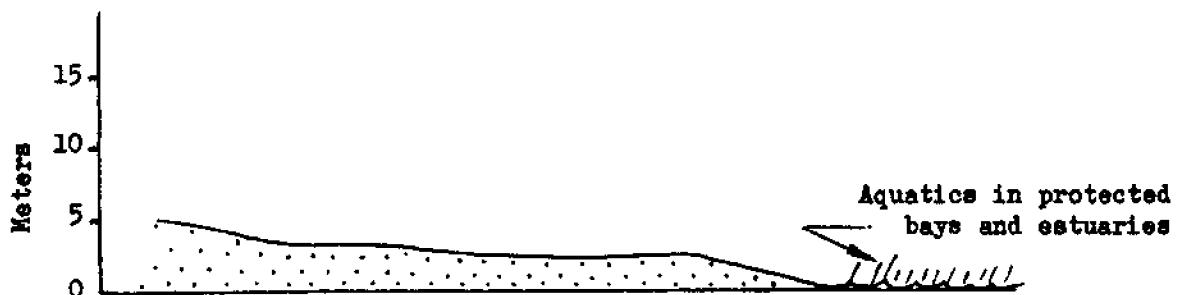
Figure 1. Types of Lake Shore Profiles in Eastern Wisconsin.

(A) Gentle slope with sandy beach.

Sandy shorelines have distinct slope profiles (Fig 1(A)), the result of both water and wind erosional and depositional processes. The area from the water's edge to the extent of the highest storm waves is the beach or strand zone. Fluctuations in water level and unpredictable storm waves cause this habitat to be characterized by instability and considerable variation in plant life. Some characteristic plants are present at the highest level of the beach. These include sea rocket (Cakile edentula), beach pea (Lathyrus maritimus var. glaber), seaside spurge (Euphorbia polygonifolia), Russian thistle (Salsola kali), bugseed (Corispermum hyssopifolium), winged pigweed (Cycloloma atriplicifolium) and silverweed (Potentilla anserina). None of these plants are found in abundance and, as Curtis (1959) has noted, their presence and densities vary from year to year.

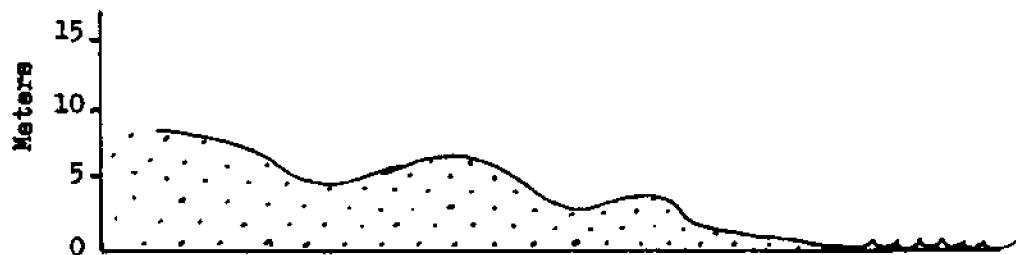
(B) Dunes, ridges, swales and sandy beach.

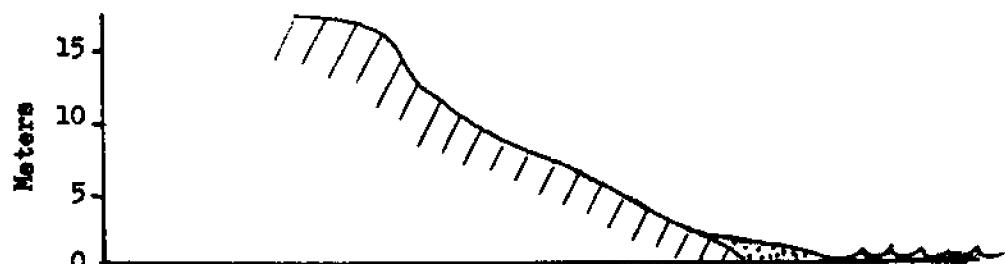
(C) Medium slope, $< 35^\circ$, with sandy beach.

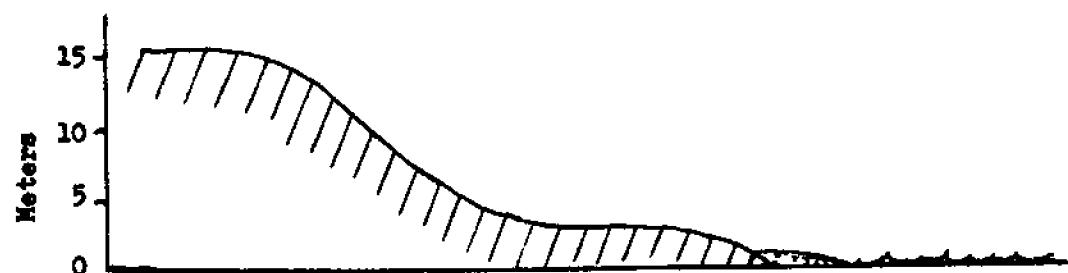
(D) Medium to steep slope with lake terrace and sandy or gravelly beach.

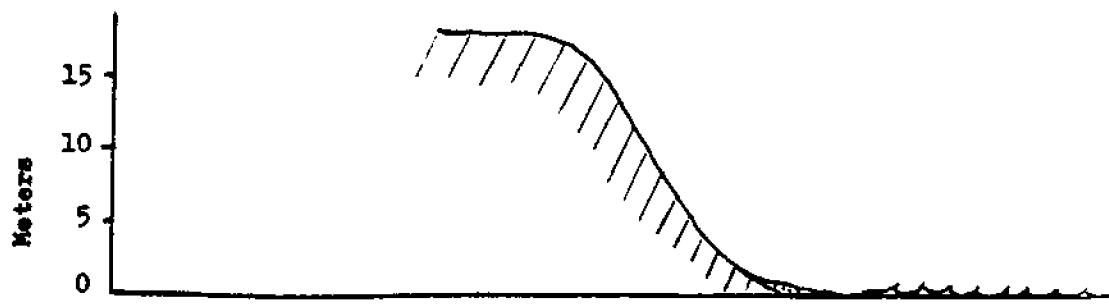
(E) Steep slope, $>35^{\circ}$, with narrow sandy or gravelly beach.

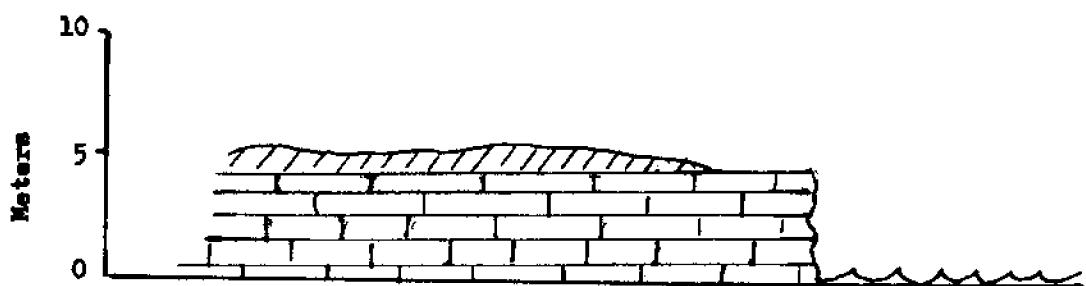
(F) Rocky bluff.

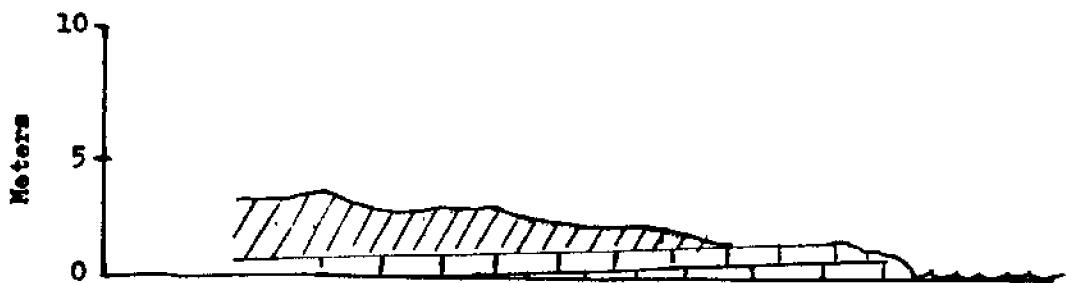
(G) Rock outcrop.

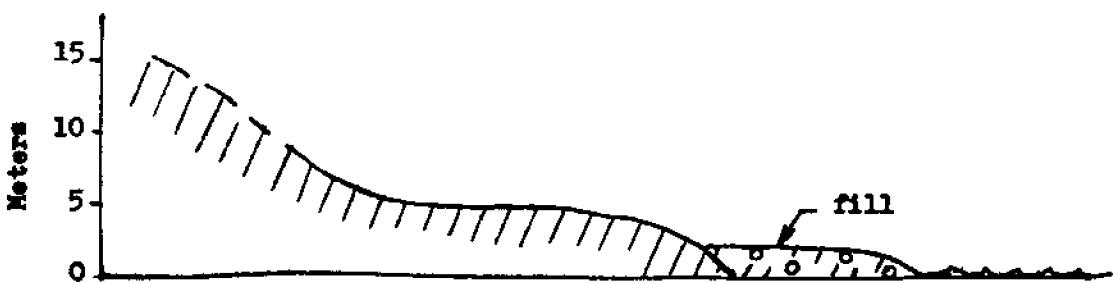
(H) Modified shoreline.

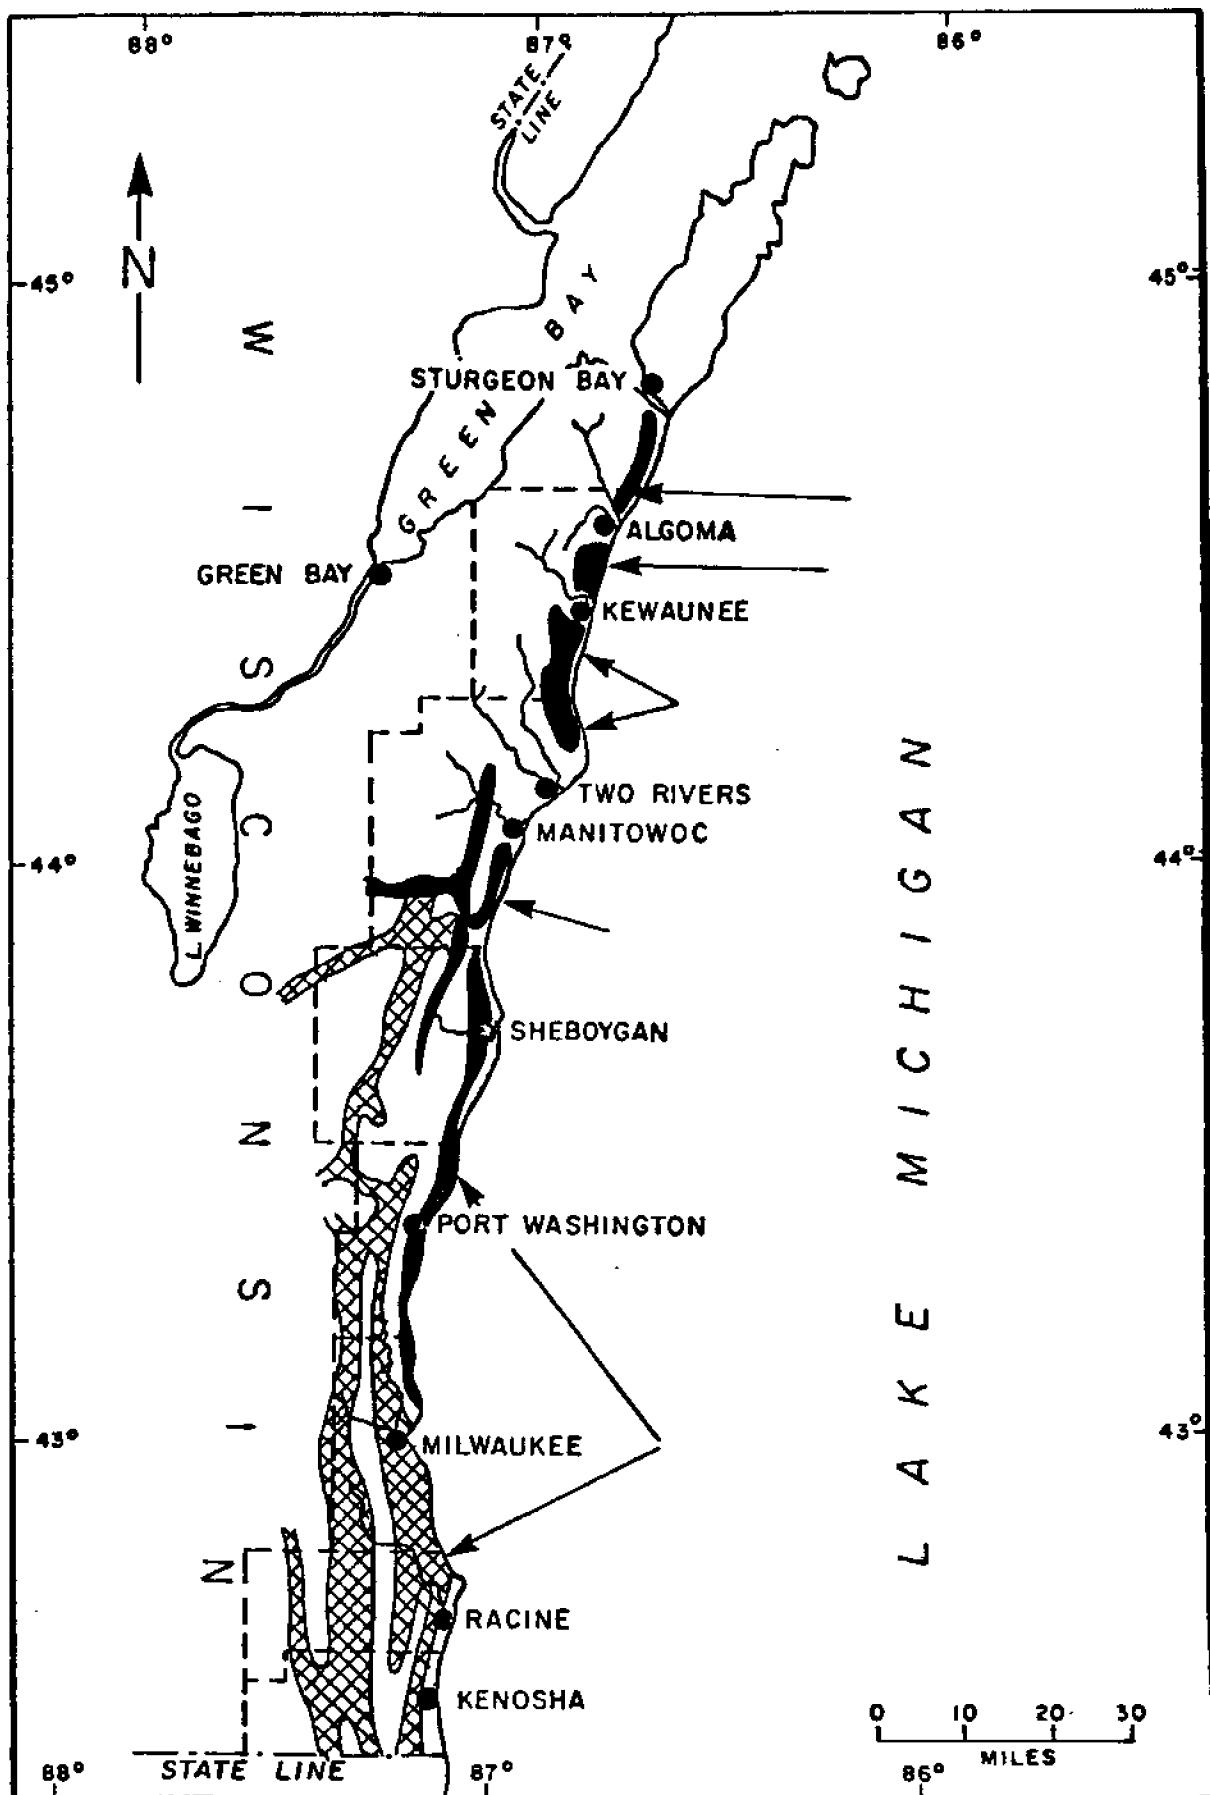
Map 7. Locations of clay bluffs, ravines and lake terraces associated with Cary (cross-hatches) and Valders (shaded) moraines.
