Pennsylvania  
Coastal Zone  
Management Program

SHORELINE EROSION  
AND FLOODING

ERIE COUNTY

THE GREAT LAKES RESEARCH INSTITUTE

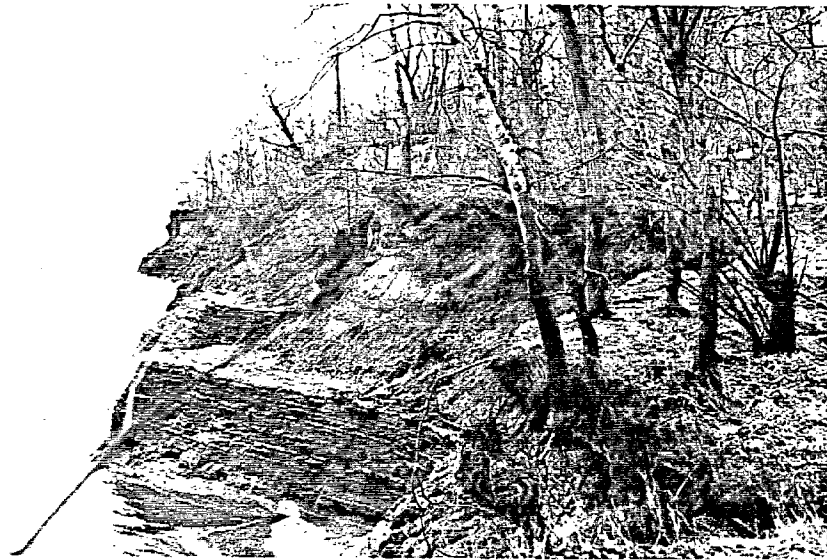
Cusate features are found in the bedrock sections of the East County. While not conclusive, these dramatic features are probably the result of jointing in the bedrock. The energy brought to the exposed rock face by waves results in hydraulic pressure which enlarges the joint to dimensions of over 100 feet. The result is the formation of rectilinear cusps that are rounded by abrasion or corrasion in the shore zone.

Above: Cuspate features in bedrock, Harborcreek Township

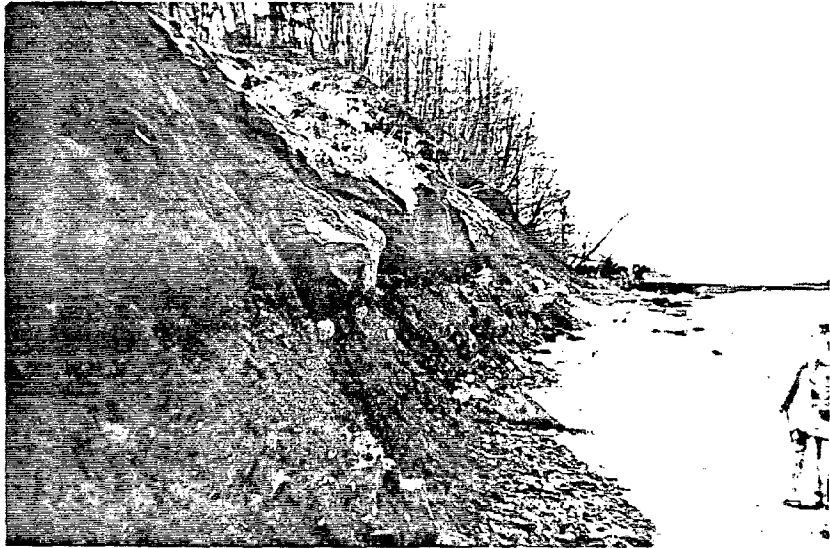
Above: Glacial tills overlain by clay and sand deposits

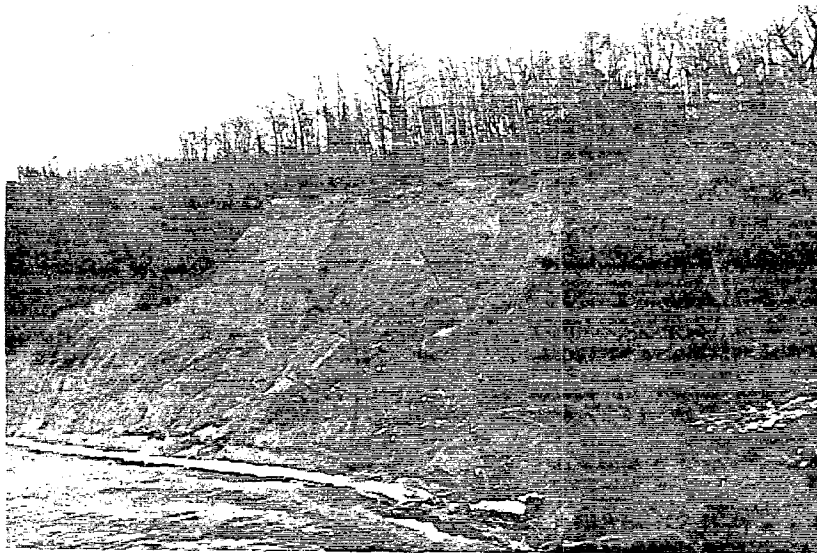
Above and below: Between Raccoon Creek and Ellis Road,  
Springfield Township

SHORE ZONE  
DESCRIPTION: Near vertical bluff; mass slumping evident. Grass  
and trees on bluff crest and slope are disrupted.  
Ground water is evident as a contributory factor  
in recession.

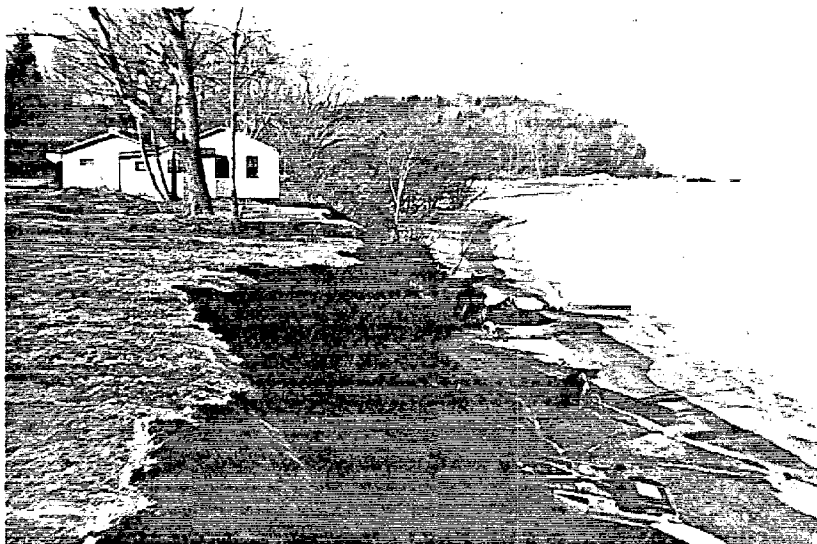
Above: Cottage overhanging bluff crest; view looking west toward mouth of Elk Creek, Girard Township; note abandoned cars at base of bluff

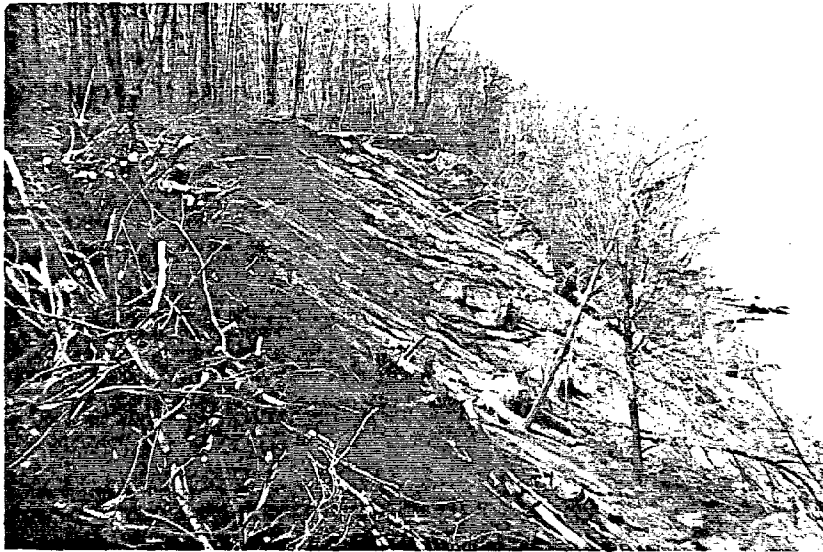
SHORE ZONE DESCRIPTION: The high bluffs with 60° slope are generally stable from Elk Creek to Lake Erie Community Park. In the park there are two massive slump blocks on 80° slopes which have been displaced downward to 10 ft. in the past two years. There are also several areas that have suffered rapid erosion and recession. This area is relatively unprotected with only a narrow beach strand during low water and occasional trees acting as temporary groins. The groin used by the cement works to collect sand and gravel has built up 25-50 ft. of beach and serves to protect and stabilize the eastern edge of the park. In the Lakelands area there is another large slump block similar to the ones in the park. There is periodic erosion interspersed with stable bluffs.

Above: Lake Erie Community Park, Girard Township showing  
area of mass wasting

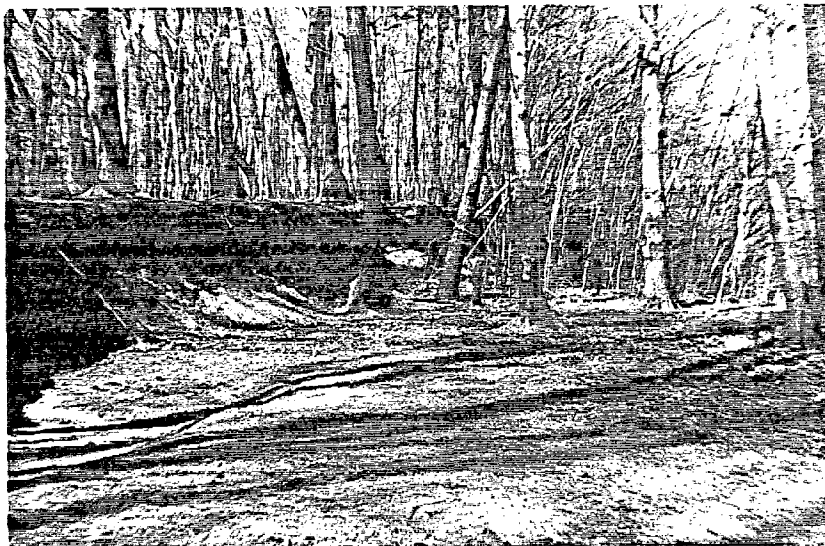
Above: Lake Erie Community Park, Girard Township; showing  
vertical displacement of massive slump block

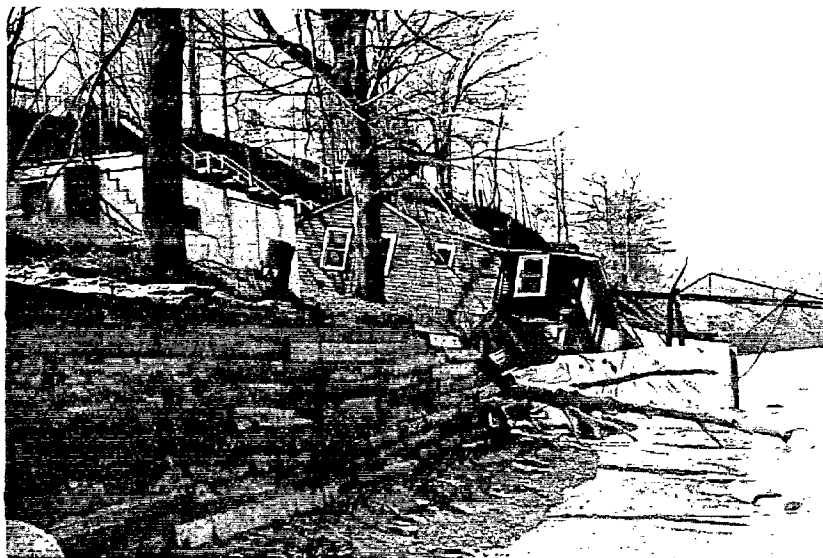
Above and below: Francroft Subdivision, North East Township;  
showing destruction of boat houses and beach cottages

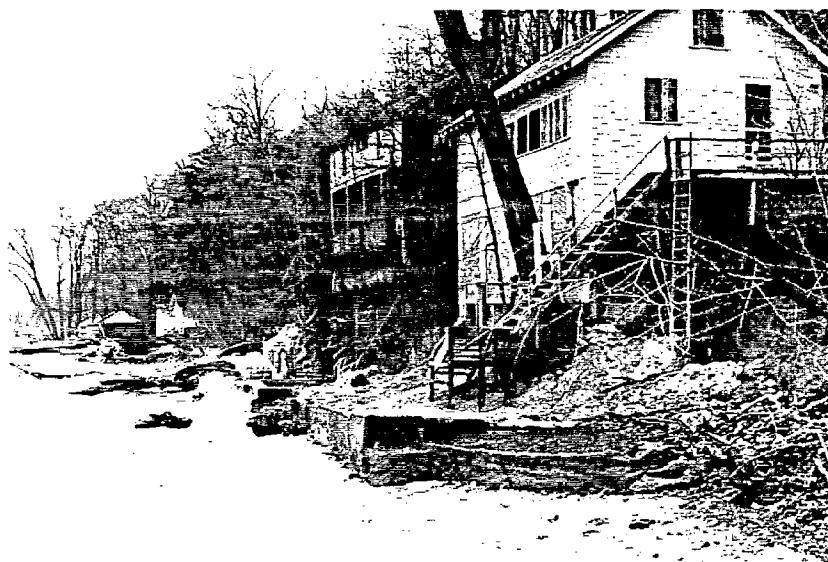
Above: East end of Glenruadh section, looking east toward Eaglehurst, Millcreek Township

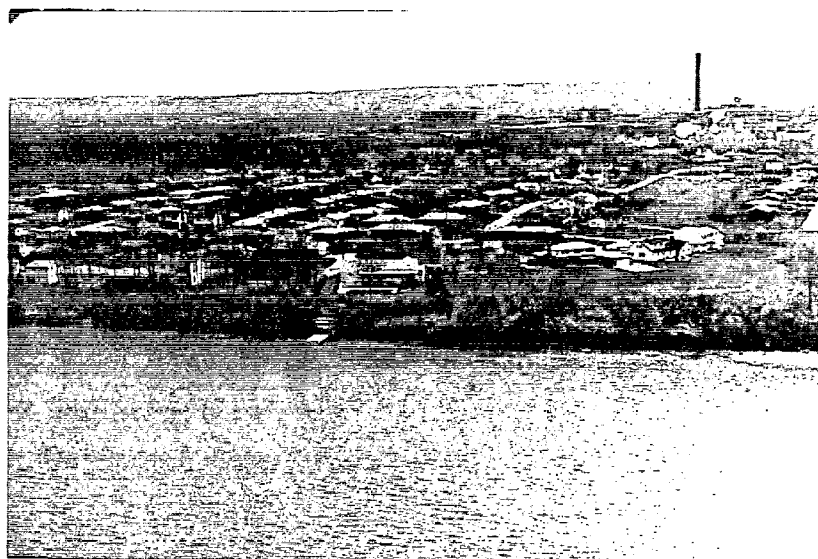
Above: Lakeside Drive, Lawrence Park Township

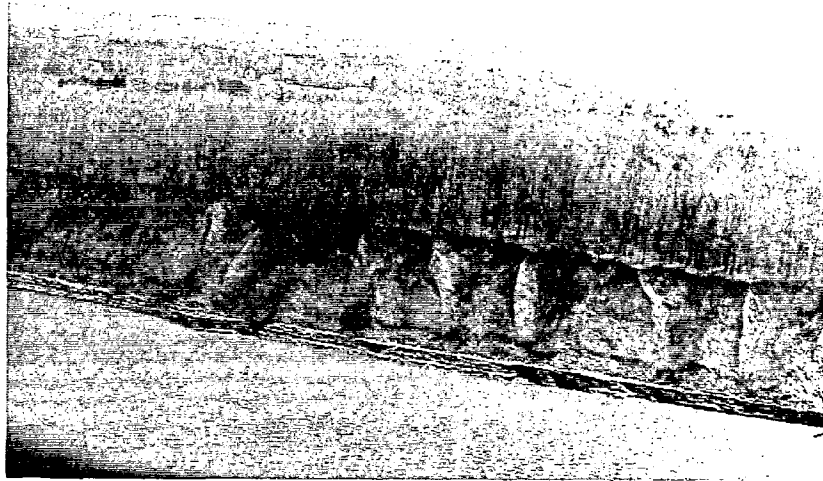
Above: East of Eight Mile Creek, Harborcreek Township

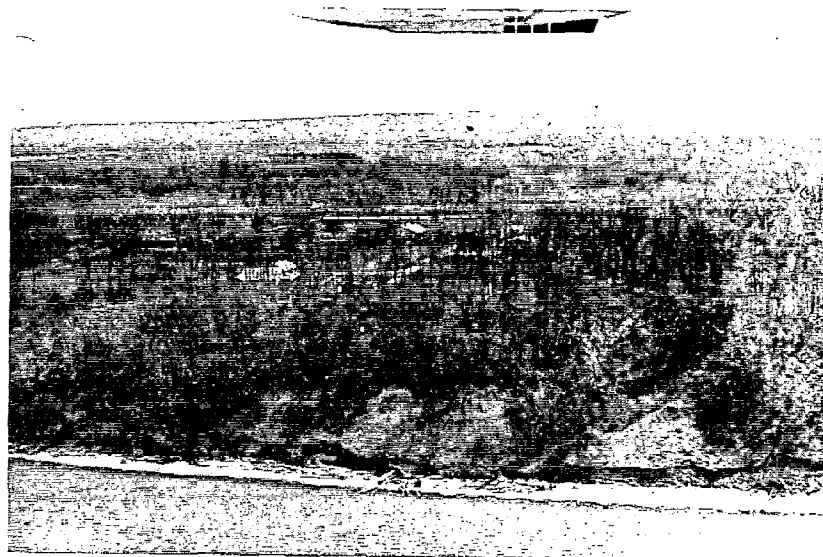
Above: Between Eight Mile Creek and Twelve Mile Creek,  
Harborcreek Township

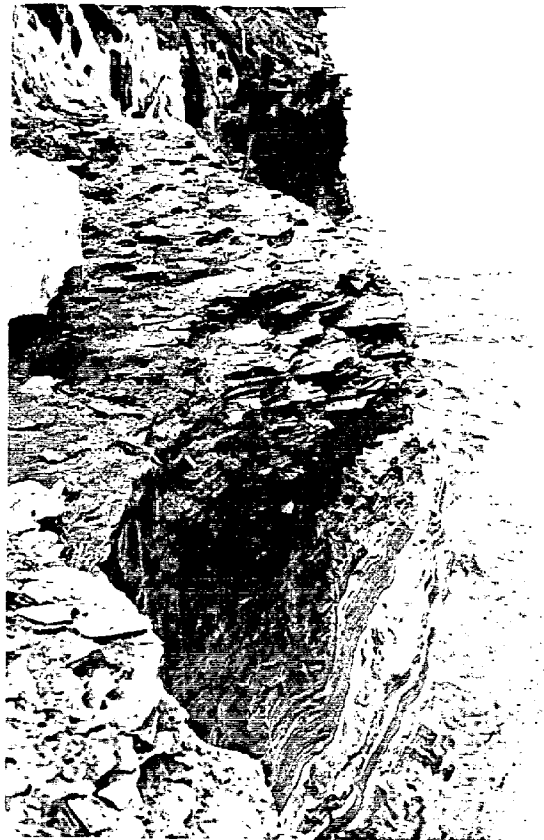
Above and below: Bedrock exposures in Lawrence Park and Harborcreek Township
